Profile/Photo Observation Report

Date:	04/22/2018	Weather:		Coding:	PACP 6.0
Pipe Length (ft):	205.8	Owner:	NA	Pre Clean:	Not Known
P.O.#:		Surveyor:	Jen Costello	PSR:	P-604-088-089
Customer:		Clean Date:	01/01/1900	Shape:	C

Street:	N PENNSYLVANIA ST	Flow Control:	Not Controlled
City:	Hobart, IN	Year Renewed:	
Location:	Light Highway	Tape/Media #:	
Purpose:	Not Known	Dia/Height:	12"
Use:	Sanitary	Material:	VCP
Drain Area:	NA	Lining:	
Category:	NA		
Comment:

Location Details:		Direction of Survey:	Downstream
US MH:	M-604-089	DS MH:	M-604-088
		Total Length Surveyed (ft):	78.8

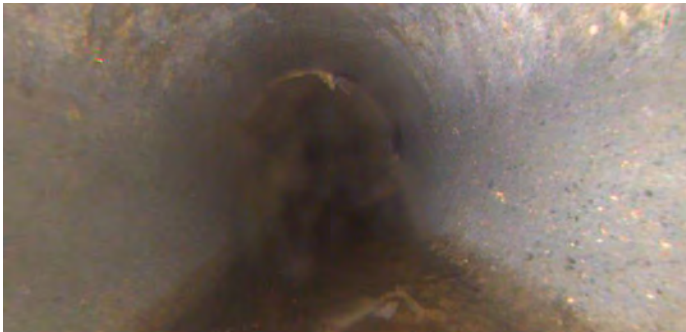
Code: **MWL**
Description: **Water Level**

Distance (ft): **.0**
Structural Grade: **0**
O&M Grade: **0**
Clock Start/From:
Clock To:
1st Value:
2nd Value:
Value Percent: **5.000**
Continuous Index:
Within 8" of Joint: **NO**
Remarks:

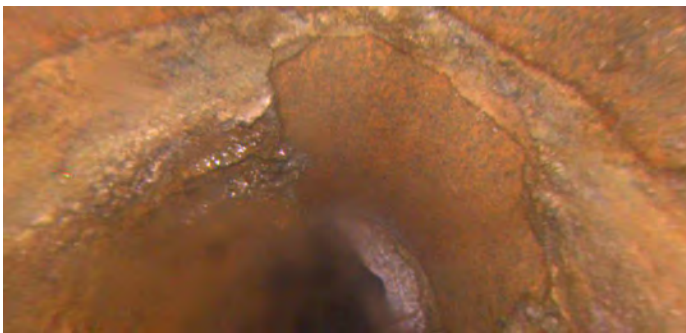
Code: DAE
Description: Deposits Attached Encrustation

Distance (ft): 5.4
Structural Grade: 0
O&M Grade: 2
Clock Start/From: 8
Clock To: 4
1st Value:
2nd Value:
Value Percent: 5.000
Continuous Index:
Within 8" of Joint: NO
Remarks:

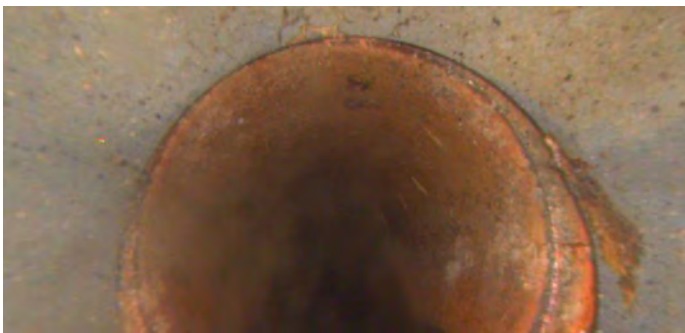
Code: **CM**
Description: **Crack Multiple**

Distance (ft): **10.3**
Structural Grade: **3**
O&M Grade: **0**
Clock Start/From: **8**
Clock To: **4**
1st Value:
2nd Value:
Value Percent:
Continuous Index: **S01**
Within 8" of Joint: **YES**
Remarks:

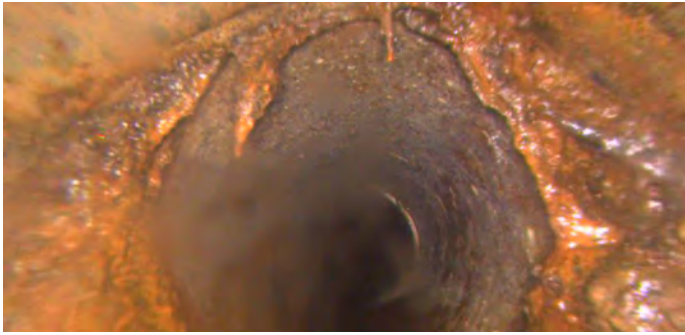
Code: **DAE**
Description: **Deposits Attached Encrustation**

Distance (ft): **14.4**
Structural Grade: **0**
O&M Grade: **2**
Clock Start/From: **8**
Clock To: **4**
1st Value:
2nd Value:
Value Percent: **10.000**
Continuous Index:
Within 8" of Joint: **YES**
Remarks:

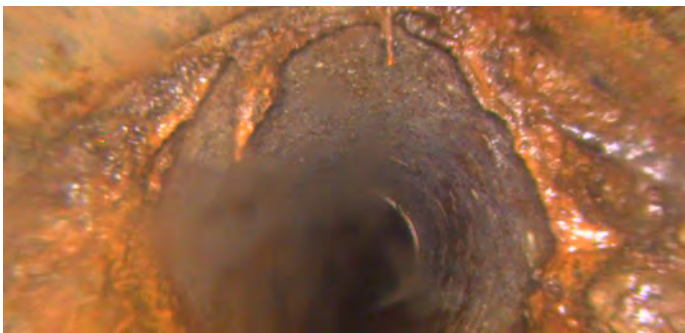
Code: **ID**
Description: **Infil Dripper**

Distance (ft): **14.4**
Structural Grade: **0**
O&M Grade: **3**
Clock Start/From: **11**
Clock To: **12**
1st Value:
2nd Value:
Value Percent:
Continuous Index:
Within 8" of Joint: **YES**
Remarks:

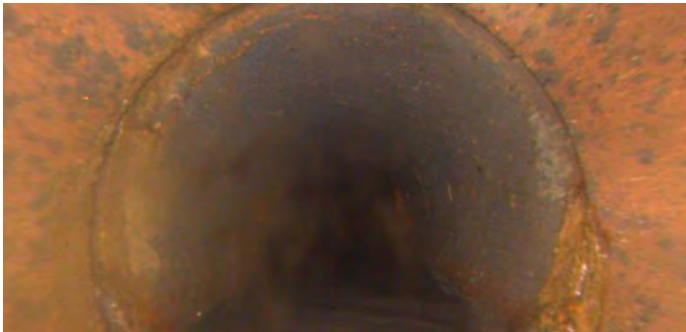
Code: **FM**
Description: **Fracture Multiple**

Distance (ft): **24.6**
Structural Grade: **4**
O&M Grade: **0**
Clock Start/From: **9**
Clock To: **11**
1st Value:
2nd Value:
Value Percent:
Continuous Index:
Within 8" of Joint: **YES**
Remarks:

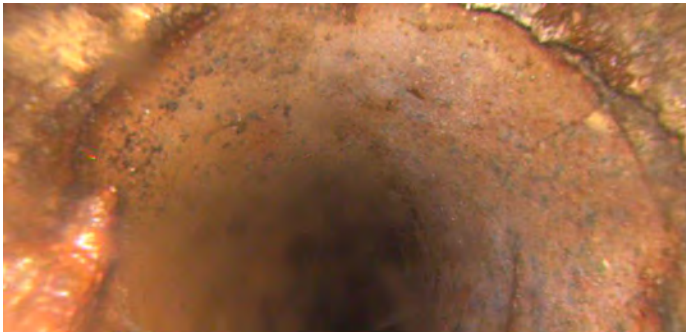
Code: **CL**
Description: **Crack Longitudinal**

Distance (ft): **43.3**
Structural Grade: **2**
O&M Grade: **0**
Clock Start/From: **2**
Clock To:
1st Value:
2nd Value:
Value Percent:
Continuous Index:
Within 8" of Joint: **YES**
Remarks:

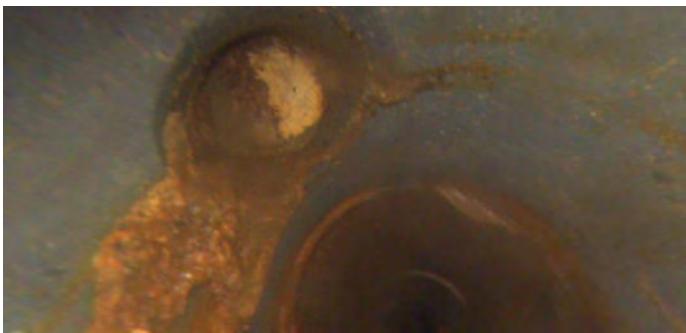
Code: **DAE**
Description: **Deposits Attached Encrustation**

Distance (ft): **49.0**
Structural Grade: **0**
O&M Grade: **2**
Clock Start/From: **12**
Clock To: **4**
1st Value:
2nd Value:
Value Percent: **5.000**
Continuous Index:
Within 8" of Joint: **NO**
Remarks:

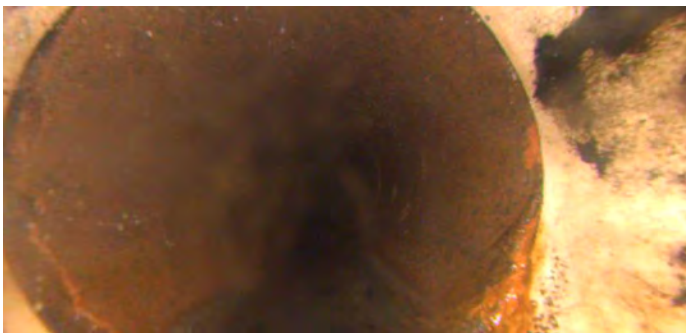
Code: **IW**
Description: **Infil Weeper**

Distance (ft): **59.8**
Structural Grade: **0**
O&M Grade: **2**
Clock Start/From: **3**
Clock To: **4**
1st Value:
2nd Value:
Value Percent:
Continuous Index:
Within 8" of Joint: **YES**
Remarks:

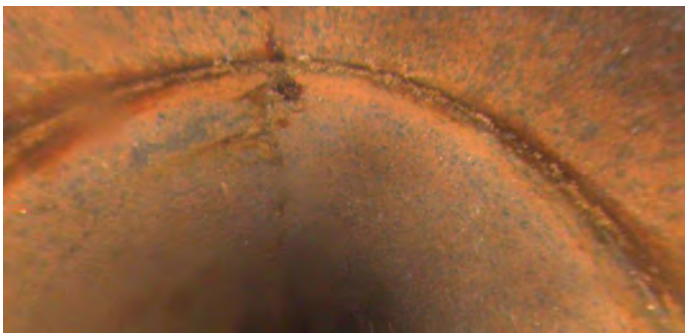
Code: **FL**
Description: **Fracture Longitudinal**

Distance (ft): **61.7**
Structural Grade: **3**
O&M Grade: **0**
Clock Start/From: **12**
Clock To:
1st Value:
2nd Value:
Value Percent:
Continuous Index: **S05**
Within 8" of Joint: **YES**
Remarks:

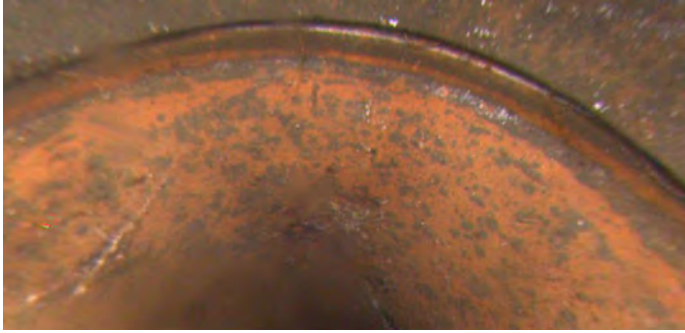
Code: **RFB**
Description: **Roots Fine Barrel**

Distance (ft): **68.0**
Structural Grade: **0**
O&M Grade: **2**
Clock Start/From: **12**
Clock To:
1st Value:
2nd Value:
Value Percent:
Continuous Index:
Within 8" of Joint: **NO**
Remarks:

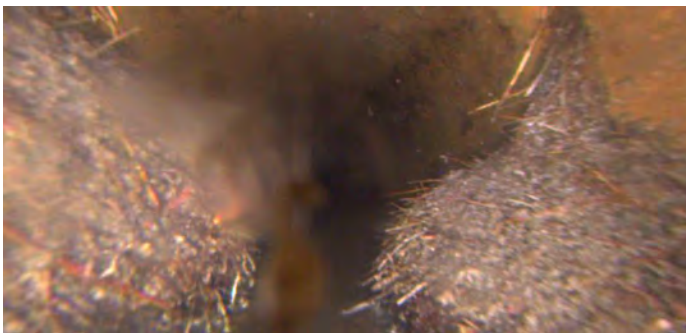
Code: **RMJ**
Description: **Roots Medium Joint**

Distance (ft): **78.2**
Structural Grade: **0**
O&M Grade: **3**
Clock Start/From: **5**
Clock To: **7**
1st Value:
2nd Value:
Value Percent: **30.000**
Continuous Index:
Within 8" of Joint: **YES**
Remarks:

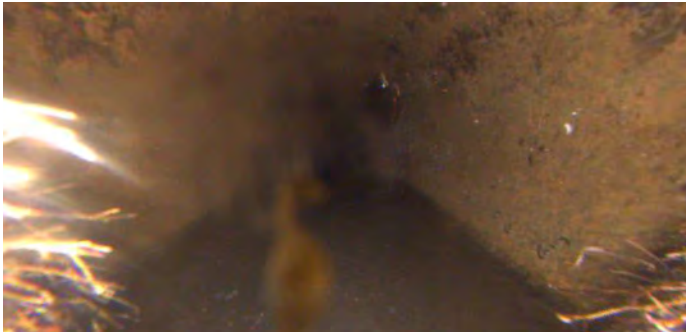
Code: **RMJ**
Description: **Roots Medium Joint**

Distance (ft): **78.8**
Structural Grade: **0**
O&M Grade: **3**
Clock Start/From: **8**
Clock To: **4**
1st Value:
2nd Value:
Value Percent: **5.000**
Continuous Index: **F06**
Within 8" of Joint: **YES**
Remarks:

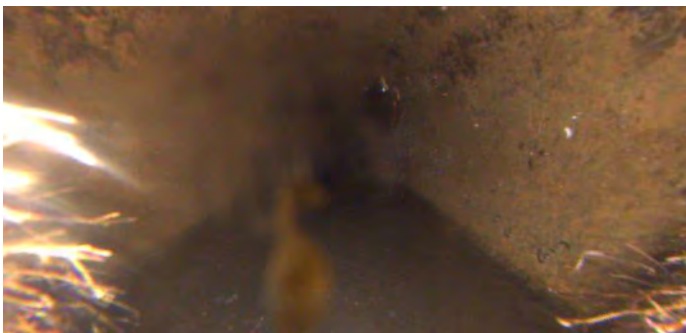
Code: **IW**
Description: **Infil Weeper**

Distance (ft): **78.8**
Structural Grade: **0**
O&M Grade: **2**
Clock Start/From: **8**
Clock To: **4**
1st Value:
2nd Value:
Value Percent:
Continuous Index: **F04**
Within 8" of Joint: **YES**
Remarks:

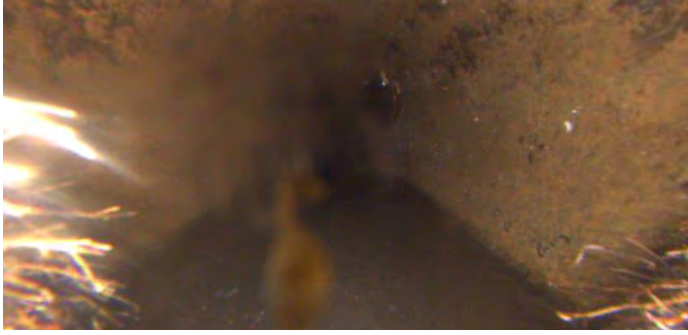
Code:	MSA
Description:	Abandoned Survey
Distance (ft):	78.8
Structural Grade:	0
O&M Grade:	0
Clock Start/From:	
Clock To:	
1st Value:	
2nd Value:	
Value Percent:	
Continuous Index:	
Within 8" of Joint:	NO
Remarks:	RMJ
