Profile/Photo Observation Report

Street:	Summerlin	Flow Control:	Not Controlled
City:	Hobart, IN	Year Renewed:	
Location:	Light Highway	Tape/Media #:	
Purpose:	Not Known	Dia/Height:	12"
Use:	Sanitary	Material:	VCP
Drain Area:	NA	Lining:	
Category:	NA		
Comment:

Location Details:		Direction of Survey:	Downstream
US MH:	M-604-090	DS MH:	M-604-091
		Total Length Surveyed (ft):	178.5

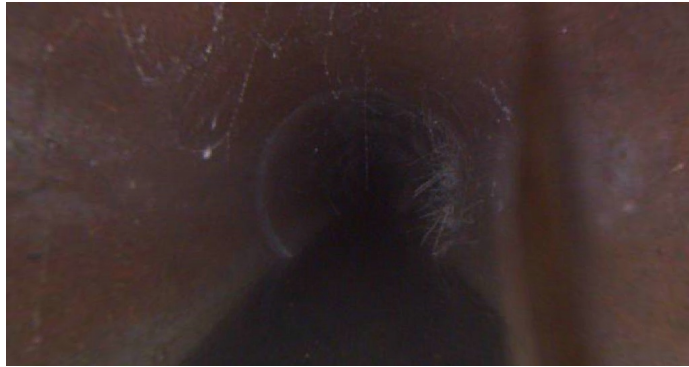
Code: **MWL**
Description: **Water Level**

Distance (ft): **.0**
Structural Grade: **0**
O&M Grade: **0**
Clock Start/From:
Clock To:
1st Value:
2nd Value:
Value Percent: **10.000**
Continuous Index:
Within 8" of Joint: **NO**
Remarks:

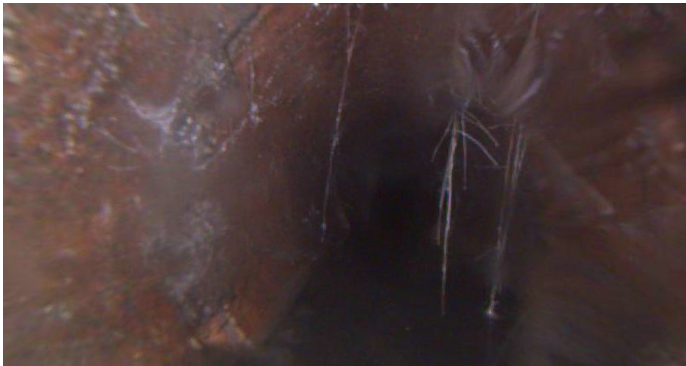
Code: **RFJ**
Description: **Roots Fine Joint**

Distance (ft): **16.3**
Structural Grade: **0**
O&M Grade: **1**
Clock Start/From: **7**
Clock To: **5**
1st Value:
2nd Value:
Value Percent:
Continuous Index: **S02**
Within 8" of Joint: **YES**
Remarks:

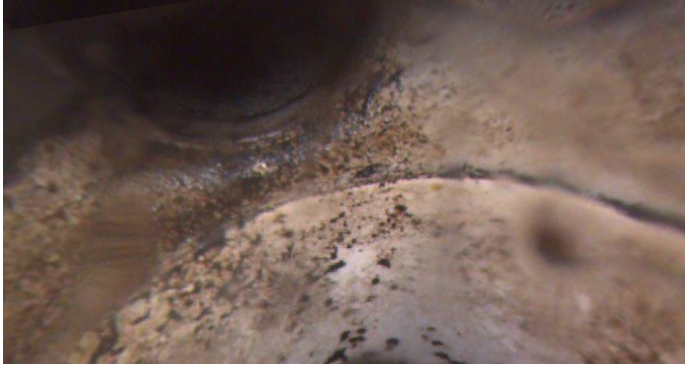
Code: **TF**
Description: **Tap Factory**

Distance (ft): **34.5**
Structural Grade: **0**
O&M Grade: **0**
Clock Start/From: **10**
Clock To:
1st Value: **4.000**
2nd Value:
Value Percent:
Continuous Index:
Within 8" of Joint:
Remarks:

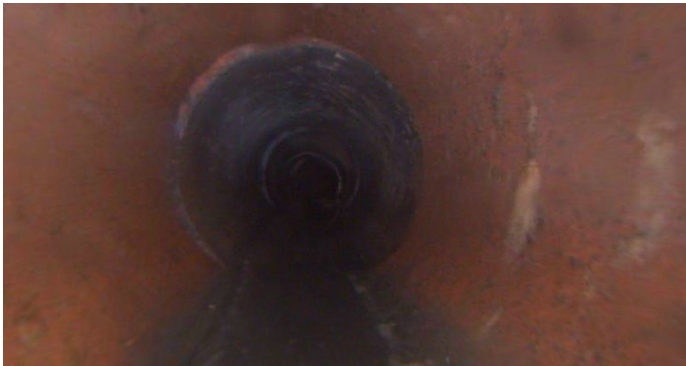
Code: **DAZ**
Description: **Deposits Attached Other**

Distance (ft): **87.2**
Structural Grade: **0**
O&M Grade: **2**
Clock Start/From: **7**
Clock To: **5**
1st Value:
2nd Value:
Value Percent: **5.000**
Continuous Index: **F04**
Within 8" of Joint: **YES**
Remarks:

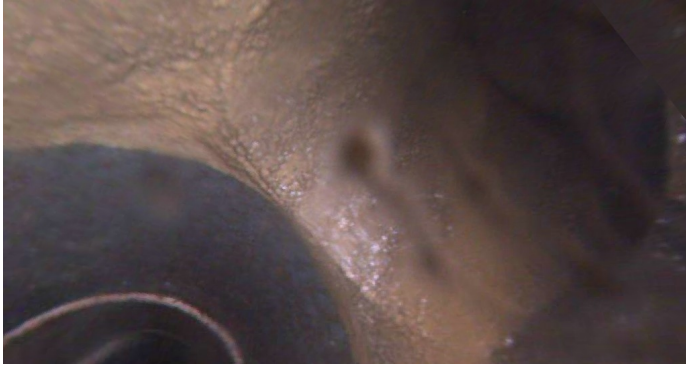
Code: **TF**
Description: **Tap Factory**

Distance (ft): **90.9**
Structural Grade: **0**
O&M Grade: **0**
Clock Start/From: **2**
Clock To:
1st Value: **4.000**
2nd Value:
Value Percent:
Continuous Index:
Within 8" of Joint:
Remarks:

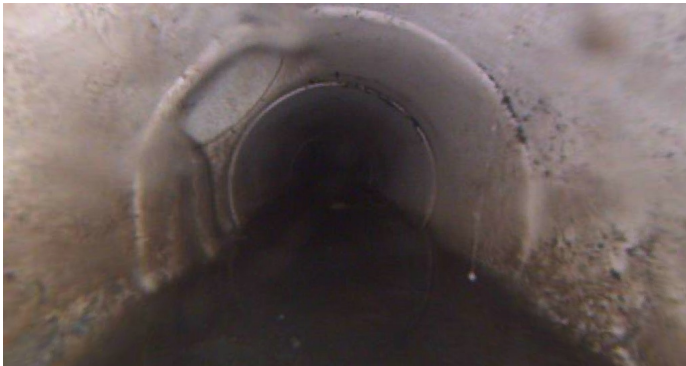
Code: **MMC**
Description: **Material Change**

Distance (ft): **93.1**
Structural Grade: **0**
O&M Grade: **0**
Clock Start/From:
Clock To:
1st Value:
2nd Value:
Value Percent:
Continuous Index:
Within 8" of Joint: **NO**
Remarks: **PVC**

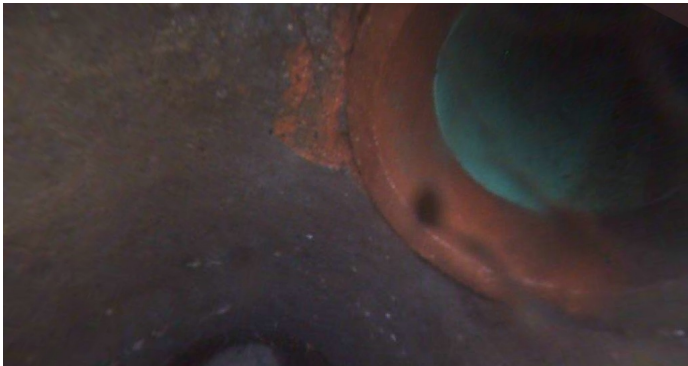
Code: **TB**
Description: **Tap Break-in**

Distance (ft): **136.7**
Structural Grade: **0**
O&M Grade: **0**
Clock Start/From: **2**
Clock To:
1st Value: **4.000**
2nd Value:
Value Percent:
Continuous Index:
Within 8" of Joint:
Remarks:

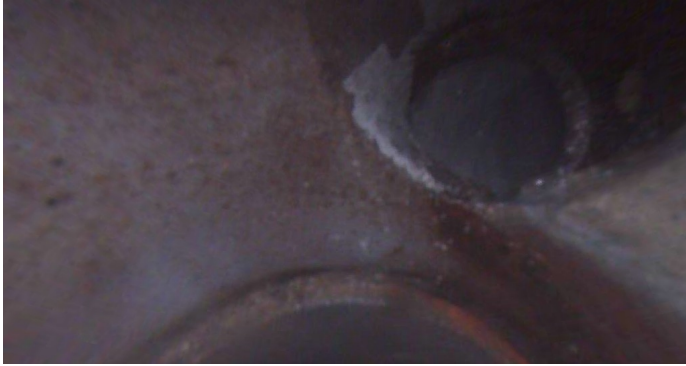
Code: **TF**
Description: **Tap Factory**

Distance (ft): **139.0**
Structural Grade: **0**
O&M Grade: **0**
Clock Start/From: **11**
Clock To:
1st Value: **4.000**
2nd Value:
Value Percent:
Continuous Index:
Within 8" of Joint:
Remarks:

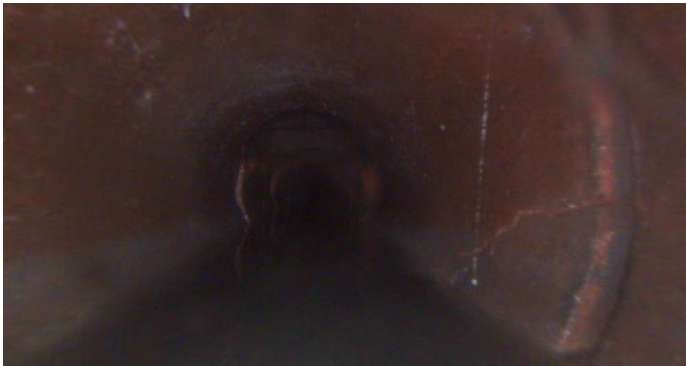
Code: **CS**
Description: **Crack Spiral**

Distance (ft): **174.7**
Structural Grade: **2**
O&M Grade: **0**
Clock Start/From: **4**
Clock To: **5**
1st Value:
2nd Value:
Value Percent:
Continuous Index:
Within 8" of Joint: **YES**
Remarks:

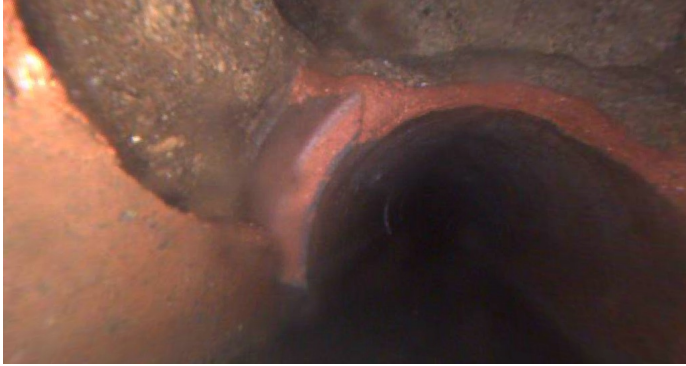
Code:	AMH
Description:	Manhole
Distance (ft):	178.5
Structural Grade:	0
O&M Grade:	0
Clock Start/From:	
Clock To:	
1st Value:	
2nd Value:	
Value Percent:	
Continuous Index:	
Within 8" of Joint:	NO
Remarks:	M-604-091
