Profile/Photo Observation Report

Date:	04/22/2018	Weather:		Coding:	PACP 6.0
Pipe Length (ft):	170.0	Owner:	NA	Pre Clean:	Not Known
P.O.#:		Surveyor:	Jen Costello	PSR:	P-604-096-095
Customer:		Clean Date:	01/01/1900	Shape:	C

Street:	Summerlin	Flow Control:	Not Controlled
City:	Hobart, IN	Year Renewed:	
Location:	Light Highway	Tape/Media #:	
Purpose:	Not Known	Dia/Height:	12"
Use:	Sanitary	Material:	VCP
Drain Area:	NA	Lining:	
Category:	NA		
Comment:

Location Details:		Direction of Survey:	Downstream
US MH:	M-604-095	DS MH:	M-604-096
		Total Length Surveyed (ft):	6.5

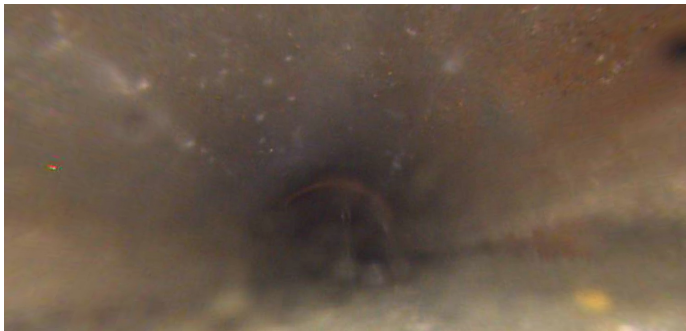
Code: **AMH**
Description: **Manhole**

Distance (ft): **.0**
Structural Grade: **0**
O&M Grade: **0**
Clock Start/From:
Clock To:
1st Value:
2nd Value:
Value Percent:
Continuous Index:
Within 8" of Joint: **NO**
Remarks: **M-604-095**

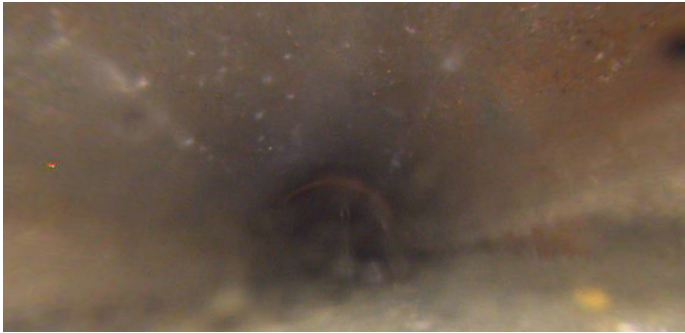
Code:	MWL
Description:	Water Level

Distance (ft):	.0
Structural Grade:	0
O&M Grade:	0
Clock Start/From:	
Clock To:	
1st Value:	
2nd Value:	
Value Percent:	40.000
Continuous Index:	
Within 8" of Joint:	NO
Remarks:

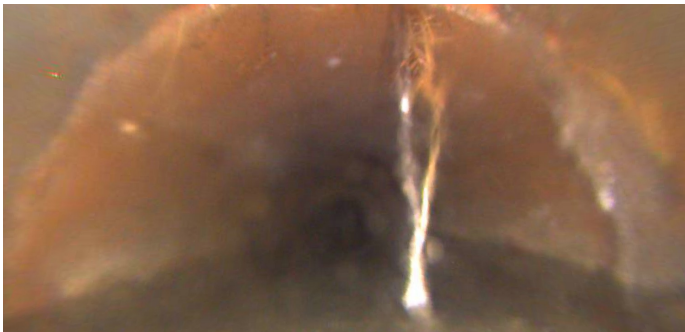
Code:	RFJ
Description:	Roots Fine Joint

Distance (ft):	2.8
Structural Grade:	0
O&M Grade:	1
Clock Start/From:	11
Clock To:	1
1st Value:	
2nd Value:	
Value Percent:	
Continuous Index:	
Within 8" of Joint:	YES
Remarks:

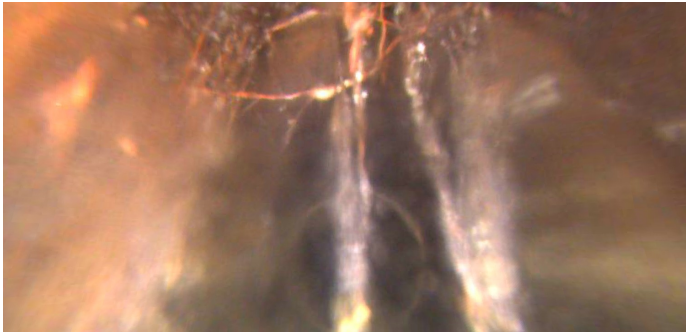
Code: **RMJ**
Description: **Roots Medium Joint**

Distance (ft): **4.9**
Structural Grade: **0**
O&M Grade: **3**
Clock Start/From: **8**
Clock To: **4**
1st Value:
2nd Value:
Value Percent: **20.000**
Continuous Index:
Within 8" of Joint: **YES**
Remarks:

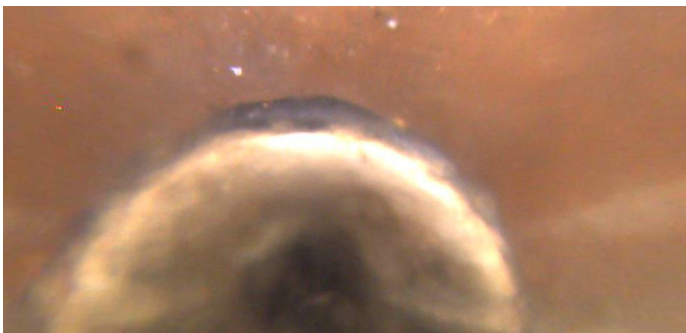
Code: **MSA**
Description: **Abandoned Survey**

Distance (ft): **6.5**
Structural Grade: **0**
O&M Grade: **0**
Clock Start/From:
Clock To:
1st Value:
2nd Value:
Value Percent:
Continuous Index:
Within 8" of Joint: **NO**
Remarks: **roots**
