Profile/Photo Observation Report

Date:	04/22/2018	Weather:		Coding:	PACP 6.0
Pipe Length (ft):	170.0	Owner:	NA	Pre Clean:	Not Known
P.O.#:		Surveyor:	Jen Costello	PSR:	P-604-096-095
Customer:		Clean Date:	01/01/1900	Shape:	C

Street:	N PENNSYLVANIA ST	Flow Control:	Not Controlled
City:	Hobart, IN	Year Renewed:	
Location:	Light Highway	Tape/Media #:	
Purpose:	Not Known	Dia/Height:	12"
Use:	Sanitary	Material:	VCP
Drain Area:	NA	Lining:	
Category:	NA		
Comment:

Location Details:		Direction of Survey:	Upstream
US MH:	M-604-095	DS MH:	M-604-096
		Total Length Surveyed (ft):	8.3

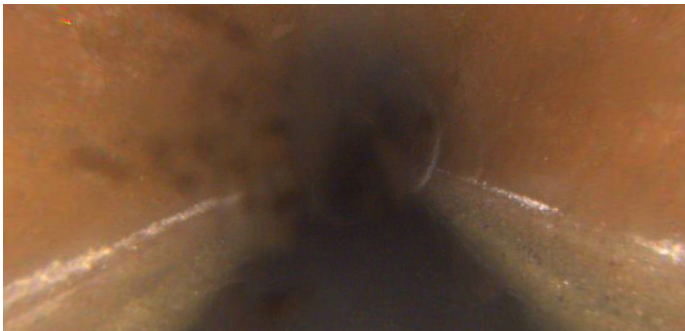
Code: **AMH**
Description: **Manhole**

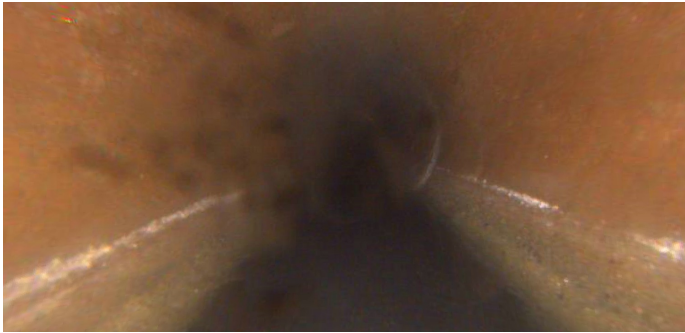
Code:	MWL
Description:	Water Level

Distance (ft):	.0
Structural Grade:	0
O&M Grade:	0
Clock Start/From:	
Clock To:	
1st Value:	
2nd Value:	
Value Percent:	10.000
Continuous Index:	
Within 8" of Joint:	NO
Remarks:

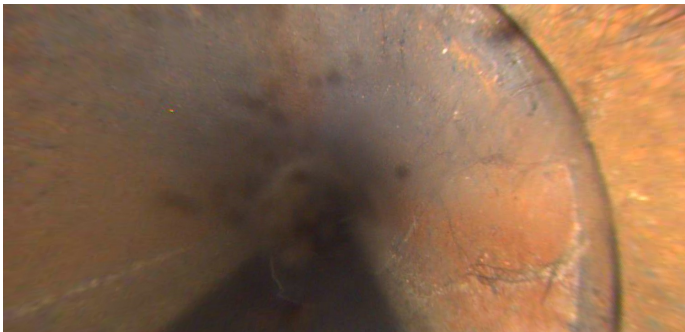
Code:	RFJ
Description:	Roots Fine Joint

Distance (ft):	2.7
Structural Grade:	0
O&M Grade:	1
Clock Start/From:	8
Clock To:	4
1st Value:	
2nd Value:	
Value Percent:	
Continuous Index:	
Within 8" of Joint:	YES
Remarks:

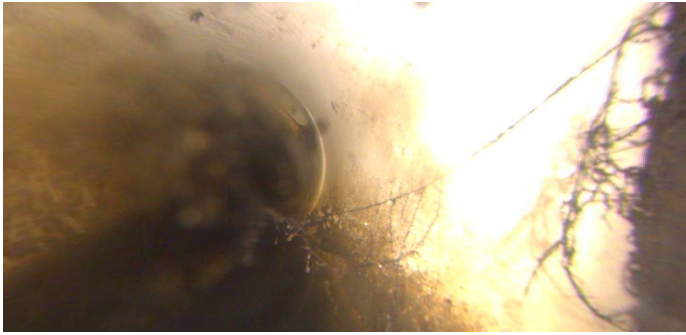
Code: **RFJ**
Description: **Roots Fine Joint**

Distance (ft): **4.9**
Structural Grade: **0**
O&M Grade: **1**
Clock Start/From: **2**
Clock To: **4**
1st Value:
2nd Value:
Value Percent:
Continuous Index:
Within 8" of Joint: **YES**
Remarks:

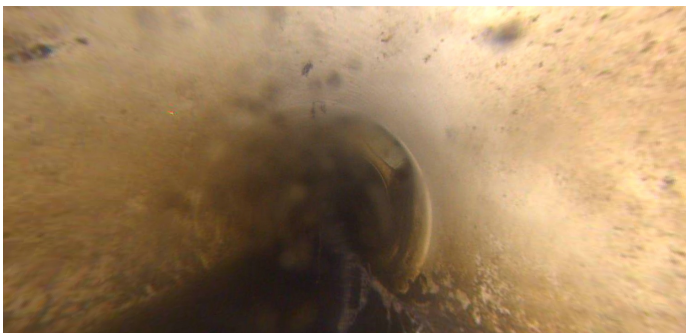
Code: **MMC**
Description: **Material Change**

Distance (ft): **5.0**
Structural Grade: **0**
O&M Grade: **0**
Clock Start/From:
Clock To:
1st Value:
2nd Value:
Value Percent:
Continuous Index:
Within 8" of Joint: **NO**
Remarks: **PVC**

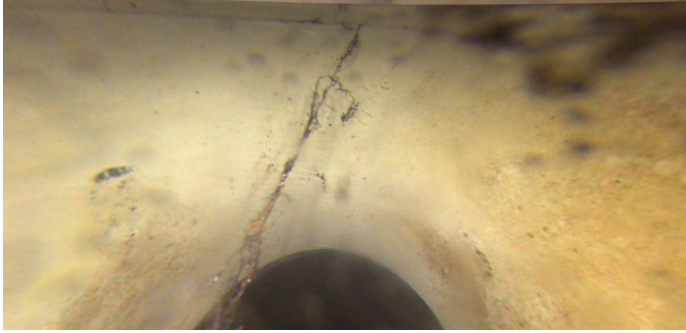
Code: **RFJ**
Description: **Roots Fine Joint**

Distance (ft): **5.9**
Structural Grade: **0**
O&M Grade: **1**
Clock Start/From: **12**
Clock To:
1st Value:
2nd Value:
Value Percent:
Continuous Index:
Within 8" of Joint: **YES**
Remarks:

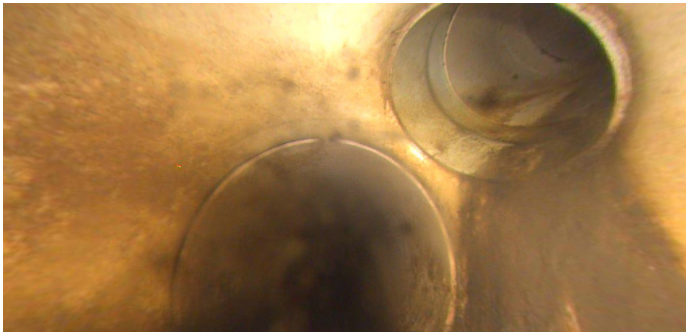
Code: **TF**
Description: **Tap Factory**

Distance (ft): **5.9**
Structural Grade: **0**
O&M Grade: **0**
Clock Start/From: **2**
Clock To:
1st Value: **4.000**
2nd Value:
Value Percent:
Continuous Index:
Within 8" of Joint:
Remarks:

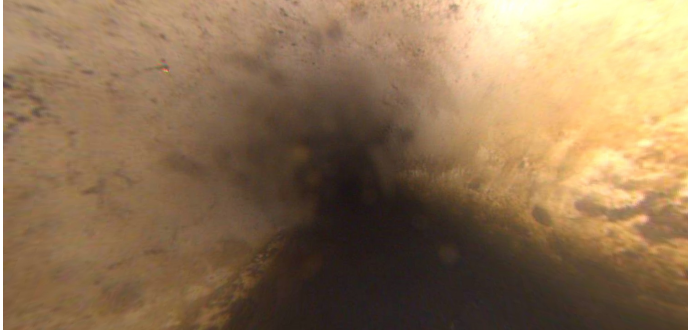
Code:	MSA
Description:	Abandoned Survey
Distance (ft):	8.3
Structural Grade:	0
O&M Grade:	0
Clock Start/From:	
Clock To:	
1st Value:	
2nd Value:	
Value Percent:	
Continuous Index:	
Within 8" of Joint:	NO
Remarks:	debris
