Profile/Photo Observation Report

Date:	02/10/2024	Weather:		Coding:	PACP 7.0
Pipe Length (ft):	230.0	Owner:	City of Hobart	Pre Clean:	Heavy Cleaning
P.O.#:	YES502259	Surveyor:	S. Bucklin	PSR:	P-604-100-099
Customer:	City of Hobart	Clean Date:	03/07/2023	Shape:	C

Street:	N WISCONSIN ST	Flow Control:	Not Controlled
City:	Hobart, IN	Year Renewed:	
Location:	Alley	Tape/Media #:	
Purpose:	Routine Assessment	Dia/Height:	12"
Use:	Sanitary Sewage Pipe	Material:	VCP
Drain Area:		Lining:	None
Category:	NA		
Comment:			
Location Details:		Direction of Survey:	Downstream
US MH:	M-604-100	DS MH:	M-604-099
		Total Length Surveyed (ft):	30.6

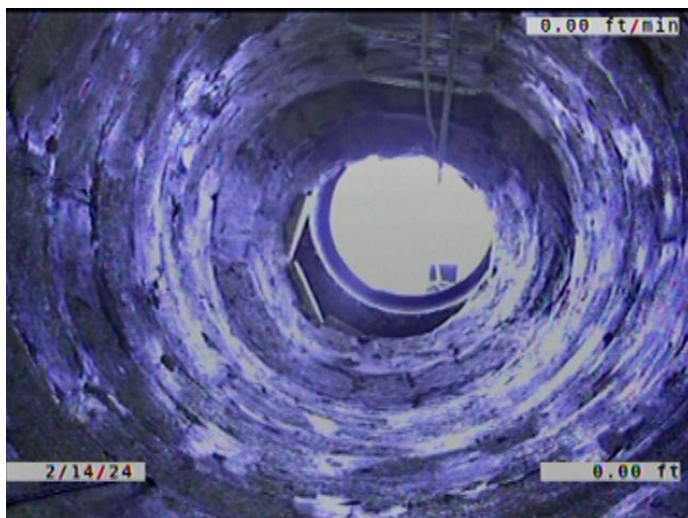
Code: **AMH**
Description: **Manhole**

Distance (ft): **.0**
Structural Grade: **0**
O&M Grade: **0**
Clock Start/From:
Clock To:
1st Value:
2nd Value:
Value Percent:
Continuous Index:
Within 8" of Joint: **NO**
Remarks: **M-604-100**

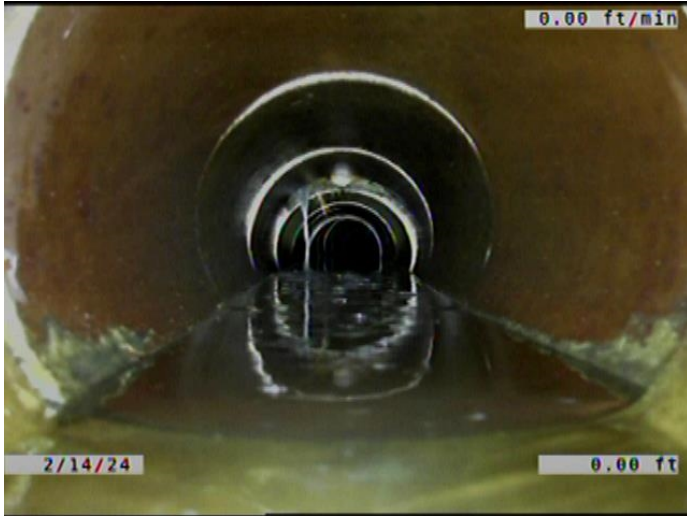
Code: **MWL**
Description: **Miscellaneous Water Level**

Distance (ft): **.0**
Structural Grade: **0**
O&M Grade: **0**
Clock Start/From:
Clock To:
1st Value:
2nd Value:
Value Percent: **15.000**
Continuous Index:
Within 8" of Joint: **NO**
Remarks:

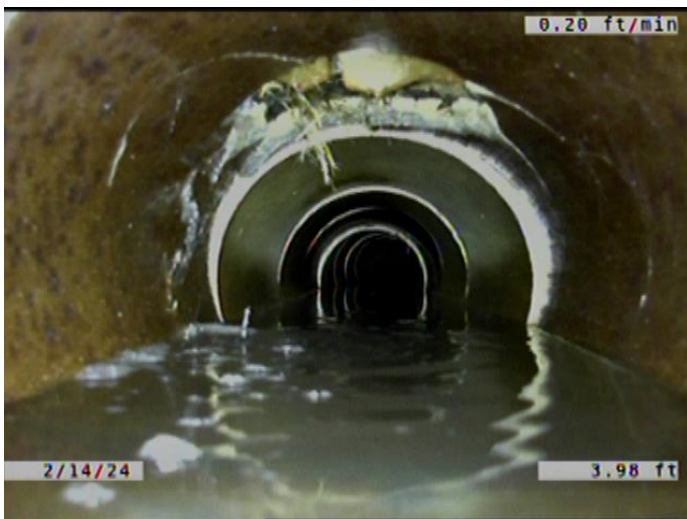
Code: **MWLS**
Description: **Miscellaneous Water Level Sag**

Distance (ft): **4.0**
Structural Grade: **2**
O&M Grade: **0**
Clock Start/From:
Clock To:
1st Value:
2nd Value:
Value Percent: **20.000**
Continuous Index: **S01**
Within 8" of Joint: **NO**
Remarks:

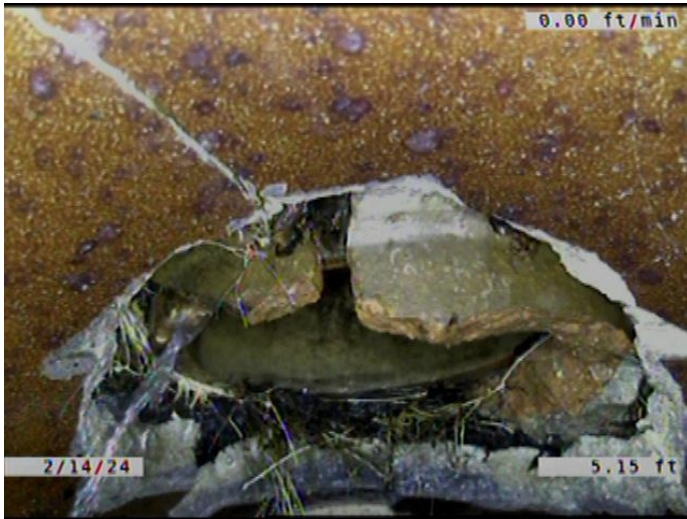
Code: **B**
Description: **Broken**

Distance (ft): **5.1**
Structural Grade: **4**
O&M Grade: **0**
Clock Start/From: **10**
Clock To: **2**
1st Value:
2nd Value:
Value Percent:
Continuous Index:
Within 8" of Joint: **YES**
Remarks:

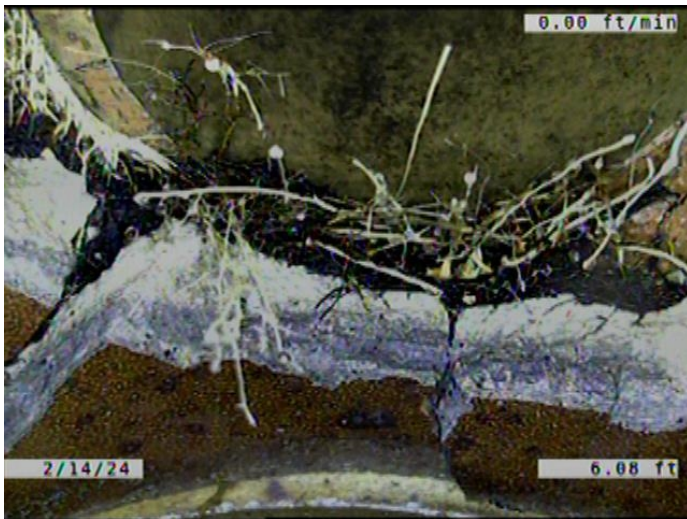
Code: **RFC**
Description: **Roots Fine Connection**

Distance (ft): **6.1**
Structural Grade: **0**
O&M Grade: **1**
Clock Start/From: **11**
Clock To: **1**
1st Value:
2nd Value:
Value Percent:
Continuous Index:
Within 8" of Joint: **NO**
Remarks:

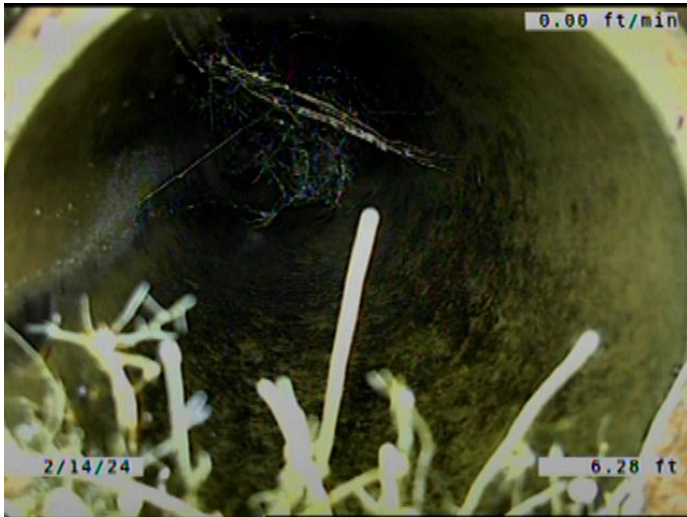
Code:	TBI
Description:	Tap Break-in Intruding
Distance (ft):	6.3
Structural Grade:	0
O&M Grade:	2
Clock Start/From:	12
Clock To:	
1st Value:	6.000
2nd Value:	1.000
Value Percent:	
Continuous Index:	
Within 8" of Joint:	YES
Remarks:	SERVICE COMES FROM THE LEFT (WEST). ACTIVITY. ROOTS GROWING

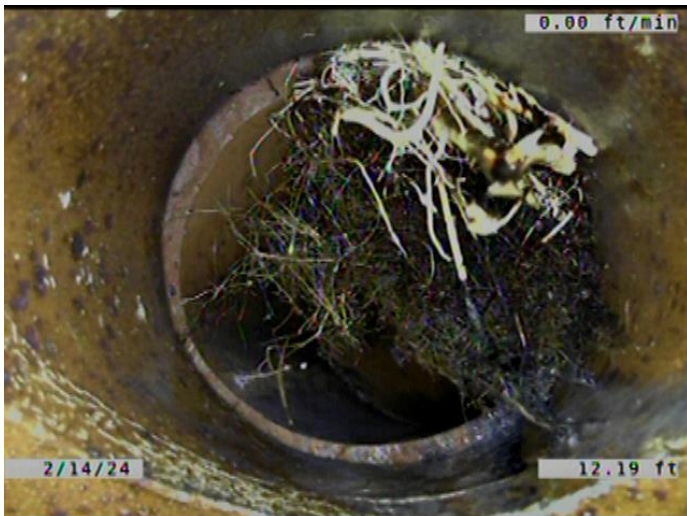
Code:	TF
Description:	Tap Factory
Distance (ft):	12.2
Structural Grade:	0
O&M Grade:	0
Clock Start/From:	1
Clock To:	
1st Value:	6.000
2nd Value:	
Value Percent:	
Continuous Index:	
Within 8" of Joint:	YES
Remarks:	ROOTS GROWING AT THE SERVICE TO MAIN CONNECTION.

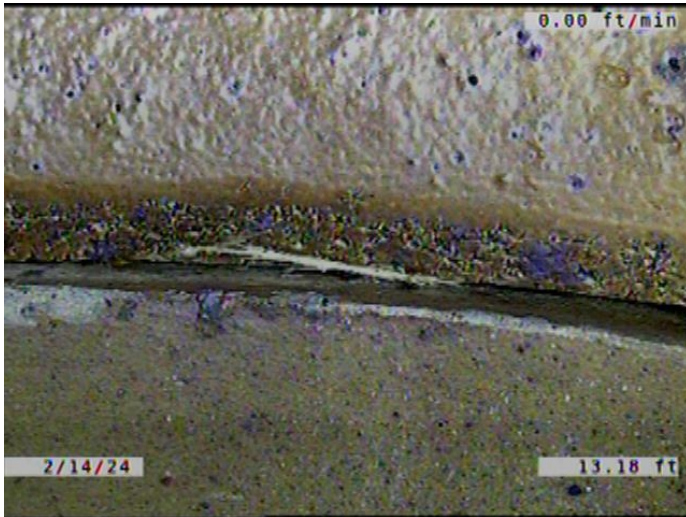
Code: **RFJ**
Description: **Roots Fine Joint**

Distance (ft): **13.2**
Structural Grade: **0**
O&M Grade: **1**
Clock Start/From: **10**
Clock To: **2**
1st Value:
2nd Value:
Value Percent:
Continuous Index:
Within 8" of Joint: **YES**
Remarks:

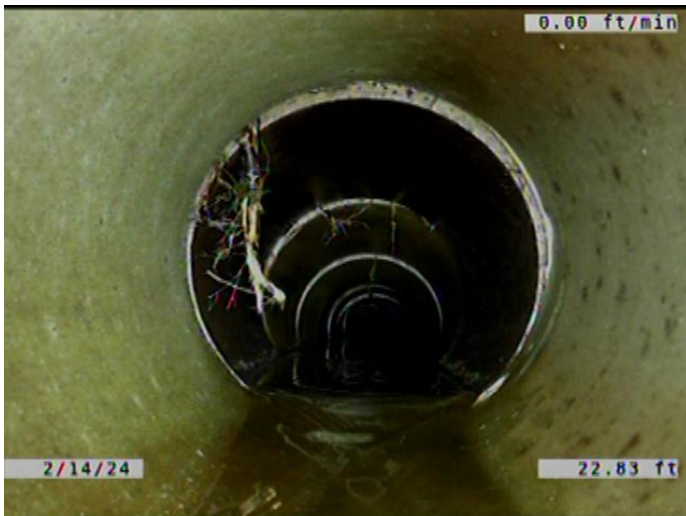
Code: **MWLS**
Description: **Miscellaneous Water Level Sag**

Distance (ft): **22.8**
Structural Grade: **2**
O&M Grade: **0**
Clock Start/From:
Clock To:
1st Value:
2nd Value:
Value Percent: **20.000**
Continuous Index: **F01**
Within 8" of Joint: **NO**
Remarks:

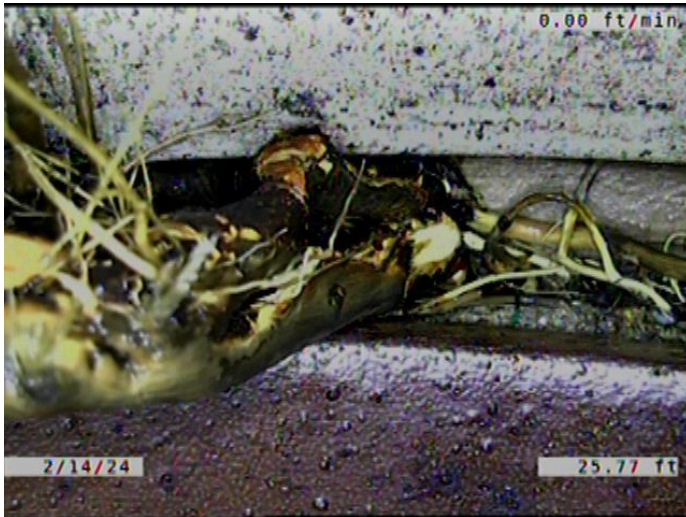
Code: **RTJ**
 Description: **Roots Tap Joint**

Distance (ft): **25.8**
 Structural Grade: **0**
 O&M Grade: **2**
 Clock Start/From: **10**
 Clock To: **2**
 1st Value:
 2nd Value:
 Value Percent: **5.000**
 Continuous Index:
 Within 8" of Joint: **YES**
 Remarks:

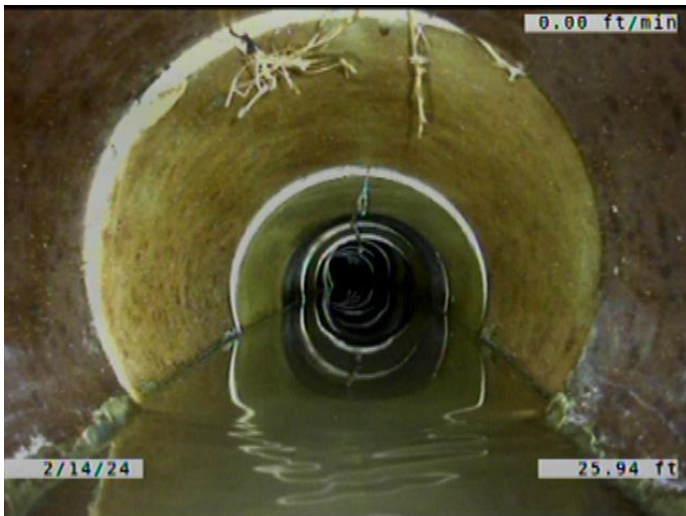
Code: **MWLS**
 Description: **Miscellaneous Water Level Sag**

Distance (ft): **25.9**
 Structural Grade: **2**
 O&M Grade: **0**
 Clock Start/From:
 Clock To:
 1st Value:
 2nd Value:
 Value Percent: **25.000**
 Continuous Index: **S02**
 Within 8" of Joint: **NO**
 Remarks:

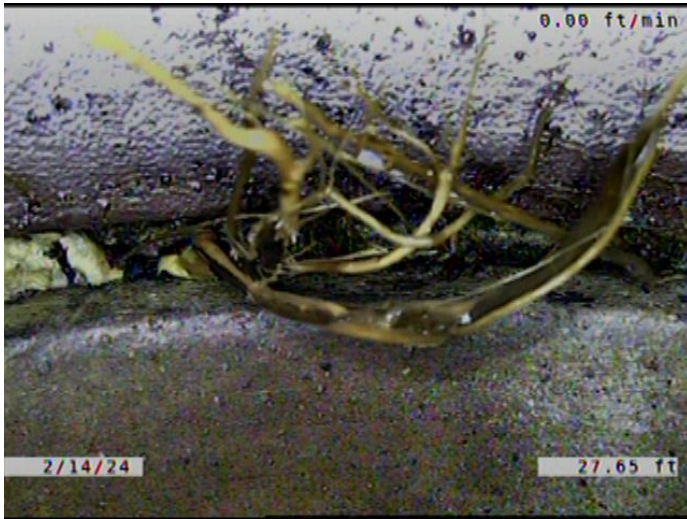
Code: **RFJ**
Description: **Roots Fine Joint**

Distance (ft): **27.6**
Structural Grade: **0**
O&M Grade: **1**
Clock Start/From: **10**
Clock To: **2**
1st Value:
2nd Value:
Value Percent:
Continuous Index:
Within 8" of Joint: **YES**
Remarks:

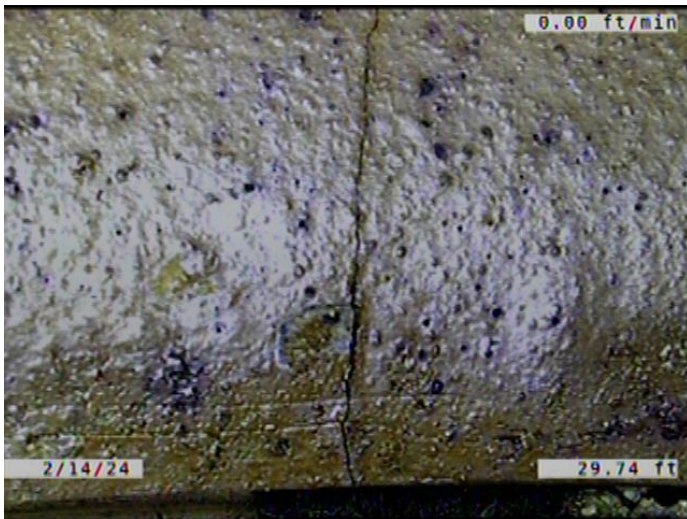
Code: **CL**
Description: **Crack Longitudinal**

Distance (ft): **29.7**
Structural Grade: **2**
O&M Grade: **0**
Clock Start/From: **10**
Clock To:
1st Value:
2nd Value:
Value Percent:
Continuous Index:
Within 8" of Joint: **YES**
Remarks:

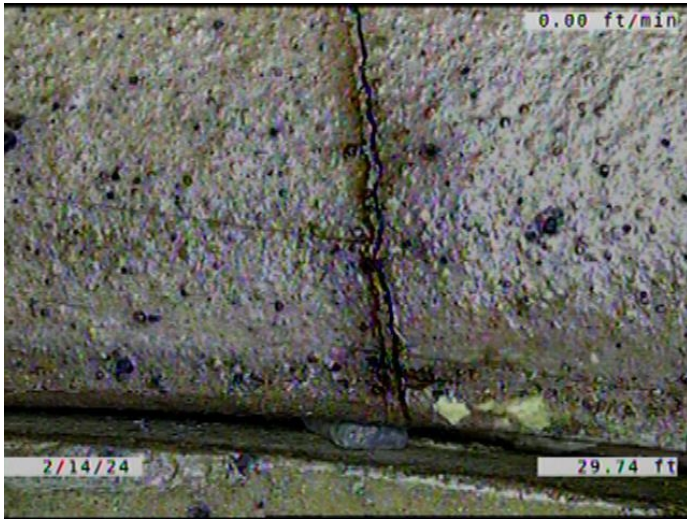
Code: **CL**
Description: **Crack Longitudinal**

Distance (ft): **29.7**
Structural Grade: **2**
O&M Grade: **0**
Clock Start/From: **2**
Clock To:
1st Value:
2nd Value:
Value Percent:
Continuous Index:
Within 8" of Joint: **YES**
Remarks:

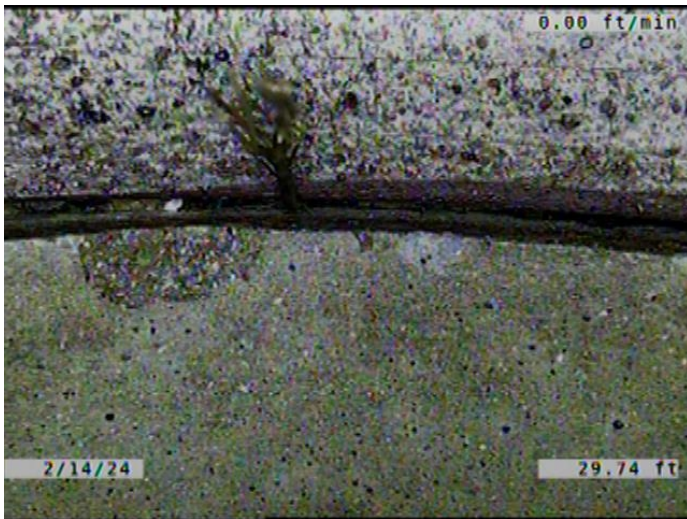
Code: **RFJ**
Description: **Roots Fine Joint**

Distance (ft): **29.7**
Structural Grade: **0**
O&M Grade: **1**
Clock Start/From: **10**
Clock To: **12**
1st Value:
2nd Value:
Value Percent:
Continuous Index:
Within 8" of Joint: **YES**
Remarks:

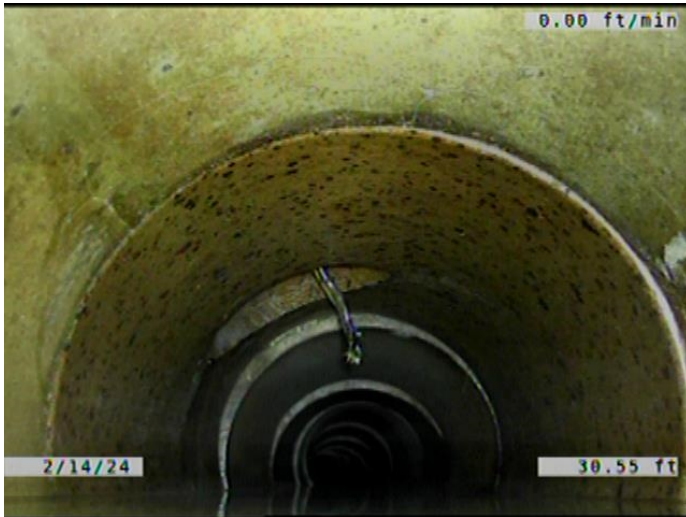
Code: **MWLS**
 Description: **Miscellaneous Water Level Sag**

Distance (ft): **30.6**
 Structural Grade: **2**
 O&M Grade: **0**
 Clock Start/From:
 Clock To:
 1st Value:
 2nd Value:
 Value Percent: **25.000**
 Continuous Index: **F02**
 Within 8" of Joint: **NO**
 Remarks:

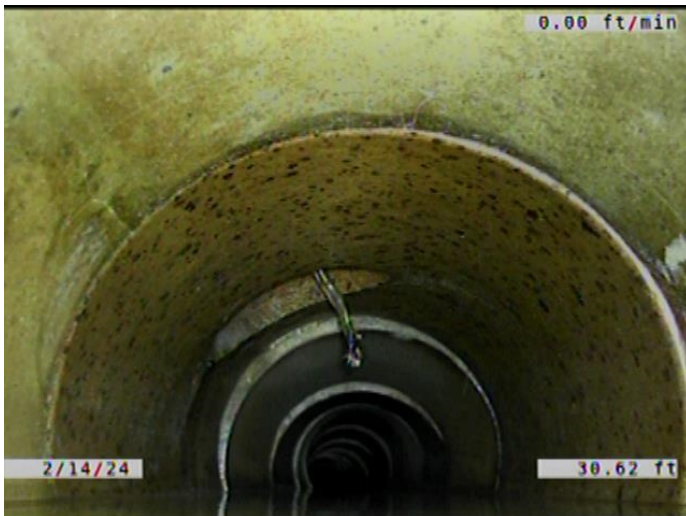
Code: **MSA**
 Description: **Miscellaneous Survey Abandoned**

Distance (ft): **30.6**
 Structural Grade: **0**
 O&M Grade: **0**
 Clock Start/From:
 Clock To:
 1st Value:
 2nd Value:
 Value Percent:
 Continuous Index:
 Within 8" of Joint: **NO**
 Remarks: **MADE IT TO THE POINT OF OVERLAP.
 REVERSAL COMPLETE.**
