Profile/Photo Observation Report

Date:	04/22/2018	Weather:		Coding:	PACP 6.0
Pipe Length (ft):	260.0	Owner:	NA	Pre Clean:	Not Known
P.O.#:		Surveyor:	Jen Costello	PSR:	P-604-101-100
Customer:		Clean Date:	01/01/1900	Shape:	C

Street:	Summerlin	Flow Control:	Not Controlled
City:	Hobart, IN	Year Renewed:	
Location:	Light Highway	Tape/Media #:	
Purpose:	Not Known	Dia/Height:	12"
Use:	Sanitary	Material:	VCP
Drain Area:	NA	Lining:	
Category:	NA		
Comment:			
Location Details:		Direction of Survey:	Downstream
US MH:	M-604-101	DS MH:	M-604-100
		Total Length Surveyed (ft):	257.2

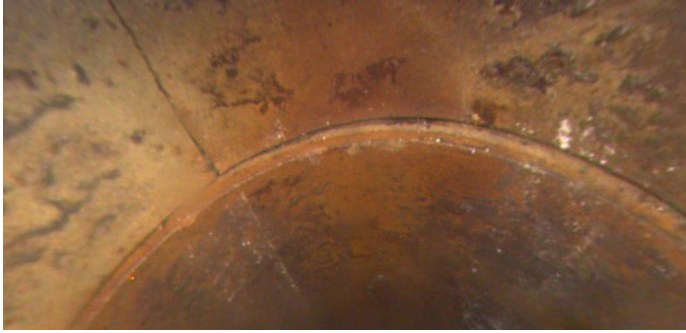
Code: **FL**
Description: **Fracture Longitudinal**

Distance (ft): **16.5**
Structural Grade: **3**
O&M Grade: **0**
Clock Start/From: **11**
Clock To:
1st Value:
2nd Value:
Value Percent:
Continuous Index:
Within 8" of Joint: **YES**
Remarks:

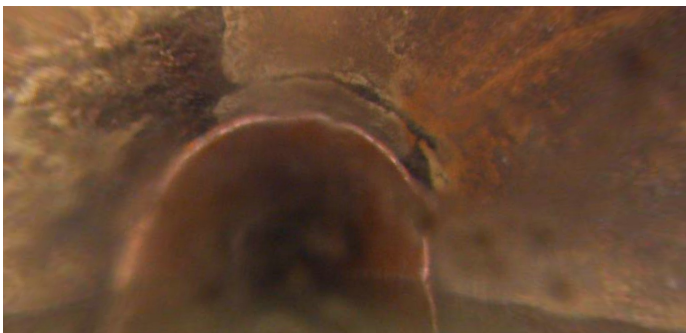
Code: **FM**
Description: **Fracture Multiple**

Distance (ft): **42.4**
Structural Grade: **4**
O&M Grade: **0**
Clock Start/From: **10**
Clock To: **2**
1st Value:
2nd Value:
Value Percent:
Continuous Index:
Within 8" of Joint: **YES**
Remarks:

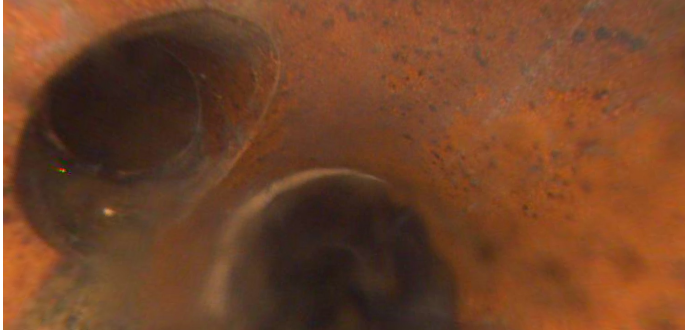
Code: **TF**
Description: **Tap Factory**

Distance (ft): **44.3**
Structural Grade: **0**
O&M Grade: **0**
Clock Start/From: **10**
Clock To:
1st Value: **4.000**
2nd Value:
Value Percent:
Continuous Index:
Within 8" of Joint:
Remarks:

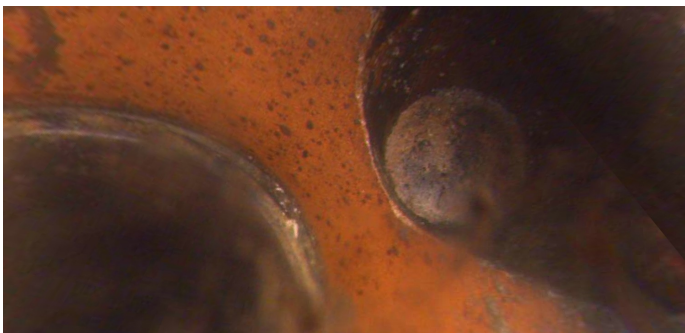
Code: **TFC**
Description: **Tap Factory Capped**

Distance (ft): **67.1**
Structural Grade: **0**
O&M Grade: **0**
Clock Start/From: **2**
Clock To:
1st Value: **4.000**
2nd Value:
Value Percent:
Continuous Index:
Within 8" of Joint:
Remarks:

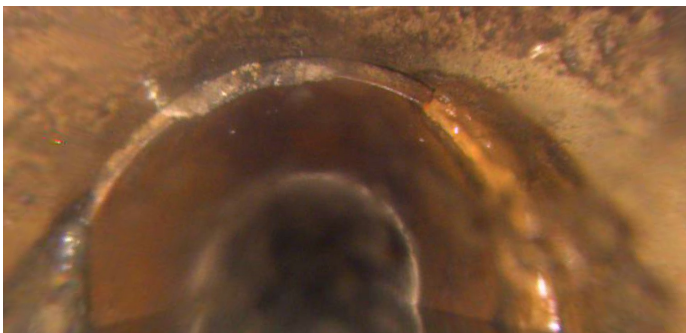
Code: **DAE**
Description: **Deposits Attached Encrustation**

Distance (ft): **71.3**
Structural Grade: **0**
O&M Grade: **2**
Clock Start/From: **8**
Clock To: **4**
1st Value:
2nd Value:
Value Percent: **5.000**
Continuous Index:
Within 8" of Joint: **YES**
Remarks:

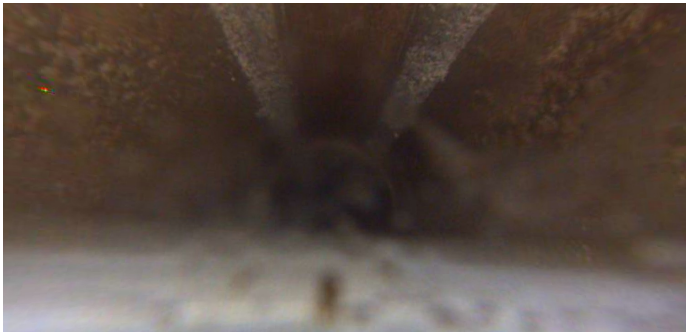
Code: **MMC**
Description: **Material Change**

Distance (ft): **92.2**
Structural Grade: **0**
O&M Grade: **0**
Clock Start/From:
Clock To:
1st Value:
2nd Value:
Value Percent:
Continuous Index:
Within 8" of Joint: **NO**
Remarks: **VCP**

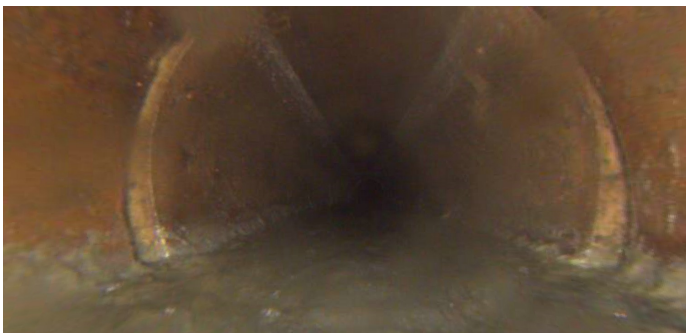
Code: **MGO**
Description: **General Observation**

Distance (ft): **103.1**
Structural Grade: **0**
O&M Grade: **0**
Clock Start/From:
Clock To:
1st Value:
2nd Value:
Value Percent:
Continuous Index:
Within 8" of Joint: **NO**
Remarks: **REAR CAMERA**

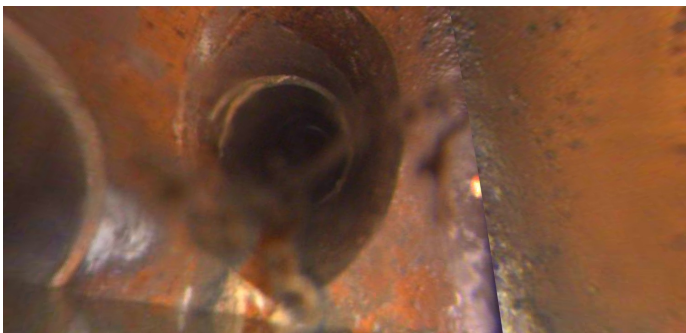
Code: **TF**
Description: **Tap Factory**

Distance (ft): **148.4**
Structural Grade: **0**
O&M Grade: **0**
Clock Start/From: **3**
Clock To:
1st Value: **4.000**
2nd Value:
Value Percent:
Continuous Index:
Within 8" of Joint:
Remarks:

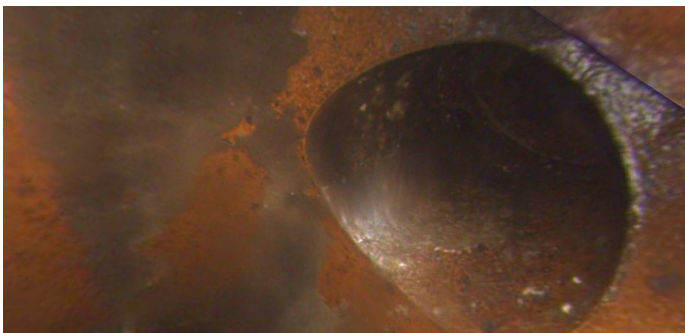
Code: **TF**
Description: **Tap Factory**

Distance (ft): **208.2**
Structural Grade: **0**
O&M Grade: **0**
Clock Start/From: **10**
Clock To:
1st Value: **4.000**
2nd Value:
Value Percent:
Continuous Index:
Within 8" of Joint:
Remarks:

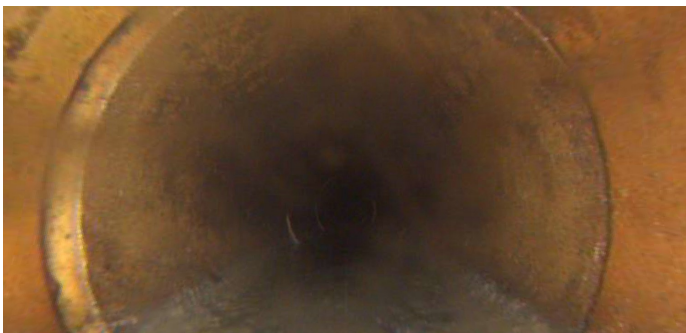
Code: **RFJ**
Description: **Roots Fine Joint**

Distance (ft): **219.3**
Structural Grade: **0**
O&M Grade: **1**
Clock Start/From: **8**
Clock To: **4**
1st Value:
2nd Value:
Value Percent:
Continuous Index: **F02**
Within 8" of Joint: **YES**
Remarks:

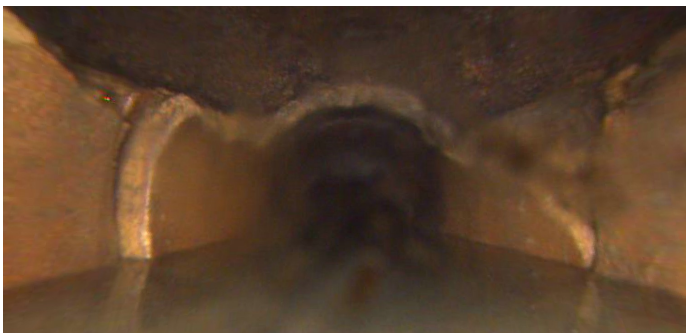
Code: **FM**
Description: **Fracture Multiple**

Distance (ft): **257.2**
Structural Grade: **4**
O&M Grade: **0**
Clock Start/From: **8**
Clock To: **4**
1st Value:
2nd Value:
Value Percent:
Continuous Index: **F03**
Within 8" of Joint: **YES**
Remarks:

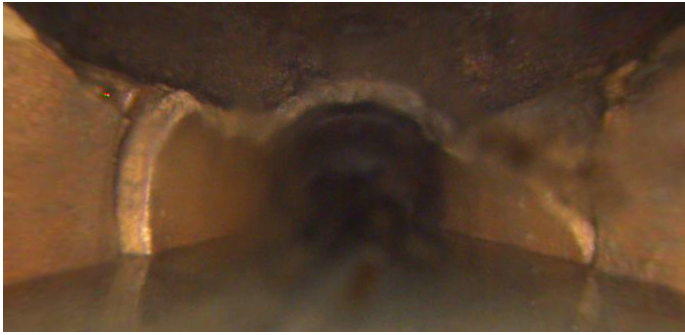
Code: **DAGS**
Description: **Deposits Attached Grease**

Distance (ft): **257.2**
Structural Grade: **0**
O&M Grade: **2**
Clock Start/From: **8**
Clock To: **4**
1st Value:
2nd Value:
Value Percent: **5.000**
Continuous Index: **F01**
Within 8" of Joint: **NO**
Remarks:

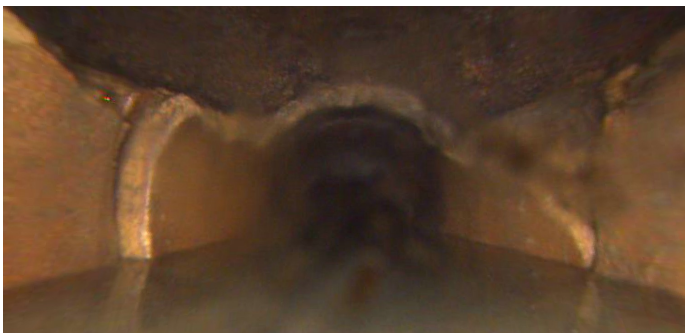
Code: **AMH**
Description: **Manhole**

Distance (ft): **257.2**
Structural Grade: **0**
O&M Grade: **0**
Clock Start/From:
Clock To:
1st Value:
2nd Value:
Value Percent:
Continuous Index:
Within 8" of Joint: **NO**
Remarks: **M-604-100**
