RedZone[®]
ROBOTICS

US MH: **M-604-103** DS MH: **M-604-101** Total Length Surveyed (ft): **213.2**

Overall Index:	2.47	Overall Quick:	4731	Overall Rating:	47.00
----------------	------	----------------	------	-----------------	-------

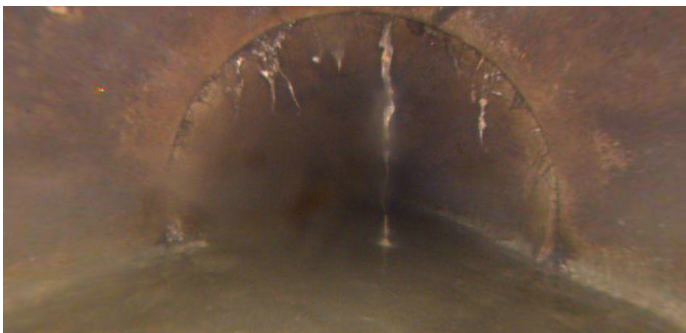
Code: **RFJ**
Description: **Roots Fine Joint**

Distance (ft): **8.7**
Structural Grade: **0**
O&M Grade: **1**
Clock Start/From: **8**
Clock To: **4**
1st Value:
2nd Value:
Value Percent:
Continuous Index:
Within 8" of Joint: **YES**
Remarks:

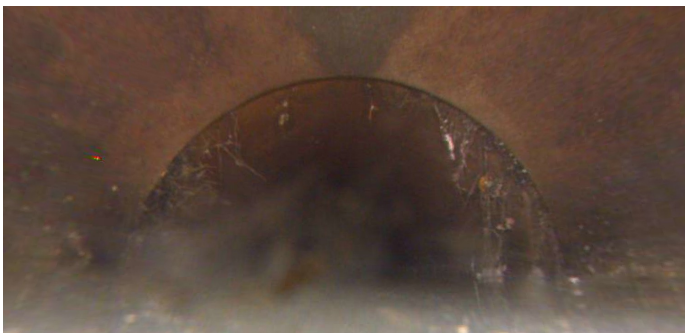
Code: **RFJ**
Description: **Roots Fine Joint**

Distance (ft): **12.7**
Structural Grade: **0**
O&M Grade: **1**
Clock Start/From: **8**
Clock To: **4**
1st Value:
2nd Value:
Value Percent:
Continuous Index:
Within 8" of Joint: **YES**
Remarks:

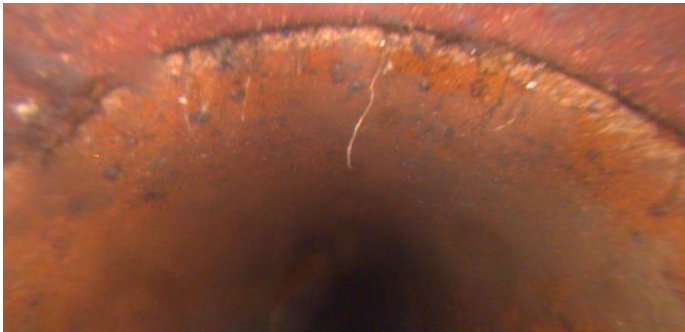
Code: **RFJ**
Description: **Roots Fine Joint**

Distance (ft): **19.1**
Structural Grade: **0**
O&M Grade: **1**
Clock Start/From: **8**
Clock To: **4**
1st Value:
2nd Value:
Value Percent:
Continuous Index:
Within 8" of Joint: **YES**
Remarks:

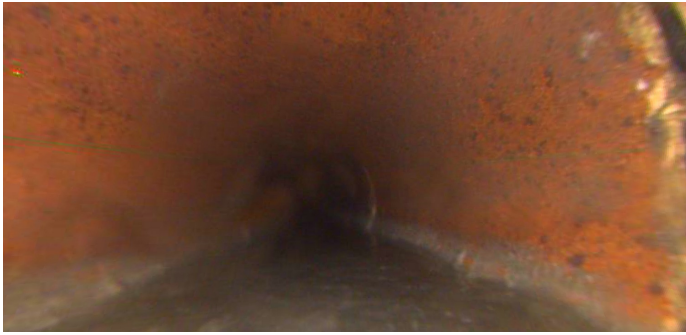
Code: **MMC**
Description: **Material Change**

Distance (ft): **39.5**
Structural Grade: **0**
O&M Grade: **0**
Clock Start/From:
Clock To:
1st Value:
2nd Value:
Value Percent:
Continuous Index:
Within 8" of Joint: **NO**
Remarks: **vcp**

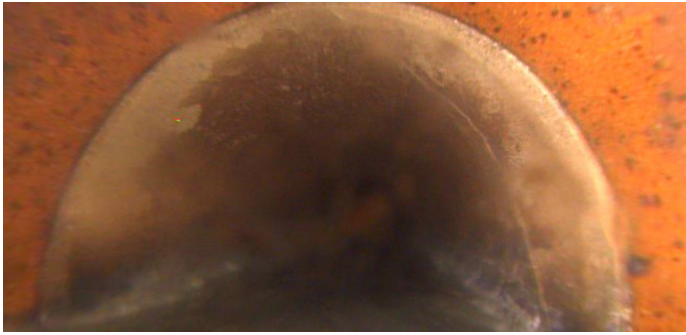
Code: **FM**
Description: **Fracture Multiple**

Distance (ft): **47.3**
Structural Grade: **4**
O&M Grade: **0**
Clock Start/From: **12**
Clock To: **3**
1st Value:
2nd Value:
Value Percent:
Continuous Index:
Within 8" of Joint: **YES**
Remarks:

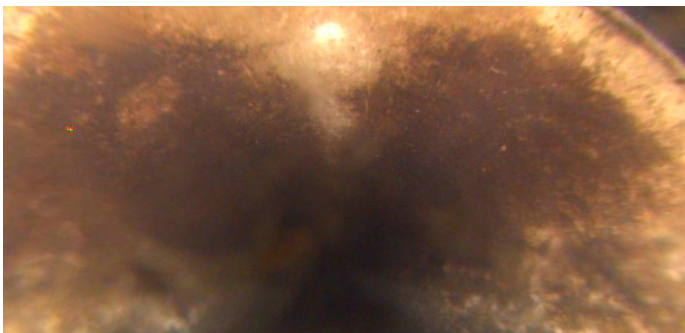
Code: **MMC**
Description: **Material Change**

Distance (ft): **88.2**
Structural Grade: **0**
O&M Grade: **0**
Clock Start/From:
Clock To:
1st Value:
2nd Value:
Value Percent:
Continuous Index:
Within 8" of Joint: **NO**
Remarks: **PVC**

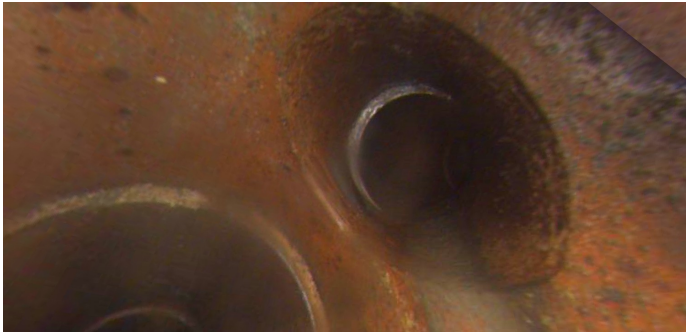
Code: **TFA**
Description: **Tap Factory Active**

Distance (ft): **128.3**
Structural Grade: **0**
O&M Grade: **0**
Clock Start/From: **10**
Clock To:
1st Value: **4.000**
2nd Value:
Value Percent:
Continuous Index:
Within 8" of Joint:
Remarks:

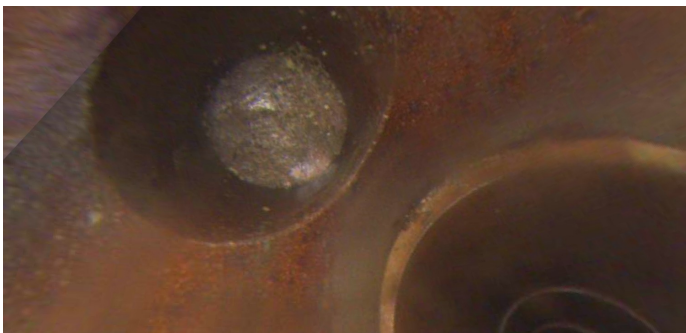
Code: **TFC**
Description: **Tap Factory Capped**

Distance (ft): **142.5**
Structural Grade: **0**
O&M Grade: **0**
Clock Start/From: **2**
Clock To:
1st Value: **4.000**
2nd Value:
Value Percent:
Continuous Index:
Within 8" of Joint:
Remarks:

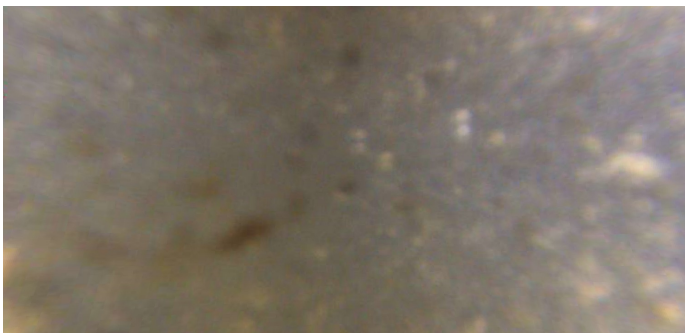
Code: **MCU**
Description: **Camera Underwater**

Distance (ft): **158.5**
Structural Grade: **0**
O&M Grade: **4**
Clock Start/From:
Clock To:
1st Value:
2nd Value:
Value Percent:
Continuous Index:
Within 8" of Joint: **NO**
Remarks:

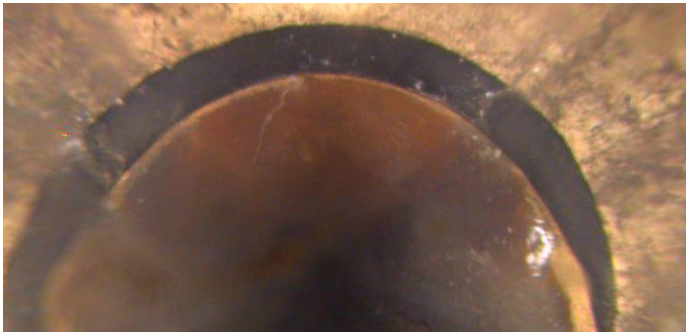
Code: **JSM**
Description: **Joint Separated Medium**

Distance (ft): **167.9**
Structural Grade: **1**
O&M Grade: **0**
Clock Start/From:
Clock To:
1st Value:
2nd Value:
Value Percent:
Continuous Index:
Within 8" of Joint: **NO**
Remarks:

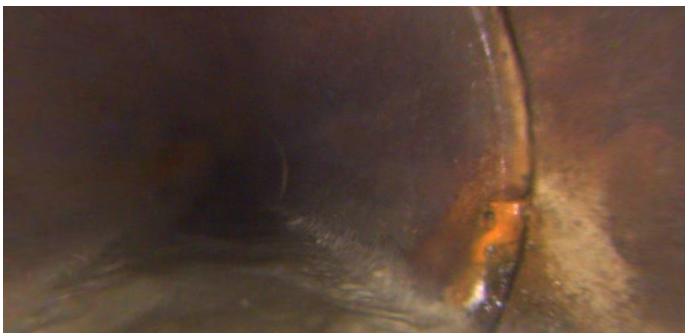
Code: **IW**
Description: **Infil Weeper**

Distance (ft): **190.6**
Structural Grade: **0**
O&M Grade: **2**
Clock Start/From: **3**
Clock To: **4**
1st Value:
2nd Value:
Value Percent:
Continuous Index:
Within 8" of Joint: **YES**
Remarks:

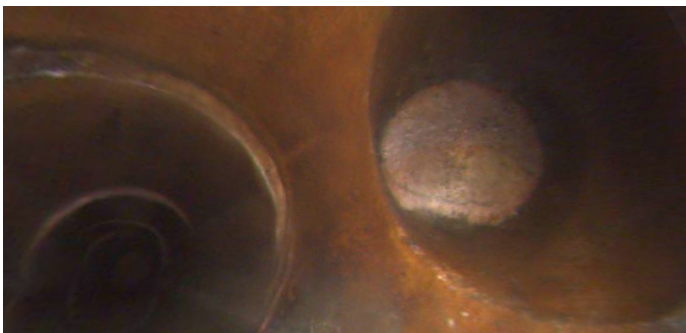
Code: **TFC**
Description: **Tap Factory Capped**

Distance (ft): **202.3**
Structural Grade: **0**
O&M Grade: **0**
Clock Start/From: **10**
Clock To:
1st Value: **4.000**
2nd Value:
Value Percent:
Continuous Index:
Within 8" of Joint:
Remarks:
