# Profile/Photo Observation Report

Date:	<b>04/22/2018</b>	Weather:		Coding:	<b>PACP 6.0</b>
Pipe Length (ft):	<b>218.7</b>	Owner:	<b>NA</b>	Pre Clean:	<b>Not Known</b>
P.O.#:		Surveyor:	<b>Jen Costello</b>	PSR:	<b>P-604-103-101</b>
Customer:		Clean Date:	<b>01/01/1900</b>	Shape:	<b>C</b>

Street:	<b>Summerlin</b>	Flow Control:	<b>Not Controlled</b>
City:	<b>Hobart, IN</b>	Year Renewed:	
Location:	<b>Light Highway</b>	Tape/Media #:	
Purpose:	<b>Not Known</b>	Dia/Height:	<b>12"</b>
Use:	<b>Sanitary</b>	Material:	<b>VCP</b>
Drain Area:	<b>NA</b>	Lining:	
Category:	<b>NA</b>		
Comment:			
Location Details:		Direction of Survey:	<b>Downstream</b>
US MH:	<b>M-604-103</b>	DS MH:	<b>M-604-101</b>
		Total Length Surveyed (ft):	<b>213.2</b>

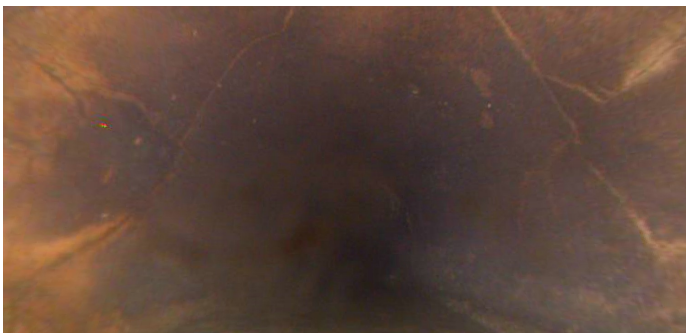
Code: **FM**  
Description: **Fracture Multiple**

Distance (ft): **5.2**  
Structural Grade: **4**  
O&M Grade: **0**  
Clock Start/From: **8**  
Clock To: **4**  
1st Value:  
2nd Value:  
Value Percent:  
Continuous Index:  
Within 8" of Joint: **YES**  
Remarks:

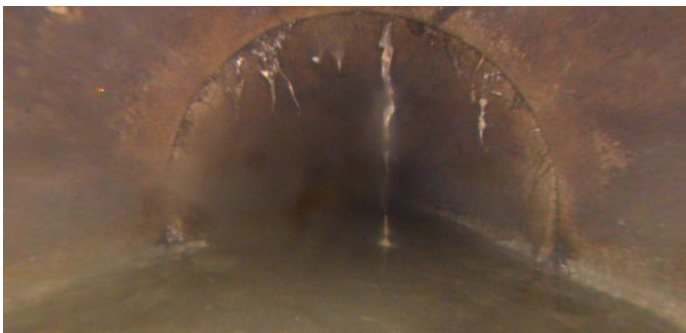
Code: **RFJ**  
Description: **Roots Fine Joint**

Distance (ft): **8.7**  
Structural Grade: **0**  
O&M Grade: **1**  
Clock Start/From: **8**  
Clock To: **4**  
1st Value:  
2nd Value:  
Value Percent:  
Continuous Index:  
Within 8" of Joint: **YES**  
Remarks:

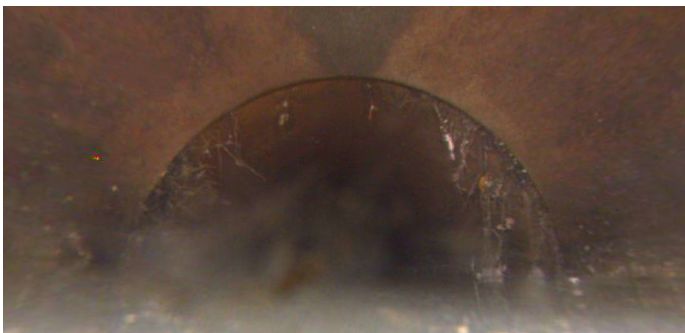
Code: **RFJ**  
Description: **Roots Fine Joint**

Distance (ft): **12.7**  
Structural Grade: **0**  
O&M Grade: **1**  
Clock Start/From: **8**  
Clock To: **4**  
1st Value:  
2nd Value:  
Value Percent:  
Continuous Index:  
Within 8" of Joint: **YES**  
Remarks:

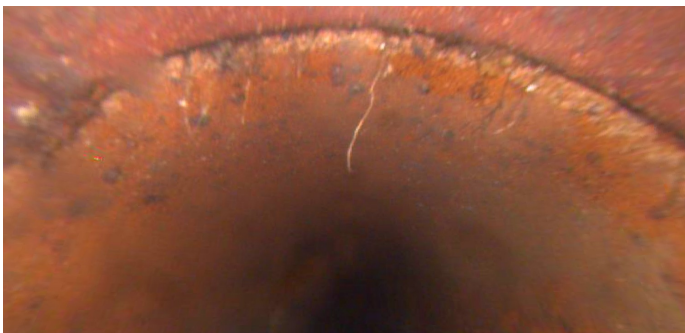
Code: **RFJ**  
Description: **Roots Fine Joint**

Distance (ft): **19.1**  
Structural Grade: **0**  
O&M Grade: **1**  
Clock Start/From: **8**  
Clock To: **4**  
1st Value:  
2nd Value:  
Value Percent:  
Continuous Index:  
Within 8" of Joint: **YES**  
Remarks:

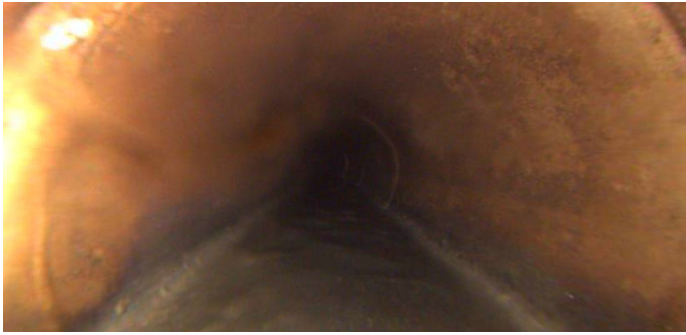
Code: **MMC**  
Description: **Material Change**

Distance (ft): **21.0**  
Structural Grade: **0**  
O&M Grade: **0**  
Clock Start/From:  
Clock To:  
1st Value:  
2nd Value:  
Value Percent:  
Continuous Index:  
Within 8" of Joint: **NO**  
Remarks: **PVC**

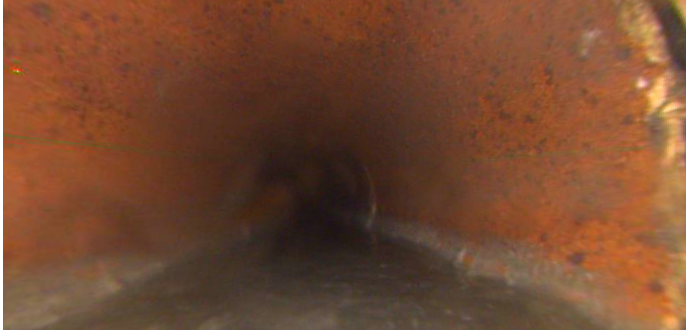
Code: **MMC**  
Description: **Material Change**

Distance (ft): **39.5**  
Structural Grade: **0**  
O&M Grade: **0**  
Clock Start/From:  
Clock To:  
1st Value:  
2nd Value:  
Value Percent:  
Continuous Index:  
Within 8" of Joint: **NO**  
Remarks: **vcp**

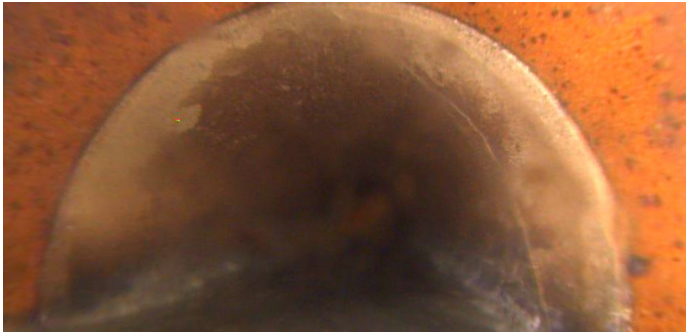
Code: **FM**  
Description: **Fracture Multiple**

Distance (ft): **47.3**  
Structural Grade: **4**  
O&M Grade: **0**  
Clock Start/From: **12**  
Clock To: **3**  
1st Value:  
2nd Value:  
Value Percent:  
Continuous Index:  
Within 8" of Joint: **YES**  
Remarks:

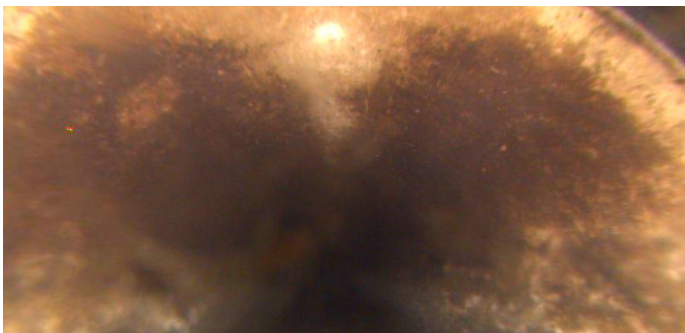
Code: **MMC**  
Description: **Material Change**

Distance (ft): **88.2**  
Structural Grade: **0**  
O&M Grade: **0**  
Clock Start/From:  
Clock To:  
1st Value:  
2nd Value:  
Value Percent:  
Continuous Index:  
Within 8" of Joint: **NO**  
Remarks: **PVC**

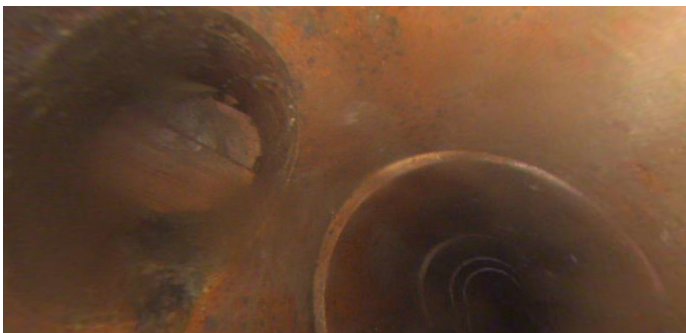
Code: **TFC**  
Description: **Tap Factory Capped**

Distance (ft): **101.7**  
Structural Grade: **0**  
O&M Grade: **0**  
Clock Start/From: **2**  
Clock To:  
1st Value: **4.000**  
2nd Value:  
Value Percent:  
Continuous Index:  
Within 8" of Joint:  
Remarks:

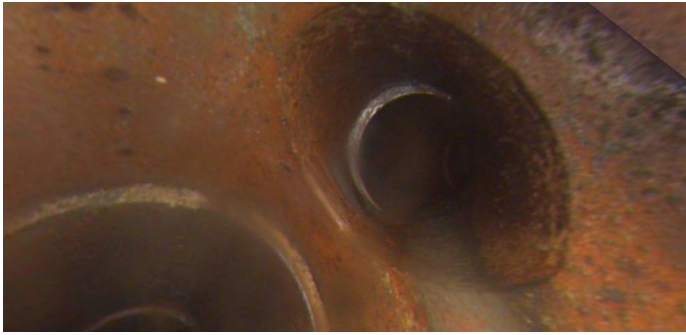
Code: **TFA**  
Description: **Tap Factory Active**

Distance (ft): **128.3**  
Structural Grade: **0**  
O&M Grade: **0**  
Clock Start/From: **10**  
Clock To:  
1st Value: **4.000**  
2nd Value:  
Value Percent:  
Continuous Index:  
Within 8" of Joint:  
Remarks:

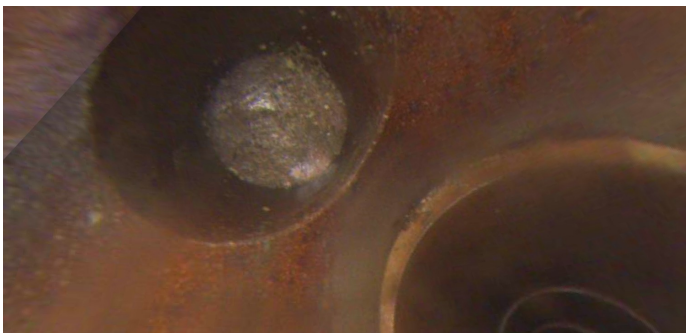
Code: **TFC**  
Description: **Tap Factory Capped**

Distance (ft): **142.5**  
Structural Grade: **0**  
O&M Grade: **0**  
Clock Start/From: **2**  
Clock To:  
1st Value: **4.000**  
2nd Value:  
Value Percent:  
Continuous Index:  
Within 8" of Joint:  
Remarks:

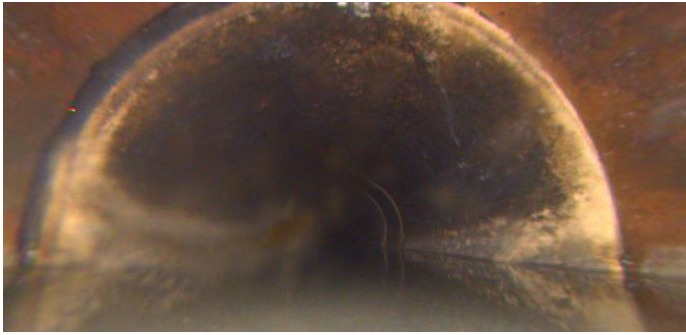
Code: **MWL**  
Description: **Water Level**

Distance (ft): **161.7**  
Structural Grade: **0**  
O&M Grade: **0**  
Clock Start/From:  
Clock To:  
1st Value:  
2nd Value:  
Value Percent: **40.000**  
Continuous Index:  
Within 8" of Joint: **NO**  
Remarks:

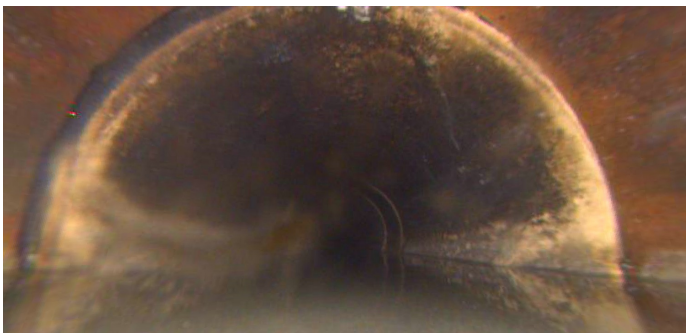
Code: **MMC**  
Description: **Material Change**

Distance (ft): **161.7**  
Structural Grade: **0**  
O&M Grade: **0**  
Clock Start/From:  
Clock To:  
1st Value:  
2nd Value:  
Value Percent:  
Continuous Index:  
Within 8" of Joint: **NO**  
Remarks: **pvc**

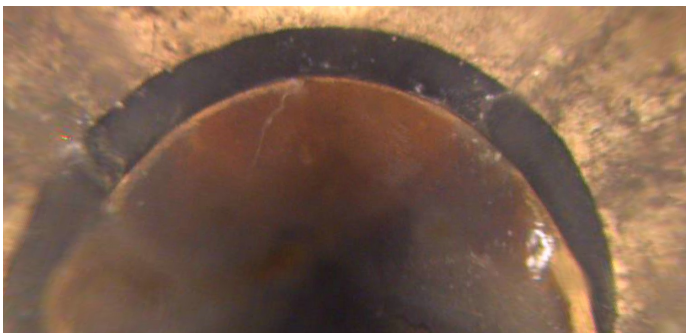
Code: **JSM**  
Description: **Joint Separated Medium**

Distance (ft): **167.9**  
Structural Grade: **1**  
O&M Grade: **0**  
Clock Start/From:  
Clock To:  
1st Value:  
2nd Value:  
Value Percent:  
Continuous Index:  
Within 8" of Joint: **NO**  
Remarks:

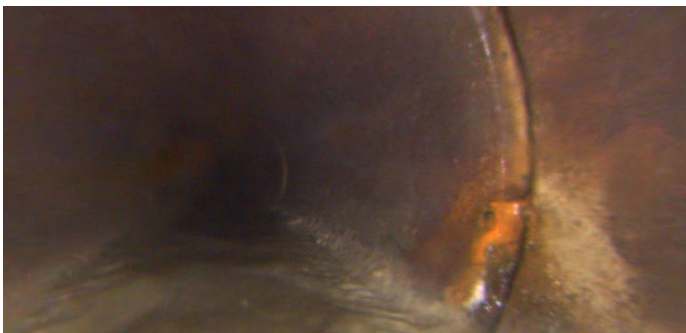
Code: **IW**  
Description: **Infil Weeper**

Distance (ft): **190.6**  
Structural Grade: **0**  
O&M Grade: **2**  
Clock Start/From: **3**  
Clock To: **4**  
1st Value:  
2nd Value:  
Value Percent:  
Continuous Index:  
Within 8" of Joint: **YES**  
Remarks:

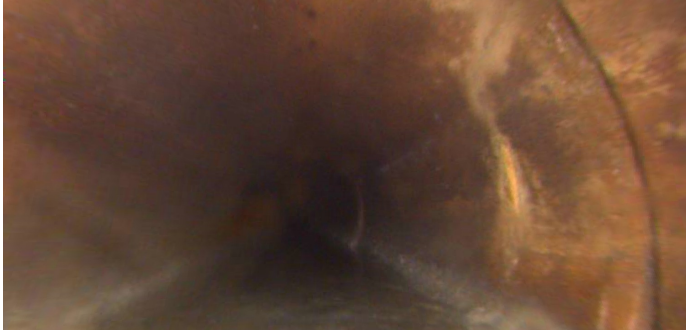
Code: **FC**  
Description: **Fracture Circumferential**

Distance (ft): **194.8**  
Structural Grade: **2**  
O&M Grade: **0**  
Clock Start/From: **2**  
Clock To: **4**  
1st Value:  
2nd Value:  
Value Percent:  
Continuous Index:  
Within 8" of Joint: **YES**  
Remarks:

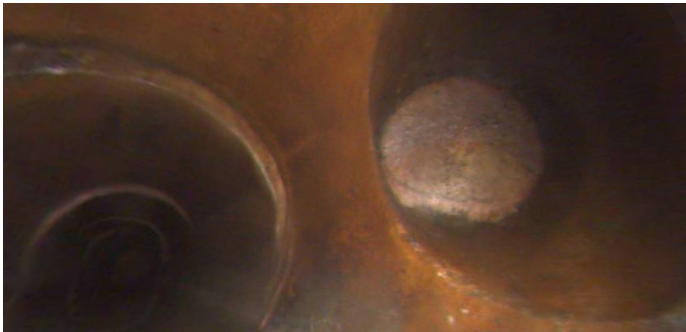
Code: **TFC**  
Description: **Tap Factory Capped**

Distance (ft): **202.3**  
Structural Grade: **0**  
O&M Grade: **0**  
Clock Start/From: **10**  
Clock To:  
1st Value: **4.000**  
2nd Value:  
Value Percent:  
Continuous Index:  
Within 8" of Joint:  
Remarks:

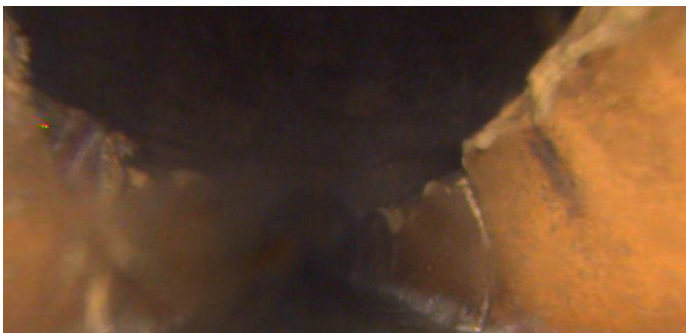
Code: **AMH**  
Description: **Manhole**

Distance (ft): **213.0**  
Structural Grade: **0**  
O&M Grade: **0**  
Clock Start/From:  
Clock To:  
1st Value:  
2nd Value:  
Value Percent:  
Continuous Index:  
Within 8" of Joint: **NO**  
Remarks: **M-604-101**
