## Profile/Photo Observation Report

Street:	<b>ALLEY BETWEEN N WISCONSIN ST &amp;</b>	Flow Control:	<b>Not Controlled</b>
City:	<b>Hobart, IN</b>	Year Renewed:	
Location:	<b>Light Highway</b>	Tape/Media #:	
Purpose:	<b>Not Known</b>	Dia/Height:	<b>12"</b>
Use:	<b>Sanitary</b>	Material:	<b>VCP</b>
Drain Area:	<b>NA</b>	Lining:	
Category:	<b>NA</b>		
Comment:

Location Details:		Direction of Survey:	<b>Downstream</b>
US MH:	<b>M-604-103</b>	DS MH:	<b>M-604-102</b>
		Total Length Surveyed (ft):	<b>24.8</b>

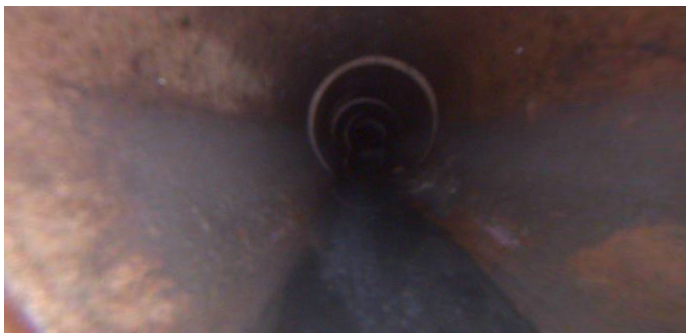
Code: **AMH**  
Description: **Manhole**

Distance (ft): **.0**  
Structural Grade: **0**  
O&M Grade: **0**  
Clock Start/From:  
Clock To:  
1st Value:  
2nd Value:  
Value Percent:  
Continuous Index:  
Within 8" of Joint: **NO**  
Remarks: **M-604-103**

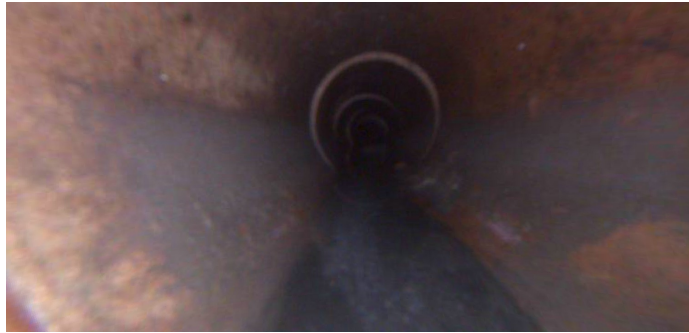
Code: **MWL**  
Description: **Water Level**

Distance (ft): **.0**  
Structural Grade: **0**  
O&M Grade: **0**  
Clock Start/From:  
Clock To:  
1st Value:  
2nd Value:  
Value Percent: **5.000**  
Continuous Index:  
Within 8" of Joint: **NO**  
Remarks:

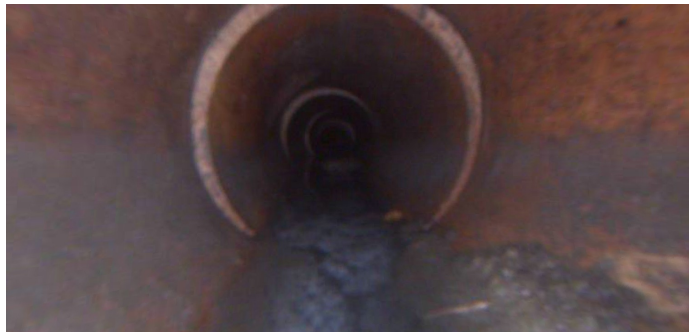
Code: **DAGS**  
Description: **Deposits Attached Grease**

Distance (ft): **2.5**  
Structural Grade: **0**  
O&M Grade: **2**  
Clock Start/From: **8**  
Clock To: **4**  
1st Value:  
2nd Value:  
Value Percent: **5.000**  
Continuous Index: **S01**  
Within 8" of Joint: **NO**  
Remarks:

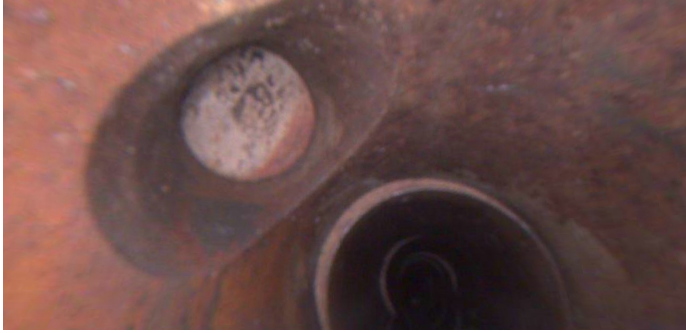
Code: **TFC**  
Description: **Tap Factory Capped**

Distance (ft): **4.2**  
Structural Grade: **0**  
O&M Grade: **0**  
Clock Start/From: **10**  
Clock To:  
1st Value: **4.000**  
2nd Value:  
Value Percent:  
Continuous Index:  
Within 8" of Joint:  
Remarks:

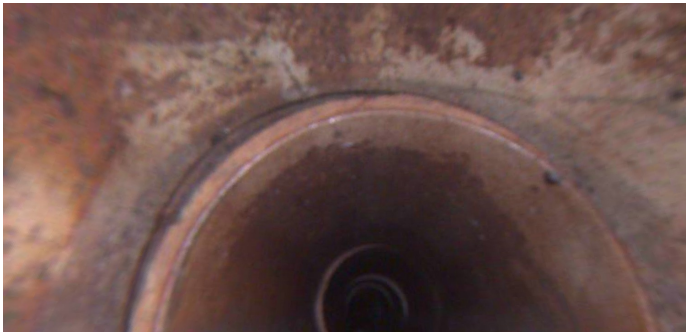
Code: **FM**  
Description: **Fracture Multiple**

Distance (ft): **4.9**  
Structural Grade: **4**  
O&M Grade: **0**  
Clock Start/From: **8**  
Clock To: **4**  
1st Value:  
2nd Value:  
Value Percent:  
Continuous Index:  
Within 8" of Joint: **YES**  
Remarks:

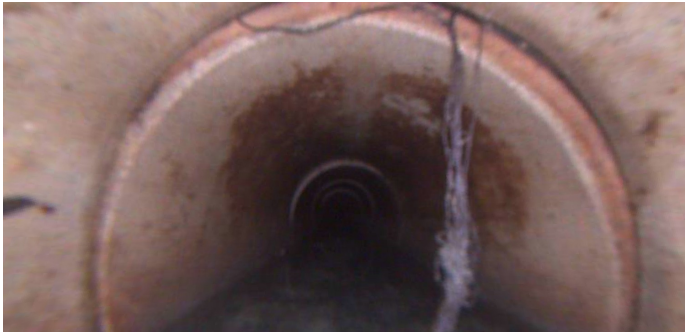
Code: **DAGS**  
Description: **Deposits Attached Grease**

Distance (ft): **11.1**  
Structural Grade: **0**  
O&M Grade: **2**  
Clock Start/From: **8**  
Clock To: **4**  
1st Value:  
2nd Value:  
Value Percent: **5.000**  
Continuous Index: **F01**  
Within 8" of Joint: **NO**  
Remarks:

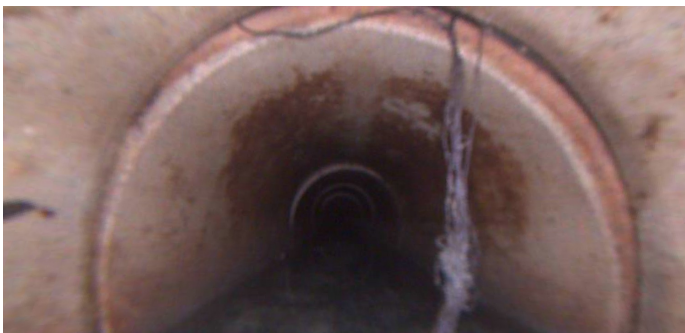
Code: **RFJ**  
Description: **Roots Fine Joint**

Distance (ft): **11.1**  
Structural Grade: **0**  
O&M Grade: **1**  
Clock Start/From: **8**  
Clock To: **4**  
1st Value:  
2nd Value:  
Value Percent:  
Continuous Index: **S02**  
Within 8" of Joint: **YES**  
Remarks:

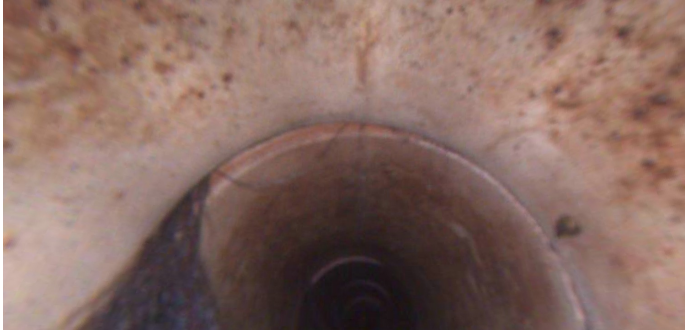
Code: **CM**  
Description: **Crack Multiple**

Distance (ft): **21.3**  
Structural Grade: **3**  
O&M Grade: **0**  
Clock Start/From: **12**  
Clock To: **1**  
1st Value:  
2nd Value:  
Value Percent:  
Continuous Index:  
Within 8" of Joint: **YES**  
Remarks:

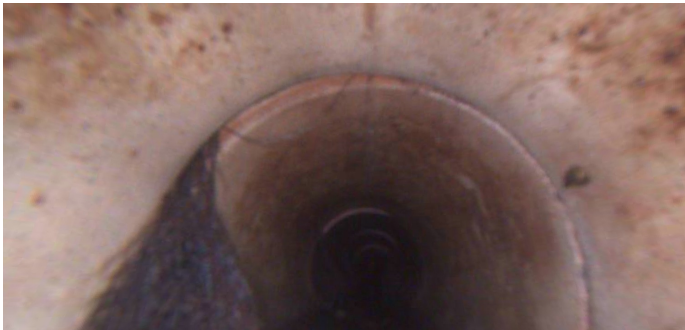
Code: **RMJ**  
Description: **Roots Medium Joint**

Distance (ft): **21.3**  
Structural Grade: **0**  
O&M Grade: **3**  
Clock Start/From: **8**  
Clock To: **11**  
1st Value:  
2nd Value:  
Value Percent: **10.000**  
Continuous Index:  
Within 8" of Joint: **YES**  
Remarks:

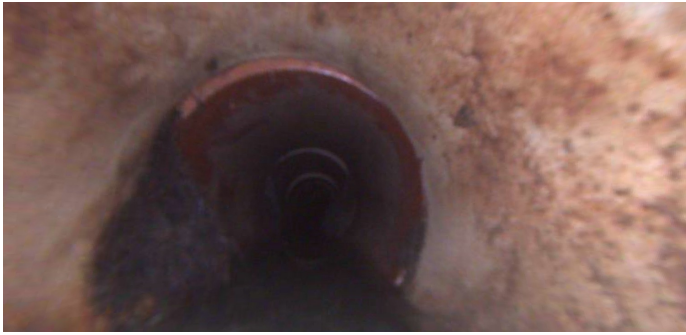
Code: **RMJ**  
Description: **Roots Medium Joint**

Distance (ft): **23.0**  
Structural Grade: **0**  
O&M Grade: **3**  
Clock Start/From: **8**  
Clock To: **4**  
1st Value:  
2nd Value:  
Value Percent: **15.000**  
Continuous Index:  
Within 8" of Joint: **YES**  
Remarks:

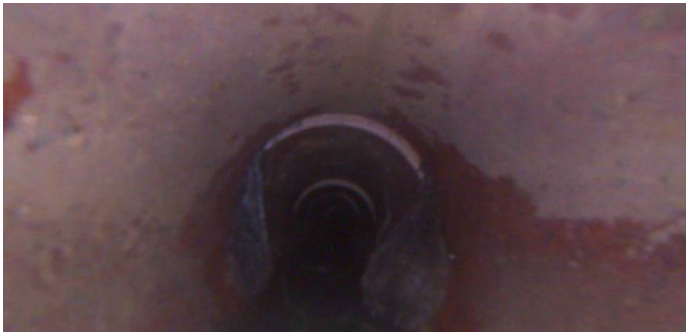
Code: **RFJ**  
Description: **Roots Fine Joint**

Distance (ft): **24.8**  
Structural Grade: **0**  
O&M Grade: **1**  
Clock Start/From: **8**  
Clock To: **4**  
1st Value:  
2nd Value:  
Value Percent:  
Continuous Index: **F02**  
Within 8" of Joint: **YES**  
Remarks:

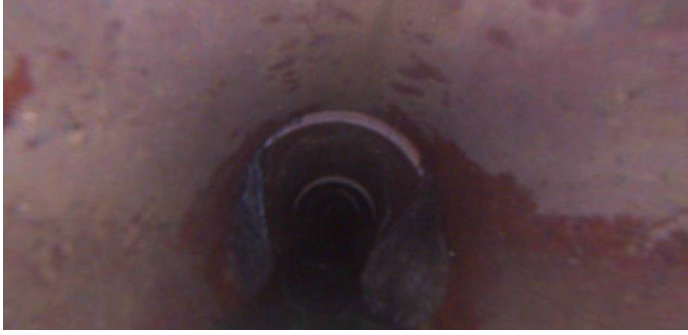
Code:	<b>MSA</b>
Description:	<b>Abandoned Survey</b>
Distance (ft):	<b>24.8</b>
Structural Grade:	<b>0</b>
O&M Grade:	<b>0</b>
Clock Start/From:	
Clock To:	
1st Value:	
2nd Value:	
Value Percent:	
Continuous Index:	
Within 8" of Joint:	<b>NO</b>
Remarks:	<b>rmj</b>
