Profile/Photo Observation Report

Street:	Summerlin	Flow Control:	Not Controlled
City:	Hobart, IN	Year Renewed:	
Location:	Light Highway	Tape/Media #:	
Purpose:	Not Known	Dia/Height:	12"
Use:	Sanitary	Material:	VCP
Drain Area:	NA	Lining:	
Category:	NA		
Comment:

Location Details:		Direction of Survey:	Downstream
US MH:	M-604-103	DS MH:	M-604-102
		Total Length Surveyed (ft):	24.8

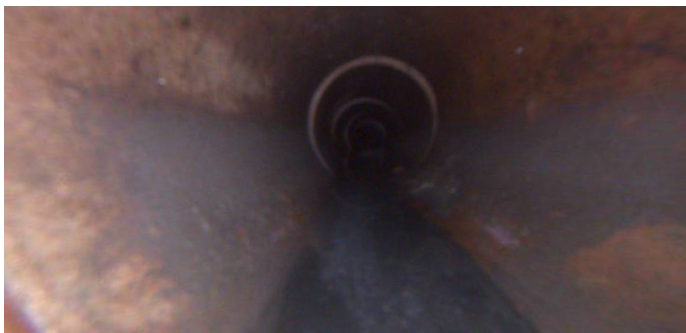
Code: **AMH**
Description: **Manhole**

Distance (ft): **.0**
Structural Grade: **0**
O&M Grade: **0**
Clock Start/From:
Clock To:
1st Value:
2nd Value:
Value Percent:
Continuous Index:
Within 8" of Joint: **NO**
Remarks: **M-604-103**

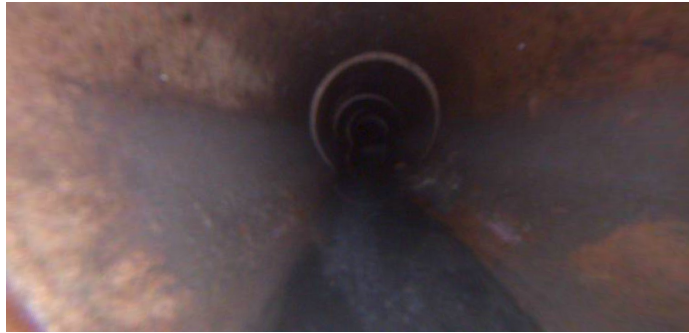
Code: **MWL**
Description: **Water Level**

Distance (ft): **.0**
Structural Grade: **0**
O&M Grade: **0**
Clock Start/From:
Clock To:
1st Value:
2nd Value:
Value Percent: **5.000**
Continuous Index:
Within 8" of Joint: **NO**
Remarks:

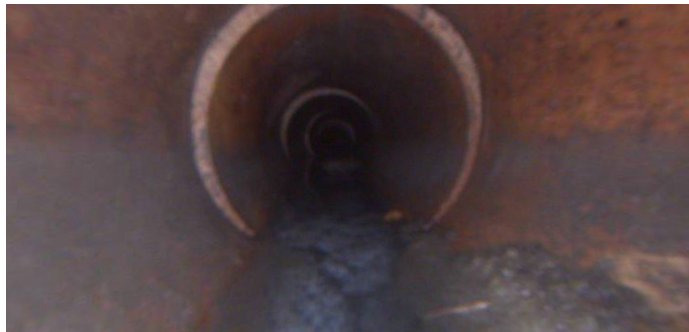
Code: **DAGS**
Description: **Deposits Attached Grease**

Distance (ft): **2.5**
Structural Grade: **0**
O&M Grade: **2**
Clock Start/From: **8**
Clock To: **4**
1st Value:
2nd Value:
Value Percent: **5.000**
Continuous Index: **S01**
Within 8" of Joint: **NO**
Remarks:

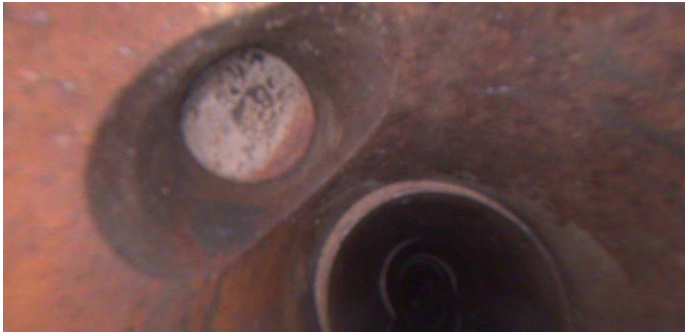
Code: **TFC**
Description: **Tap Factory Capped**

Distance (ft): **4.2**
Structural Grade: **0**
O&M Grade: **0**
Clock Start/From: **10**
Clock To:
1st Value: **4.000**
2nd Value:
Value Percent:
Continuous Index:
Within 8" of Joint:
Remarks:

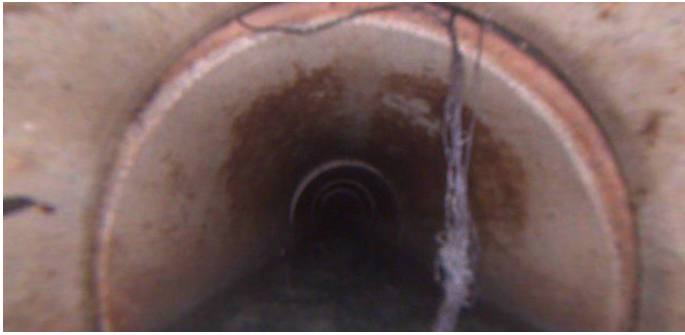
Code: **DAGS**
Description: **Deposits Attached Grease**

Distance (ft): **11.1**
Structural Grade: **0**
O&M Grade: **2**
Clock Start/From: **8**
Clock To: **4**
1st Value:
2nd Value:
Value Percent: **5.000**
Continuous Index: **F01**
Within 8" of Joint: **NO**
Remarks:

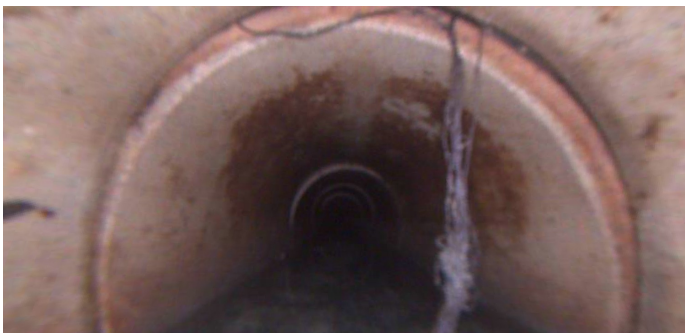
Code: **RFJ**
Description: **Roots Fine Joint**

Distance (ft): **11.1**
Structural Grade: **0**
O&M Grade: **1**
Clock Start/From: **8**
Clock To: **4**
1st Value:
2nd Value:
Value Percent:
Continuous Index: **S02**
Within 8" of Joint: **YES**
Remarks:

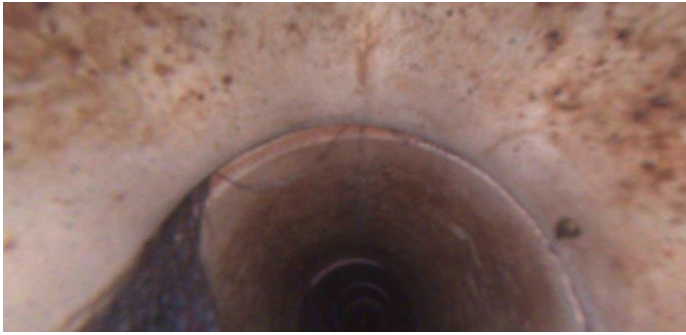
Code: **CM**
Description: **Crack Multiple**

Distance (ft): **21.3**
Structural Grade: **3**
O&M Grade: **0**
Clock Start/From: **12**
Clock To: **1**
1st Value:
2nd Value:
Value Percent:
Continuous Index:
Within 8" of Joint: **YES**
Remarks:

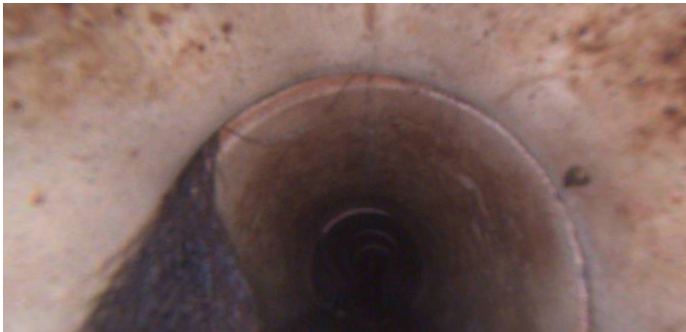
Code: **RMJ**
Description: **Roots Medium Joint**

Distance (ft): **21.3**
Structural Grade: **0**
O&M Grade: **3**
Clock Start/From: **8**
Clock To: **11**
1st Value:
2nd Value:
Value Percent: **10.000**
Continuous Index:
Within 8" of Joint: **YES**
Remarks:

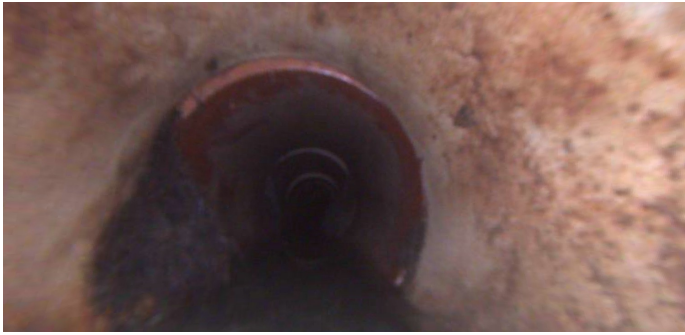
Code: **RMJ**
Description: **Roots Medium Joint**

Distance (ft): **23.0**
Structural Grade: **0**
O&M Grade: **3**
Clock Start/From: **8**
Clock To: **4**
1st Value:
2nd Value:
Value Percent: **15.000**
Continuous Index:
Within 8" of Joint: **YES**
Remarks:

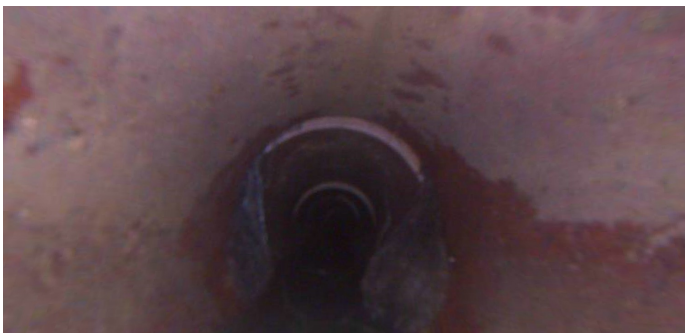
Code: **RFJ**
Description: **Roots Fine Joint**

Distance (ft): **24.8**
Structural Grade: **0**
O&M Grade: **1**
Clock Start/From: **8**
Clock To: **4**
1st Value:
2nd Value:
Value Percent:
Continuous Index: **F02**
Within 8" of Joint: **YES**
Remarks:

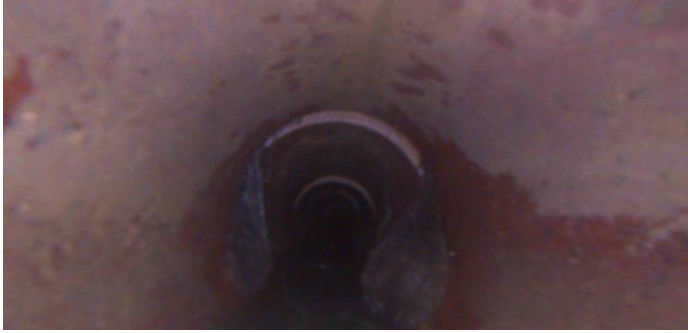
Code:	MSA
Description:	Abandoned Survey
Distance (ft):	24.8
Structural Grade:	0
O&M Grade:	0
Clock Start/From:	
Clock To:	
1st Value:	
2nd Value:	
Value Percent:	
Continuous Index:	
Within 8" of Joint:	NO
Remarks:	rmj
