## Profile/Photo Observation Report

Street:	<b>ALLEY BETWEEN N WISCONSIN ST &amp;</b>	Flow Control:	<b>Not Controlled</b>
City:	<b>Hobart, IN</b>	Year Renewed:	
Location:	<b>Light Highway</b>	Tape/Media #:	
Purpose:	<b>Not Known</b>	Dia/Height:	<b>12"</b>
Use:	<b>Sanitary</b>	Material:	<b>VCP</b>
Drain Area:	<b>NA</b>	Lining:	
Category:	<b>NA</b>		
Comment:

Location Details:		Direction of Survey:	<b>Downstream</b>
US MH:	<b>M-604-104</b>	DS MH:	<b>M-604-103</b>
		Total Length Surveyed (ft):	<b>112.5</b>

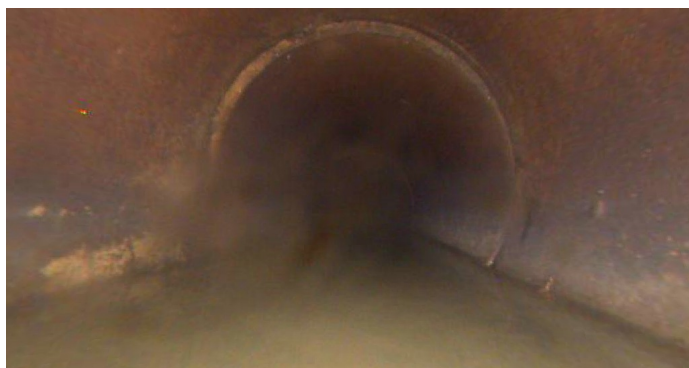
Code: **AMH**  
 Description: **Manhole**

Distance (ft): **.0**  
 Structural Grade: **0**  
 O&M Grade: **0**  
 Clock Start/From:  
 Clock To:  
 1st Value:  
 2nd Value:  
 Value Percent:  
 Continuous Index:  
 Within 8" of Joint: **NO**  
 Remarks: **M-604-104**

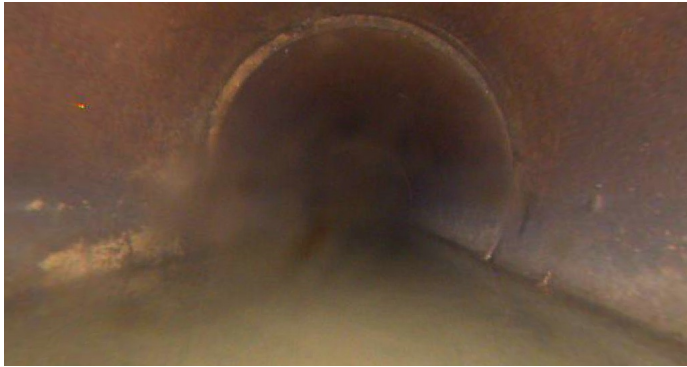
Code: **MWL**  
Description: **Water Level**

Distance (ft): **.0**  
Structural Grade: **0**  
O&M Grade: **0**  
Clock Start/From:  
Clock To:  
1st Value:  
2nd Value:  
Value Percent: **10.000**  
Continuous Index:  
Within 8" of Joint: **NO**  
Remarks:

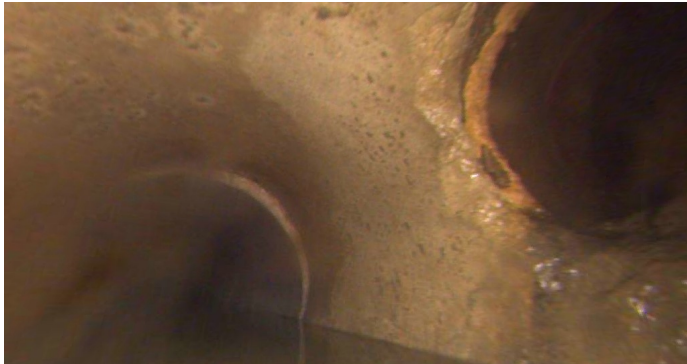
Code: **TB**  
Description: **Tap Break-in**

Distance (ft): **8.8**  
Structural Grade: **0**  
O&M Grade: **0**  
Clock Start/From: **3**  
Clock To:  
1st Value: **4.000**  
2nd Value:  
Value Percent:  
Continuous Index:  
Within 8" of Joint:  
Remarks:

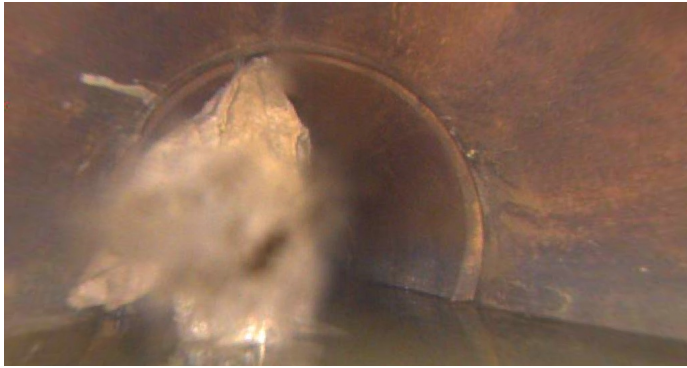
Code:	<b>DAZ</b>
Description:	<b>Deposits Attached Other</b>
Distance (ft):	<b>11.4</b>
Structural Grade:	<b>0</b>
O&M Grade:	<b>3</b>
Clock Start/From:	<b>11</b>
Clock To:	
1st Value:	
2nd Value:	
Value Percent:	<b>15.000</b>
Continuous Index:	
Within 8" of Joint:	<b>NO</b>
Remarks:

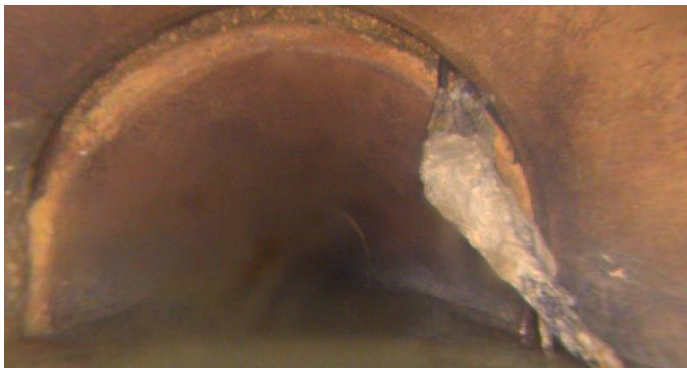
Code:	<b>DAZ</b>
Description:	<b>Deposits Attached Other</b>
Distance (ft):	<b>13.6</b>
Structural Grade:	<b>0</b>
O&M Grade:	<b>2</b>
Clock Start/From:	<b>2</b>
Clock To:	<b>5</b>
1st Value:	
2nd Value:	
Value Percent:	<b>5.000</b>
Continuous Index:	
Within 8" of Joint:	<b>YES</b>
Remarks:

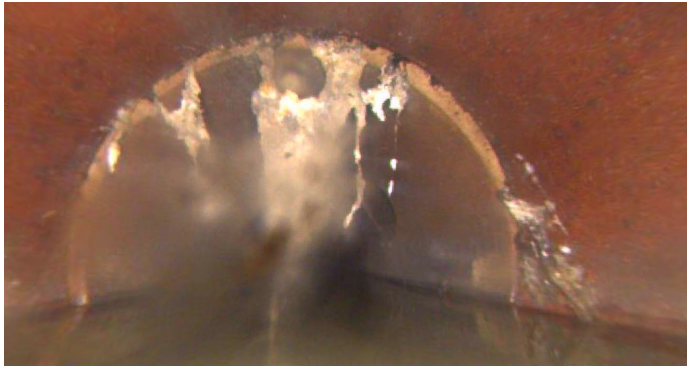
Code:	DAZ
Description:	Deposits Attached Other
Distance (ft):	19.6
Structural Grade:	0
O&M Grade:	2
Clock Start/From:	9
Clock To:	4
1st Value:	
2nd Value:	
Value Percent:	5.000
Continuous Index:	
Within 8" of Joint:	YES
Remarks:

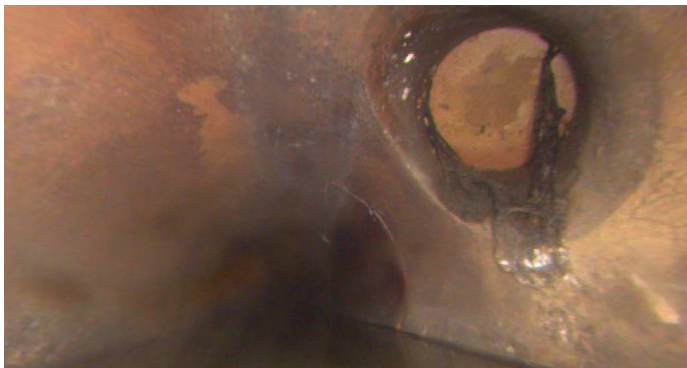
Code:	TFC
Description:	Tap Factory Capped
Distance (ft):	20.9
Structural Grade:	0
O&M Grade:	0
Clock Start/From:	2
Clock To:	
1st Value:	4.000
2nd Value:	
Value Percent:	
Continuous Index:	
Within 8" of Joint:	
Remarks:

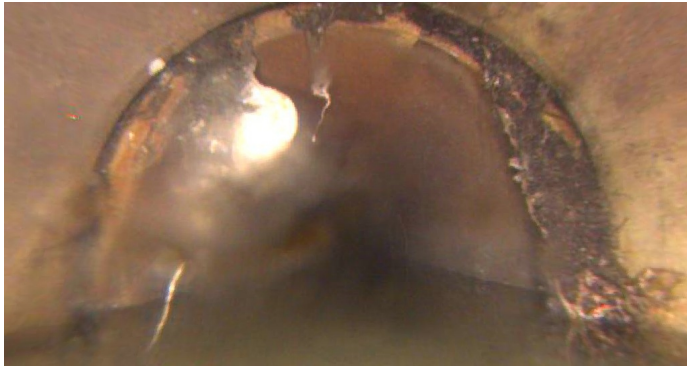
Code:	<b>DAZ</b>
Description:	<b>Deposits Attached Other</b>
Distance (ft):	<b>27.8</b>
Structural Grade:	<b>0</b>
O&M Grade:	<b>2</b>
Clock Start/From:	<b>7</b>
Clock To:	<b>5</b>
1st Value:	
2nd Value:	
Value Percent:	<b>5.000</b>
Continuous Index:	
Within 8" of Joint:	<b>YES</b>
Remarks:

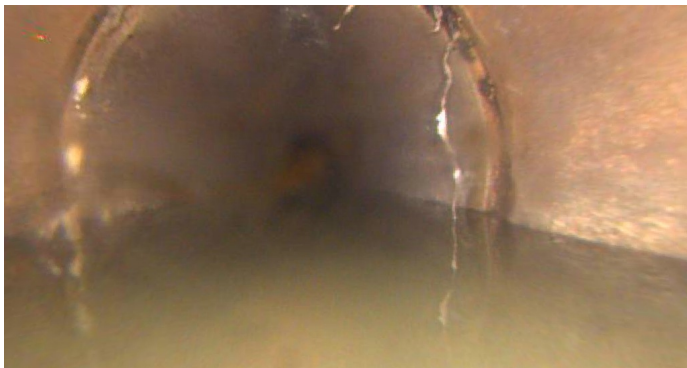
Code:	<b>RFJ</b>
Description:	<b>Roots Fine Joint</b>
Distance (ft):	<b>29.7</b>
Structural Grade:	<b>0</b>
O&M Grade:	<b>1</b>
Clock Start/From:	<b>7</b>
Clock To:	<b>5</b>
1st Value:	
2nd Value:	
Value Percent:	
Continuous Index:	<b>S01</b>
Within 8" of Joint:	<b>YES</b>
Remarks:

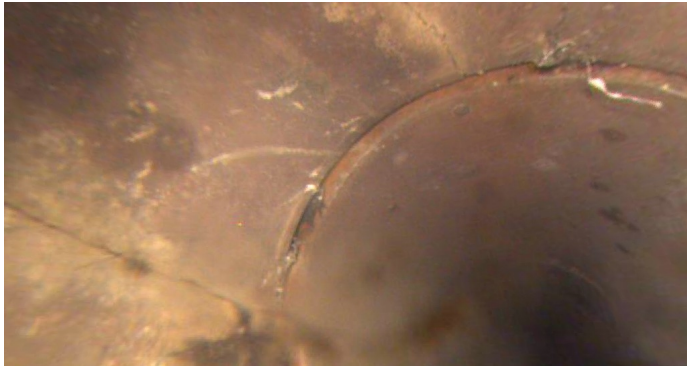
Code: **CM**  
Description: **Crack Multiple**

Distance (ft): **33.9**  
Structural Grade: **3**  
O&M Grade: **0**  
Clock Start/From: **8**  
Clock To: **10**  
1st Value:  
2nd Value:  
Value Percent:  
Continuous Index:  
Within 8" of Joint: **YES**  
Remarks:

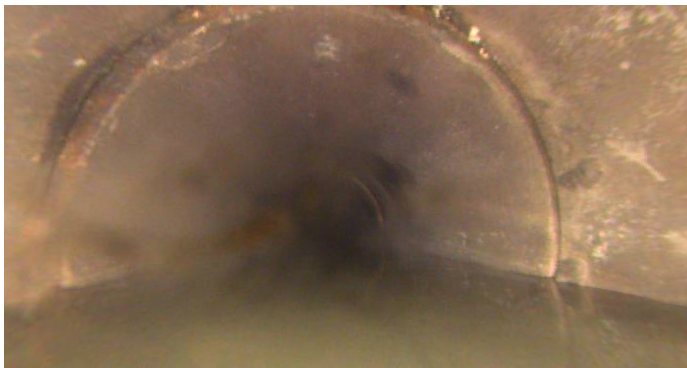
Code: **RFJ**  
Description: **Roots Fine Joint**

Distance (ft): **36.0**  
Structural Grade: **0**  
O&M Grade: **1**  
Clock Start/From: **7**  
Clock To: **5**  
1st Value:  
2nd Value:  
Value Percent:  
Continuous Index: **F01**  
Within 8" of Joint: **YES**  
Remarks:

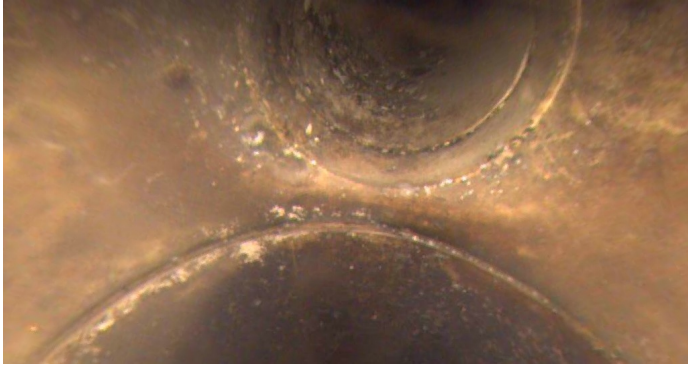
Code: **TF**  
Description: **Tap Factory**

Distance (ft): **44.8**  
Structural Grade: **0**  
O&M Grade: **0**  
Clock Start/From: **1**  
Clock To:  
1st Value: **4.000**  
2nd Value:  
Value Percent:  
Continuous Index:  
Within 8" of Joint:  
Remarks:

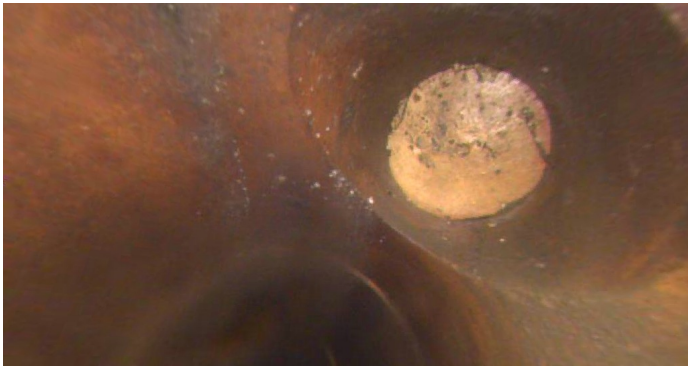
Code: **TFC**  
Description: **Tap Factory Capped**

Distance (ft): **51.7**  
Structural Grade: **0**  
O&M Grade: **0**  
Clock Start/From: **2**  
Clock To:  
1st Value: **4.000**  
2nd Value:  
Value Percent:  
Continuous Index:  
Within 8" of Joint:  
Remarks:

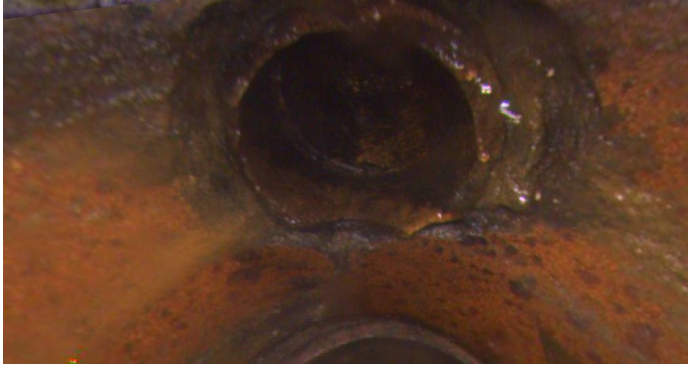
Code: **TB**  
Description: **Tap Break-in**

Distance (ft): **80.2**  
Structural Grade: **0**  
O&M Grade: **0**  
Clock Start/From: **1**  
Clock To:  
1st Value: **4.000**  
2nd Value:  
Value Percent:  
Continuous Index:  
Within 8" of Joint:  
Remarks:

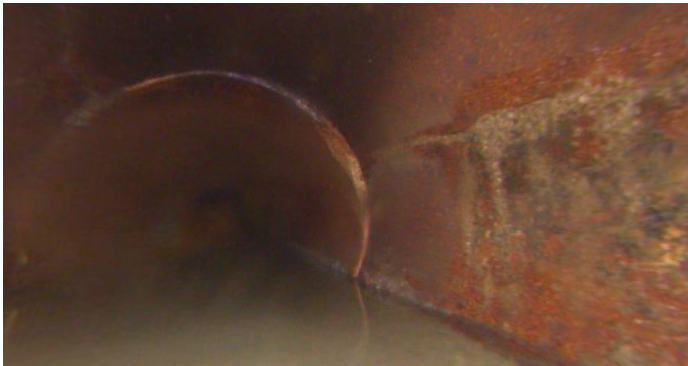
Code: **CL**  
Description: **Crack Longitudinal**

Distance (ft): **82.4**  
Structural Grade: **2**  
O&M Grade: **0**  
Clock Start/From: **3**  
Clock To:  
1st Value:  
2nd Value:  
Value Percent:  
Continuous Index:  
Within 8" of Joint: **YES**  
Remarks:

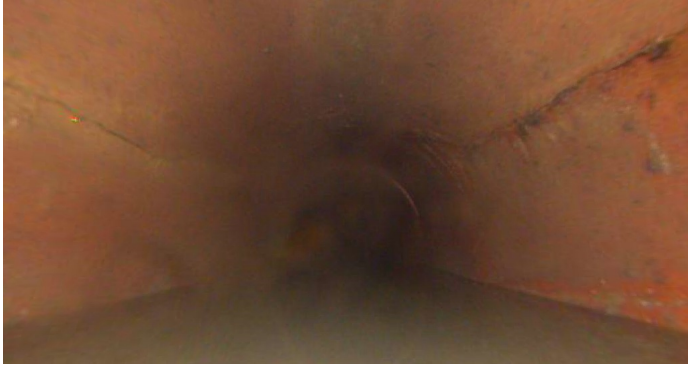
Code: **CM**  
Description: **Crack Multiple**

Distance (ft): **95.5**  
Structural Grade: **3**  
O&M Grade: **0**  
Clock Start/From: **8**  
Clock To: **3**  
1st Value:  
2nd Value:  
Value Percent:  
Continuous Index:  
Within 8" of Joint:  
Remarks:

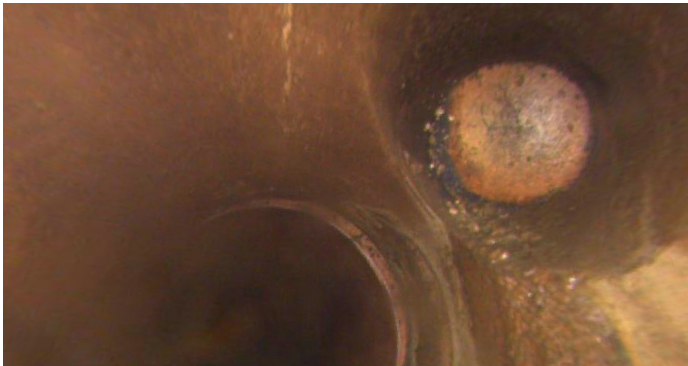
Code: **TFC**  
Description: **Tap Factory Capped**

Distance (ft): **102.5**  
Structural Grade: **0**  
O&M Grade: **0**  
Clock Start/From: **2**  
Clock To:  
1st Value: **4.000**  
2nd Value:  
Value Percent:  
Continuous Index:  
Within 8" of Joint:  
Remarks:

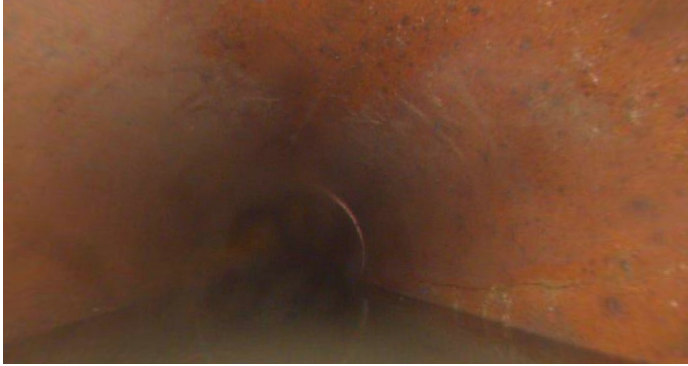
Code: **CM**  
Description: **Crack Multiple**

Distance (ft): **103.7**  
Structural Grade: **3**  
O&M Grade: **0**  
Clock Start/From: **12**  
Clock To: **5**  
1st Value:  
2nd Value:  
Value Percent:  
Continuous Index:  
Within 8" of Joint:  
Remarks:

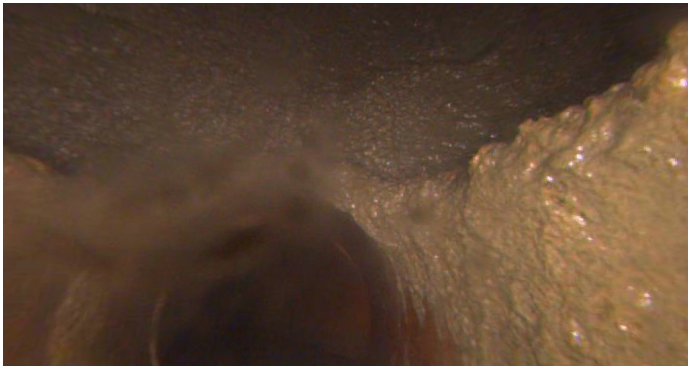
Code: **AMH**  
Description: **Manhole**

Distance (ft): **112.5**  
Structural Grade: **0**  
O&M Grade: **0**  
Clock Start/From:  
Clock To:  
1st Value:  
2nd Value:  
Value Percent:  
Continuous Index:  
Within 8" of Joint: **NO**  
Remarks: **M-604-103**
