Profile/Photo Observation Report

Date:	04/22/2018	Weather:		Coding:	PACP 6.0
Pipe Length (ft):	107.4	Owner:	NA	Pre Clean:	Not Known
P.O.#:		Surveyor:	Mark Ruby	PSR:	P-604-104-103
Customer:		Clean Date:	01/01/1900	Shape:	C

Street:	Summerlin	Flow Control:	Not Controlled
City:	Hobart, IN	Year Renewed:	
Location:	Light Highway	Tape/Media #:	
Purpose:	Not Known	Dia/Height:	12"
Use:	Sanitary	Material:	VCP
Drain Area:	NA	Lining:	
Category:	NA		
Comment:

Location Details:		Direction of Survey:	Downstream
US MH:	M-604-104	DS MH:	M-604-103
		Total Length Surveyed (ft):	112.5

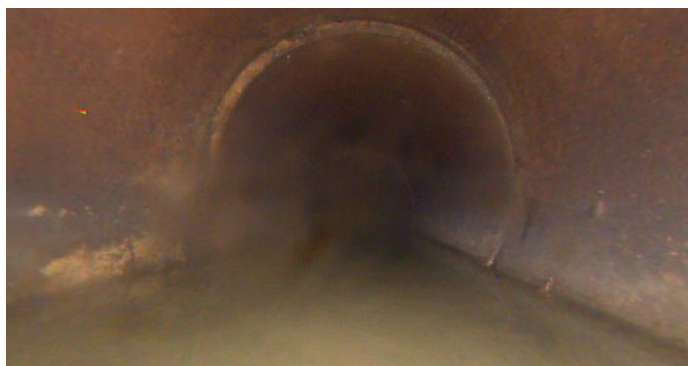
Code: **AMH**
 Description: **Manhole**

Distance (ft): **.0**
 Structural Grade: **0**
 O&M Grade: **0**
 Clock Start/From:
 Clock To:
 1st Value:
 2nd Value:
 Value Percent:
 Continuous Index:
 Within 8" of Joint: **NO**
 Remarks: **M-604-104**

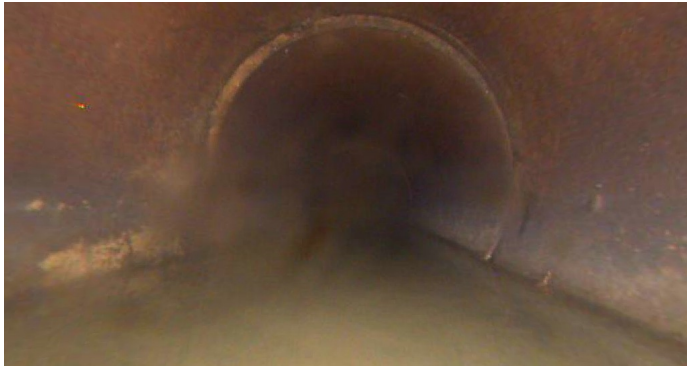
Code:	MWL
Description:	Water Level
Distance (ft):	.0
Structural Grade:	0
O&M Grade:	0
Clock Start/From:	
Clock To:	
1st Value:	
2nd Value:	
Value Percent:	10.000
Continuous Index:	
Within 8" of Joint:	NO
Remarks:

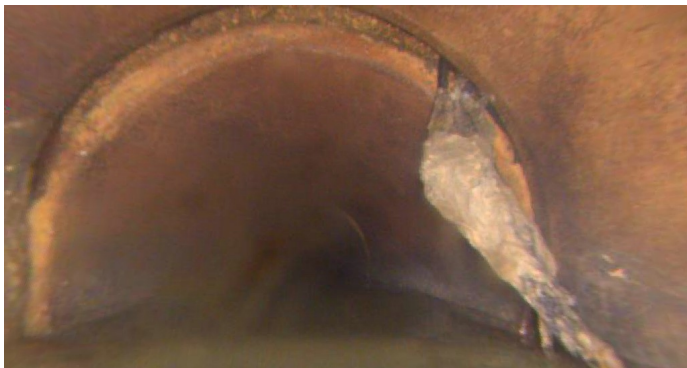
Code:	DAZ
Description:	Deposits Attached Other
Distance (ft):	13.6
Structural Grade:	0
O&M Grade:	2
Clock Start/From:	2
Clock To:	5
1st Value:	
2nd Value:	
Value Percent:	5.000
Continuous Index:	
Within 8" of Joint:	YES
Remarks:

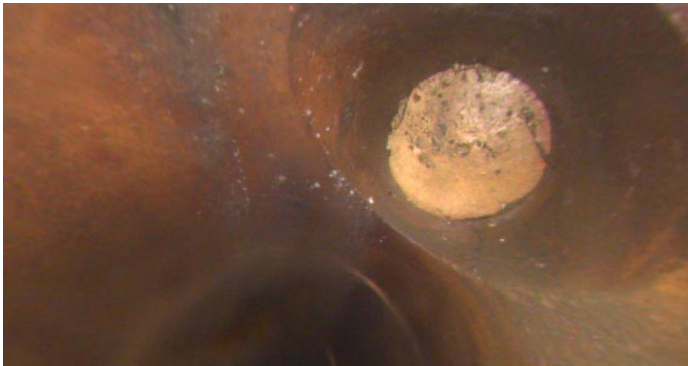
Code: **TFC**
Description: **Tap Factory Capped**

Distance (ft): **51.7**
Structural Grade: **0**
O&M Grade: **0**
Clock Start/From: **2**
Clock To:
1st Value: **4.000**
2nd Value:
Value Percent:
Continuous Index:
Within 8" of Joint:
Remarks:

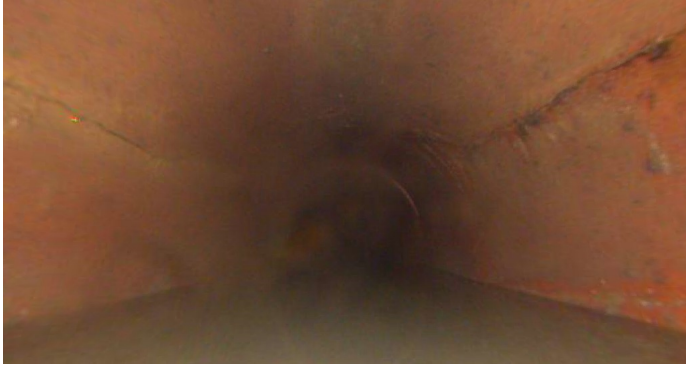
Code: **CM**
Description: **Crack Multiple**

Distance (ft): **95.5**
Structural Grade: **3**
O&M Grade: **0**
Clock Start/From: **8**
Clock To: **3**
1st Value:
2nd Value:
Value Percent:
Continuous Index:
Within 8" of Joint:
Remarks:

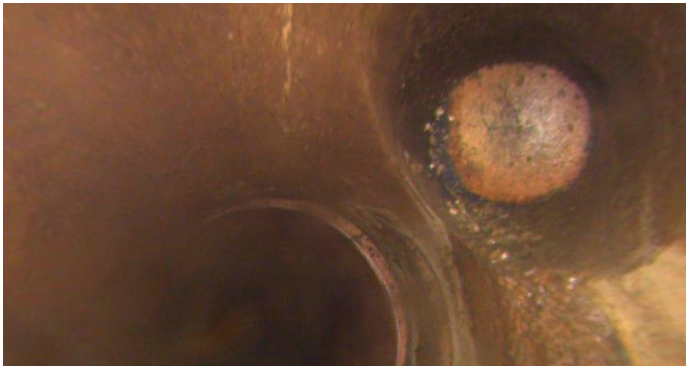
Code: **TFC**
Description: **Tap Factory Capped**

Distance (ft): **102.5**
Structural Grade: **0**
O&M Grade: **0**
Clock Start/From: **2**
Clock To:
1st Value: **4.000**
2nd Value:
Value Percent:
Continuous Index:
Within 8" of Joint:
Remarks:

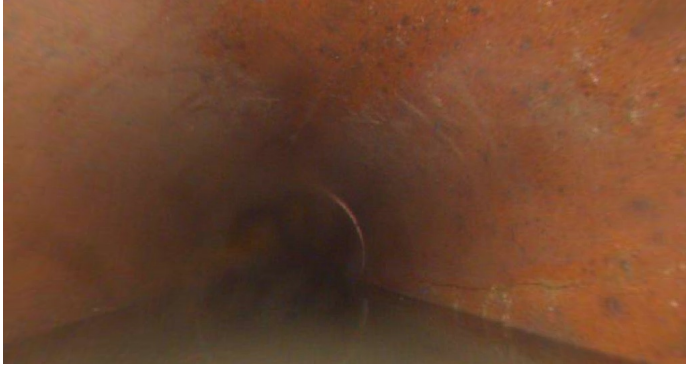
Code: **CM**
Description: **Crack Multiple**

Distance (ft): **103.7**
Structural Grade: **3**
O&M Grade: **0**
Clock Start/From: **12**
Clock To: **5**
1st Value:
2nd Value:
Value Percent:
Continuous Index:
Within 8" of Joint:
Remarks:

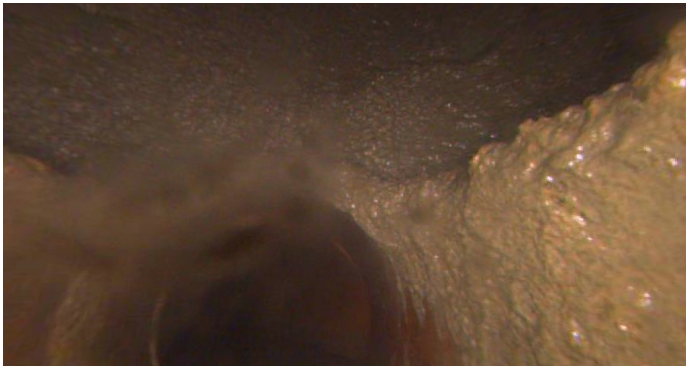
Code: **AMH**
Description: **Manhole**

Distance (ft): **112.5**
Structural Grade: **0**
O&M Grade: **0**
Clock Start/From:
Clock To:
1st Value:
2nd Value:
Value Percent:
Continuous Index:
Within 8" of Joint: **NO**
Remarks: **M-604-103**
