Profile/Photo Observation Report

Street:	N LAKE PARK AVE	Flow Control:	Not Controlled
City:	Hobart, IN	Year Renewed:	
Location:	Other	Tape/Media #:	
Purpose:	Not Known	Dia/Height:	8"
Use:	Sanitary	Material:	CP
Drain Area:	NA	Lining:	
Category:	NA		
Comment:

Location Details:		Direction of Survey:	Downstream
US MH:	M-604-120	DS MH:	M-604-121
		Total Length Surveyed (ft):	3.4

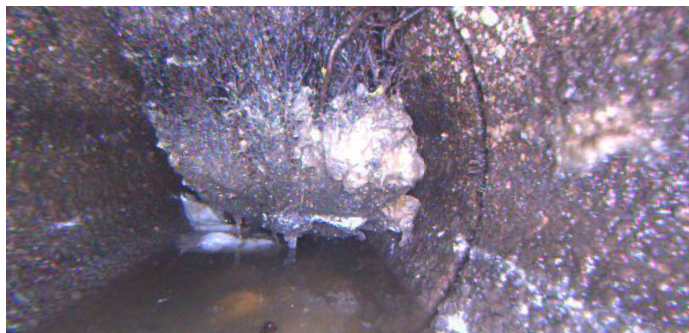
Code: AMH

Description: Manhole

Distance (ft): .0

Remarks: M-604-120

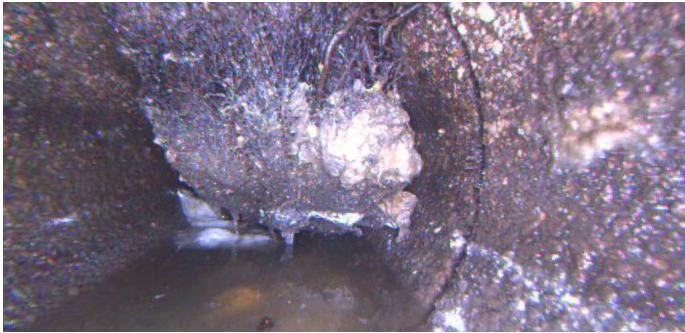
Code:	MWL
Description:	Water Level

Distance (ft):	.0
Structural Grade:	0
O&M Grade:	0
Clock Start/From:	
Clock To:	
1st Value:	
2nd Value:	
Value Percent:	10.000
Continuous Index:	
Within 8" of Joint:	NO
Remarks:

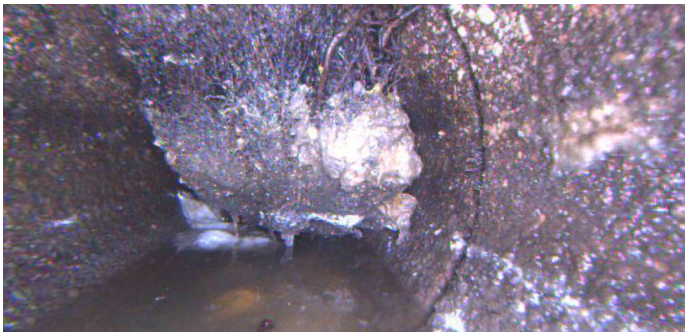
Code:	SAP
Description:	Surface Aggregate Projecting

Distance (ft):	.0
Structural Grade:	3
O&M Grade:	0
Clock Start/From:	8
Clock To:	4
1st Value:	
2nd Value:	
Value Percent:	
Continuous Index:	
Within 8" of Joint:	
Remarks:

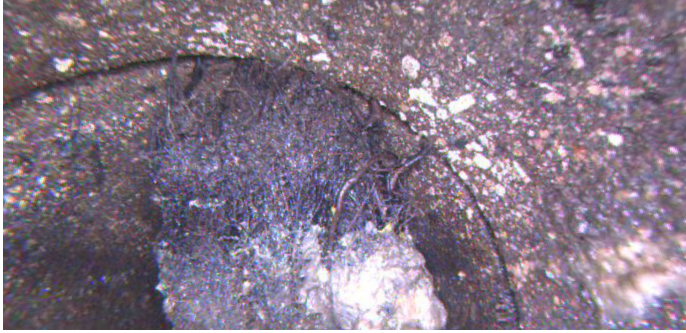
Code: **RBJ**
Description: **Roots Ball Joint**

Distance (ft): **.0**
Structural Grade: **0**
O&M Grade: **4**
Clock Start/From: **1**
Clock To: **6**
1st Value:
2nd Value:
Value Percent: **70.000**
Continuous Index:
Within 8" of Joint: **YES**
Remarks:

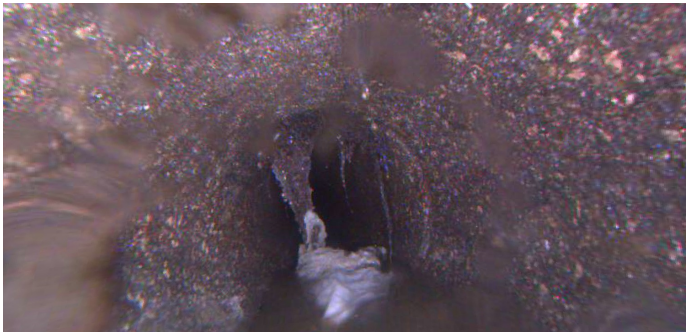
Code: **MSA**
Description: **Abandoned Survey**

Distance (ft): **3.4**
Structural Grade: **0**
O&M Grade: **0**
Clock Start/From:
Clock To:
1st Value:
2nd Value:
Value Percent:
Continuous Index:
Within 8" of Joint: **NO**
Remarks: **roots**
