Profile/Photo Observation Report

Street:	N LAKE PARK AVE	Flow Control:	Not Controlled
City:	Hobart, IN	Year Renewed:	
Location:	Other	Tape/Media #:	
Purpose:	Not Known	Dia/Height:	8"
Use:	Sanitary	Material:	CP
Drain Area:	NA	Lining:	
Category:	NA		
Comment:

Location Details:		Direction of Survey:	Upstream
US MH:	M-604-120	DS MH:	M-604-121
		Total Length Surveyed (ft):	244.6

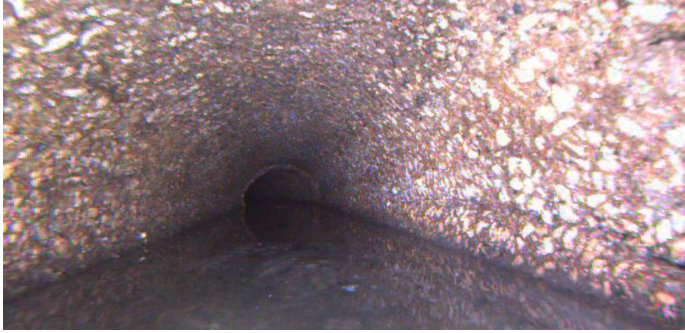
Code: **AMH**
Description: **Manhole**

Distance (ft): **.0**
Structural Grade: **0**
O&M Grade: **0**
Clock Start/From:
Clock To:
1st Value:
2nd Value:
Value Percent:
Continuous Index:
Within 8" of Joint: **NO**
Remarks: **M-604-121**

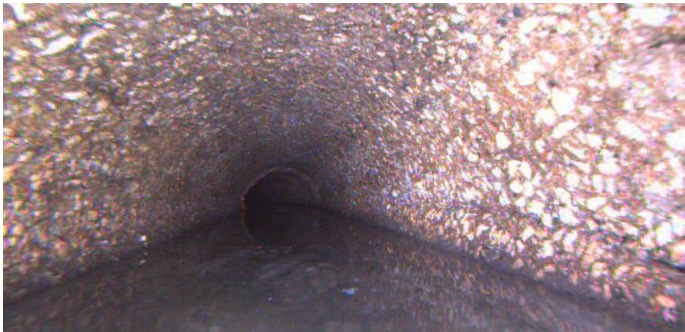
Code: **MWL**
Description: **Water Level**

Distance (ft): **.0**
Structural Grade: **0**
O&M Grade: **0**
Clock Start/From:
Clock To:
1st Value:
2nd Value:
Value Percent: **20.000**
Continuous Index:
Within 8" of Joint: **NO**
Remarks:

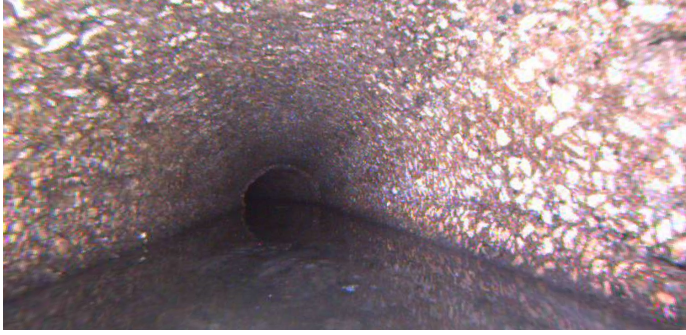
Code:	SAP
Description:	Surface Aggregate Projecting
Distance (ft):	.0
Structural Grade:	3
O&M Grade:	0
Clock Start/From:	8
Clock To:	4
1st Value:	
2nd Value:	
Value Percent:	
Continuous Index:	S01
Within 8" of Joint:	
Remarks:

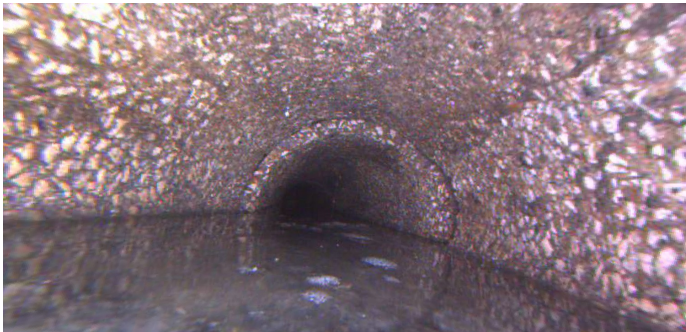
Code:	LL
Description:	Alignment Left
Distance (ft):	2.9
Structural Grade:	0
O&M Grade:	1
Clock Start/From:	
Clock To:	
1st Value:	
2nd Value:	
Value Percent:	5.000
Continuous Index:	
Within 8" of Joint:	NO
Remarks:

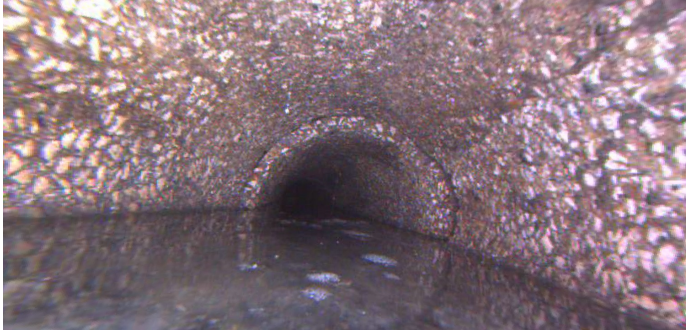
Code: **FL**
Description: **Fracture Longitudinal**

Distance (ft): **2.9**
Structural Grade: **3**
O&M Grade: **0**
Clock Start/From: **2**
Clock To:
1st Value:
2nd Value:
Value Percent:
Continuous Index:
Within 8" of Joint: **YES**
Remarks:

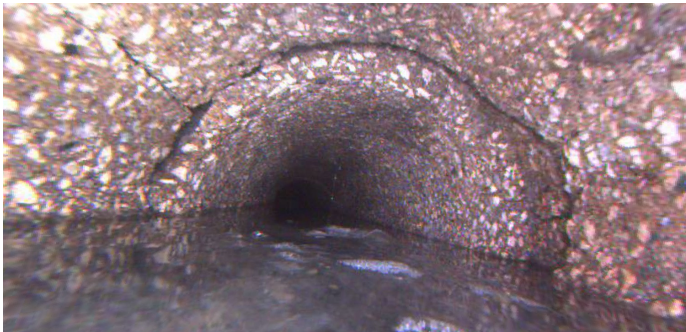
Code: **FL**
Description: **Fracture Longitudinal**

Distance (ft): **3.3**
Structural Grade: **3**
O&M Grade: **0**
Clock Start/From: **10**
Clock To:
1st Value:
2nd Value:
Value Percent:
Continuous Index:
Within 8" of Joint: **YES**
Remarks:

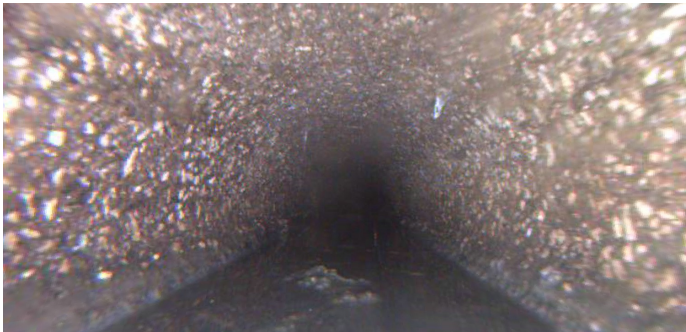
Code: **MGO**
Description: **General Observation**

Distance (ft): **15.1**
Structural Grade: **0**
O&M Grade: **0**
Clock Start/From:
Clock To:
1st Value:
2nd Value:
Value Percent:
Continuous Index:
Within 8" of Joint: **NO**
Remarks: **REAR CAMERA**

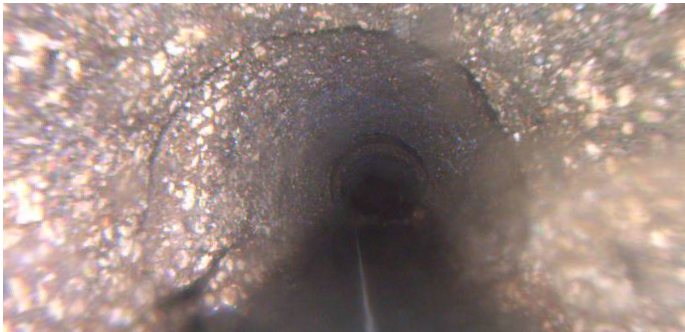
Code: **JOM**
Description: **Joint Offset Medium**

Distance (ft): **126.8**
Structural Grade: **1**
O&M Grade: **0**
Clock Start/From:
Clock To:
1st Value:
2nd Value:
Value Percent:
Continuous Index:
Within 8" of Joint: **NO**
Remarks:

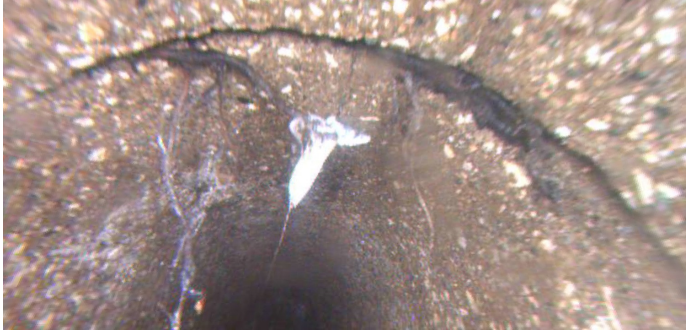
Code: **RFJ**
Description: **Roots Fine Joint**

Distance (ft): **198.3**
Structural Grade: **0**
O&M Grade: **1**
Clock Start/From: **11**
Clock To: **1**
1st Value:
2nd Value:
Value Percent:
Continuous Index:
Within 8" of Joint: **YES**
Remarks:

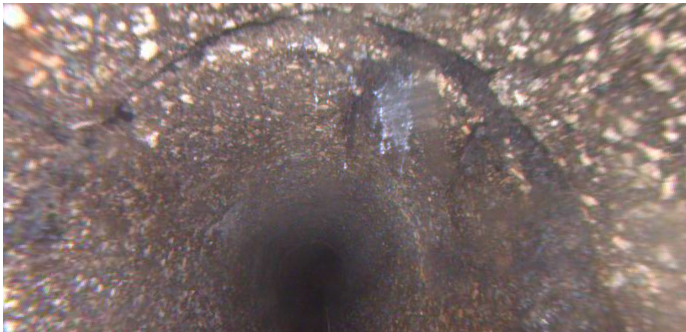
Code: **RFJ**
Description: **Roots Fine Joint**

Distance (ft): **204.6**
Structural Grade: **0**
O&M Grade: **1**
Clock Start/From: **8**
Clock To: **4**
1st Value:
2nd Value:
Value Percent:
Continuous Index:
Within 8" of Joint: **YES**
Remarks:

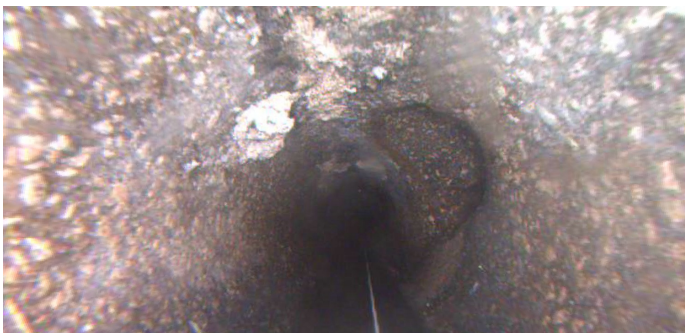
Code: **DAGS**
Description: **Deposits Attached Grease**

Distance (ft): **207.1**
Structural Grade: **0**
O&M Grade: **2**
Clock Start/From: **12**
Clock To: **1**
1st Value:
2nd Value:
Value Percent: **5.000**
Continuous Index:
Within 8" of Joint: **NO**
Remarks:

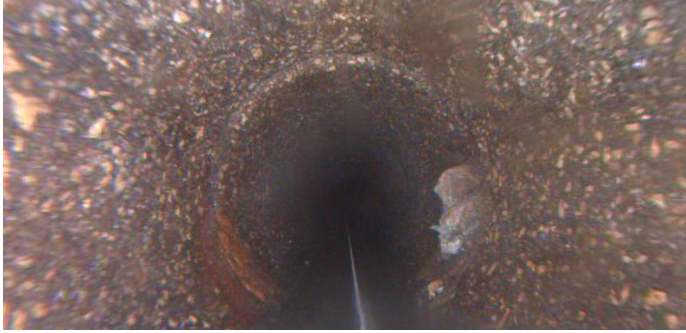
Code: **DAR**
Description: **Deposits Attached Ragging**

Distance (ft): **213.9**
Structural Grade: **0**
O&M Grade: **2**
Clock Start/From: **9**
Clock To:
1st Value:
2nd Value:
Value Percent: **5.000**
Continuous Index:
Within 8" of Joint: **YES**
Remarks:

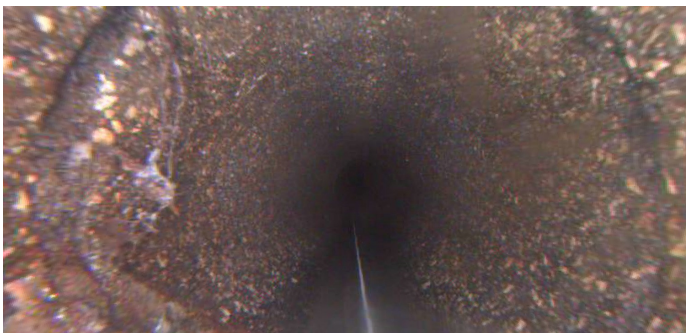
Code: **RFJ**
Description: **Roots Fine Joint**

Distance (ft): **225.6**
Structural Grade: **0**
O&M Grade: **1**
Clock Start/From: **1**
Clock To: **4**
1st Value:
2nd Value:
Value Percent:
Continuous Index:
Within 8" of Joint: **YES**
Remarks:

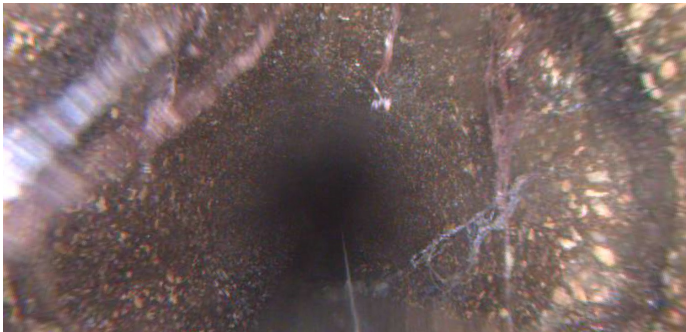
Code: **RFJ**
Description: **Roots Fine Joint**

Distance (ft): **231.7**
Structural Grade: **0**
O&M Grade: **1**
Clock Start/From: **8**
Clock To: **4**
1st Value:
2nd Value:
Value Percent:
Continuous Index:
Within 8" of Joint: **YES**
Remarks:

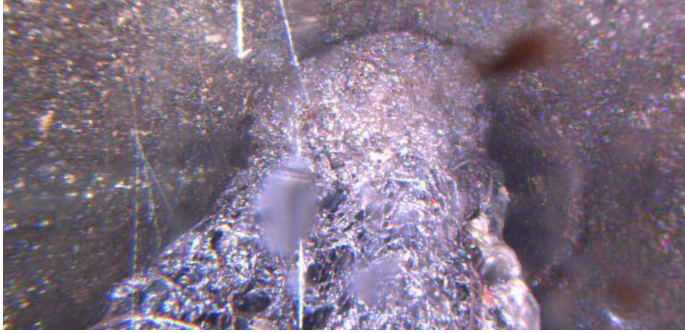
Code: **RBJ**
Description: **Roots Ball Joint**

Distance (ft): **243.2**
Structural Grade: **0**
O&M Grade: **4**
Clock Start/From: **12**
Clock To: **12**
1st Value:
2nd Value:
Value Percent: **90.000**
Continuous Index:
Within 8" of Joint: **YES**
Remarks:

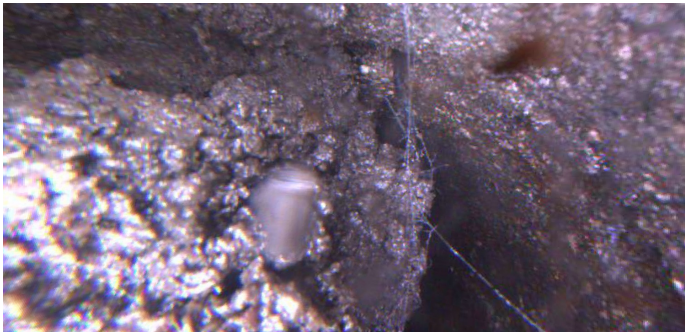
Code: **MSA**
Description: **Abandoned Survey**

Distance (ft): **244.6**
Structural Grade: **0**
O&M Grade: **0**
Clock Start/From:
Clock To:
1st Value:
2nd Value:
Value Percent:
Continuous Index:
Within 8" of Joint: **NO**
Remarks: **ROOTS**

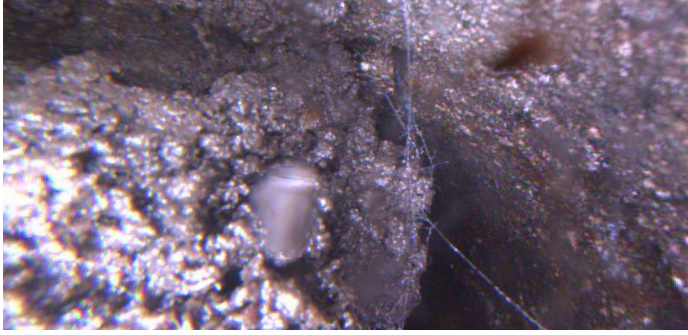
Code:	SAP
Description:	Surface Aggregate Projecting
Distance (ft):	244.6
Structural Grade:	3
O&M Grade:	0
Clock Start/From:	8
Clock To:	4
1st Value:	
2nd Value:	
Value Percent:	
Continuous Index:	F01
Within 8" of Joint:	
Remarks:
