Profile/Photo Observation Report

Street:	N Lake Park Ave	Flow Control:	Not Controlled
City:	Hobart, IN	Year Renewed:	
Location:	Other	Tape/Media #:	
Purpose:	Not Known	Dia/Height:	8"
Use:	Sanitary	Material:	CP
Drain Area:	NA	Lining:	
Category:	NA		
Comment:

Location Details:		Direction of Survey:	Upstream
US MH:	M-604-120	DS MH:	M-604-121
		Total Length Surveyed (ft):	244.6

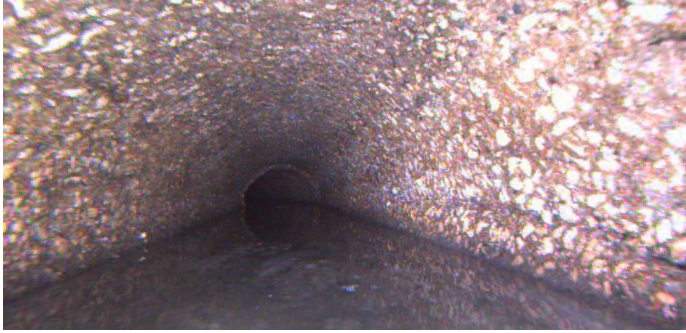
Code: **AMH**
Description: **Manhole**

Distance (ft): **.0**
Structural Grade: **0**
O&M Grade: **0**
Clock Start/From:
Clock To:
1st Value:
2nd Value:
Value Percent:
Continuous Index:
Within 8" of Joint: **NO**
Remarks: **M-604-121**

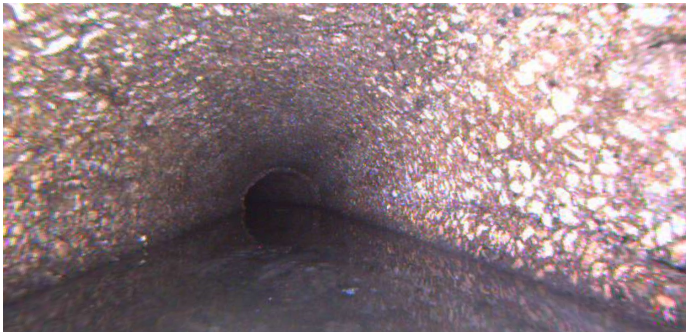
Code: **MWL**
Description: **Water Level**

Distance (ft): **.0**
Structural Grade: **0**
O&M Grade: **0**
Clock Start/From:
Clock To:
1st Value:
2nd Value:
Value Percent: **20.000**
Continuous Index:
Within 8" of Joint: **NO**
Remarks:

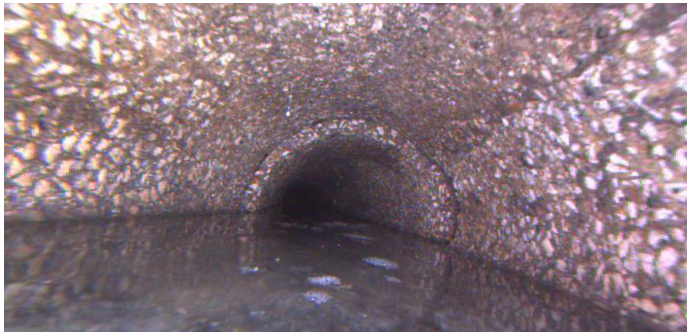
Code:	LL
Description:	Alignment Left
Distance (ft):	2.9
Structural Grade:	0
O&M Grade:	1
Clock Start/From:	
Clock To:	
1st Value:	
2nd Value:	
Value Percent:	5.000
Continuous Index:	
Within 8" of Joint:	NO
Remarks:

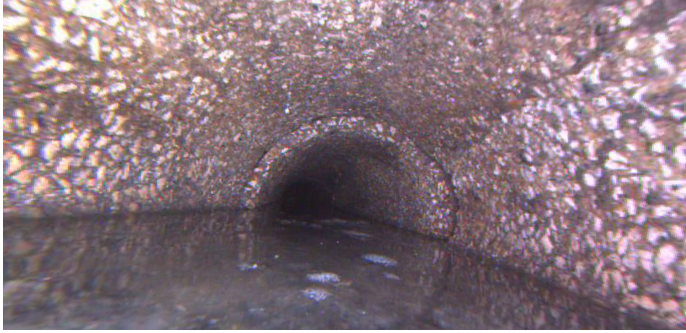
Code: **FL**
Description: **Fracture Longitudinal**

Distance (ft): **2.9**
Structural Grade: **3**
O&M Grade: **0**
Clock Start/From: **2**
Clock To:
1st Value:
2nd Value:
Value Percent:
Continuous Index:
Within 8" of Joint: **YES**
Remarks:

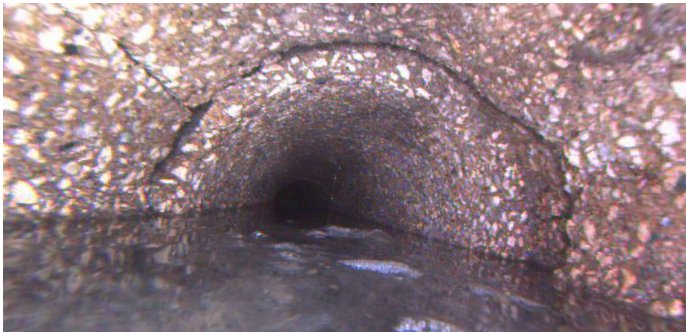
Code: **FL**
Description: **Fracture Longitudinal**

Distance (ft): **3.3**
Structural Grade: **3**
O&M Grade: **0**
Clock Start/From: **10**
Clock To:
1st Value:
2nd Value:
Value Percent:
Continuous Index:
Within 8" of Joint: **YES**
Remarks:

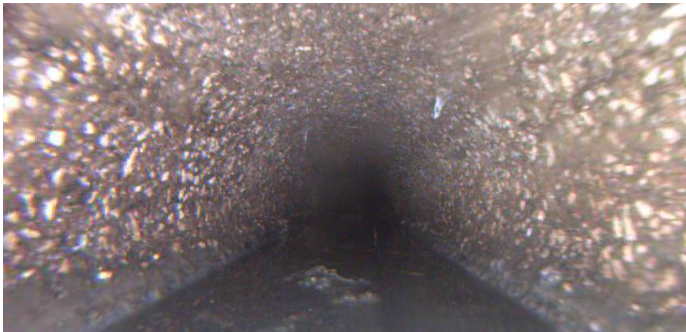
Code: **MGO**
Description: **General Observation**

Distance (ft): **15.1**
Structural Grade: **0**
O&M Grade: **0**
Clock Start/From:
Clock To:
1st Value:
2nd Value:
Value Percent:
Continuous Index:
Within 8" of Joint: **NO**
Remarks: **REAR CAMERA**

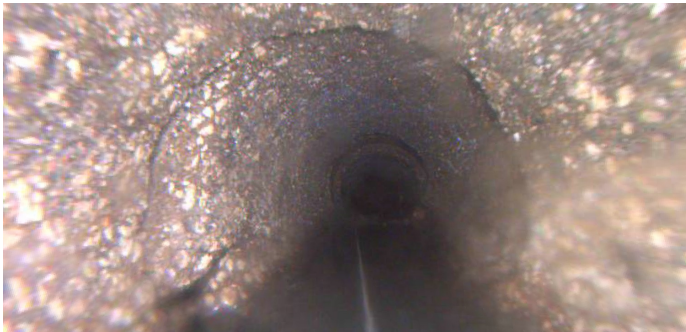
Code: **JOM**
Description: **Joint Offset Medium**

Distance (ft): **126.8**
Structural Grade: **1**
O&M Grade: **0**
Clock Start/From:
Clock To:
1st Value:
2nd Value:
Value Percent:
Continuous Index:
Within 8" of Joint: **NO**
Remarks:

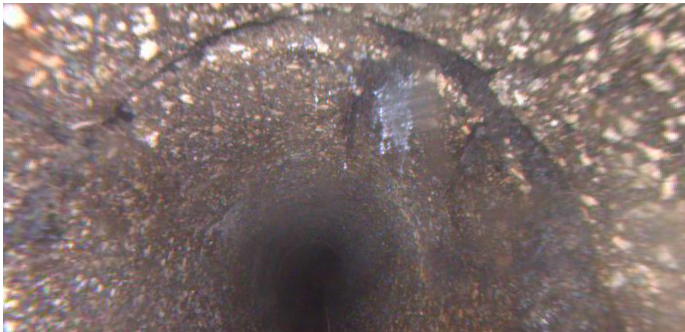
Code: **RFJ**
Description: **Roots Fine Joint**

Distance (ft): **204.6**
Structural Grade: **0**
O&M Grade: **1**
Clock Start/From: **8**
Clock To: **4**
1st Value:
2nd Value:
Value Percent:
Continuous Index:
Within 8" of Joint: **YES**
Remarks:

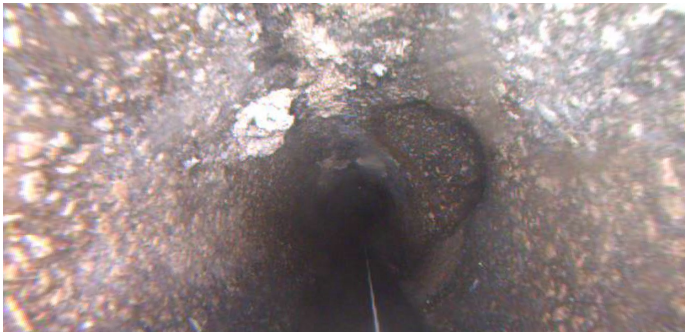
Code: **DAGS**
Description: **Deposits Attached Grease**

Distance (ft): **207.1**
Structural Grade: **0**
O&M Grade: **2**
Clock Start/From: **12**
Clock To: **1**
1st Value:
2nd Value:
Value Percent: **5.000**
Continuous Index:
Within 8" of Joint: **NO**
Remarks:

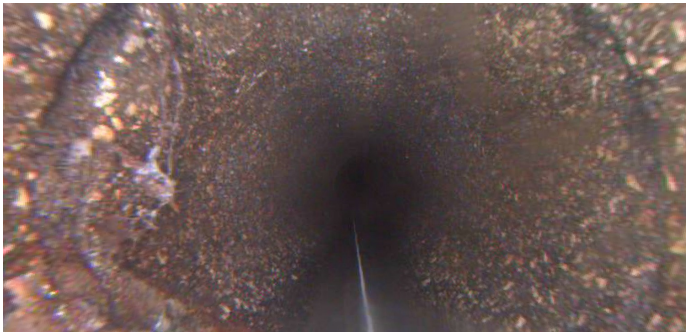
Code: **RFJ**
Description: **Roots Fine Joint**

Distance (ft): **225.6**
Structural Grade: **0**
O&M Grade: **1**
Clock Start/From: **1**
Clock To: **4**
1st Value:
2nd Value:
Value Percent:
Continuous Index:
Within 8" of Joint: **YES**
Remarks:

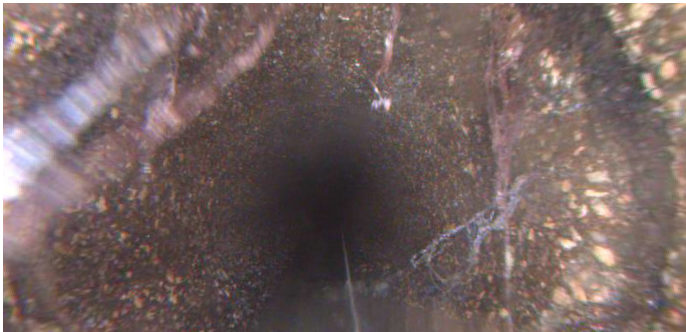
Code: **RFJ**
Description: **Roots Fine Joint**

Distance (ft): **231.7**
Structural Grade: **0**
O&M Grade: **1**
Clock Start/From: **8**
Clock To: **4**
1st Value:
2nd Value:
Value Percent:
Continuous Index:
Within 8" of Joint: **YES**
Remarks:

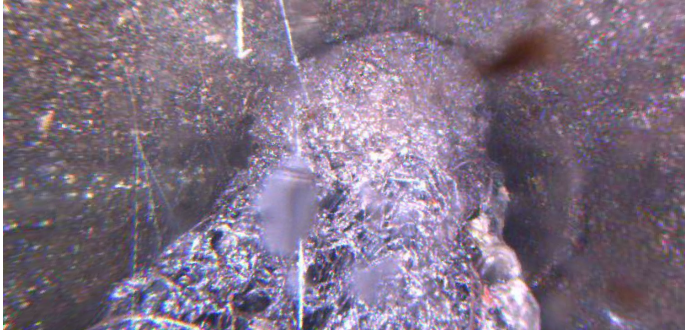
Code: **RBJ**
Description: **Roots Ball Joint**

Distance (ft): **243.2**
Structural Grade: **0**
O&M Grade: **4**
Clock Start/From: **12**
Clock To: **12**
1st Value:
2nd Value:
Value Percent: **90.000**
Continuous Index:
Within 8" of Joint: **YES**
Remarks:

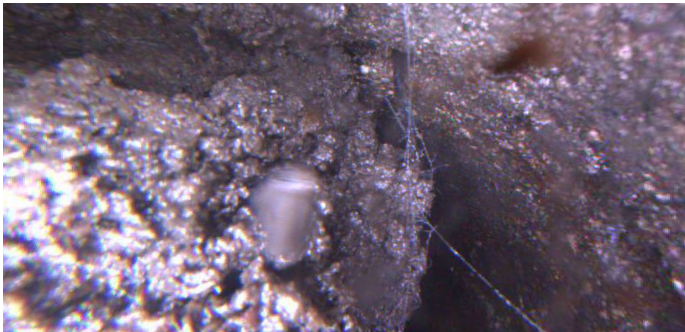
Code: **MSA**
Description: **Abandoned Survey**

Distance (ft): **244.6**
Structural Grade: **0**
O&M Grade: **0**
Clock Start/From:
Clock To:
1st Value:
2nd Value:
Value Percent:
Continuous Index:
Within 8" of Joint: **NO**
Remarks: **ROOTS**

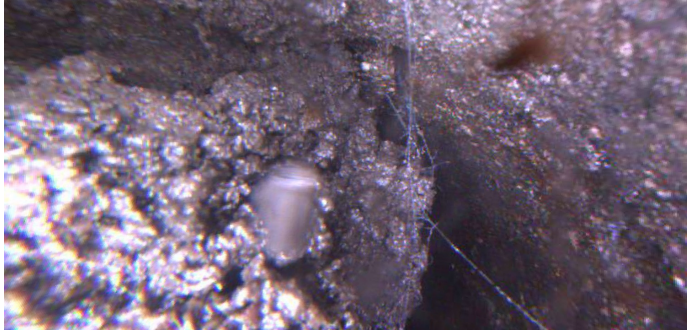
Code:	SAP
Description:	Surface Aggregate Projecting
Distance (ft):	244.6
Structural Grade:	3
O&M Grade:	0
Clock Start/From:	8
Clock To:	4
1st Value:	
2nd Value:	
Value Percent:	
Continuous Index:	F01
Within 8" of Joint:	
Remarks:
