## Profile/Photo Observation Report

Date:	<b>10/19/2021</b>	Weather:		Coding:	<b>PACP 6.0</b>
Pipe Length (ft):		Owner:	<b>Hobart, IN</b>	Pre Clean:	<b>Not Known</b>
P.O.#:	<b>898_1</b>	Surveyor:	<b>M. Pielacha</b>	PSR:	<b>P-705-055-001</b>
Customer:	<b>Hobart, IN</b>	Clean Date:		Shape:	<b>C</b>

Street:	<b>3rd Street</b>	Flow Control:	
City:	<b>Hobart, IN</b>	Year Renewed:	
Location:	<b>Light Highway</b>	Tape/Media #:	<b>898</b>
Purpose:	<b>Routine Assessment</b>	Dia/Height:	<b>10"</b>
Use:	<b>Sanitary</b>	Material:	<b>VCP</b>
Drain Area:		Lining:

US MH: **M-605-1** DS MH: **M-705-55** Total Length Surveyed (ft): **236.6**

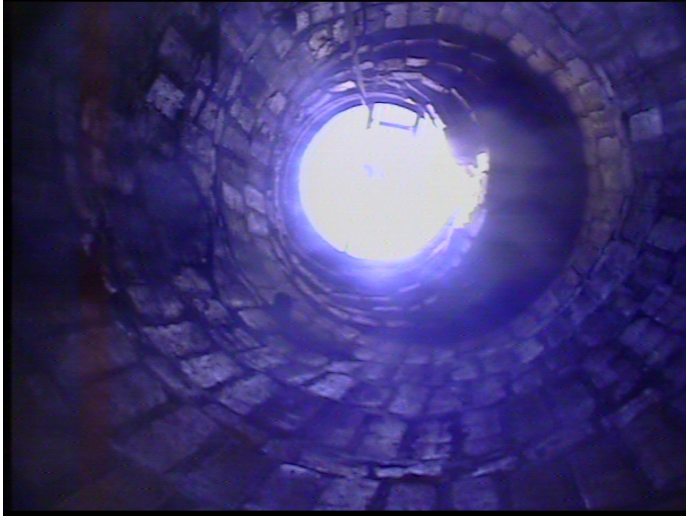
Code: **AMH**  
Description: **Manhole**

Distance (ft): **.0**  
Structural Grade: **0**  
O&M Grade: **0**  
Clock Start/From:  
Clock To:  
1st Value:  
2nd Value:  
Value Percent:  
Continuous Index:  
Within 8" of Joint: **NO**  
Remarks: **M-605-1**

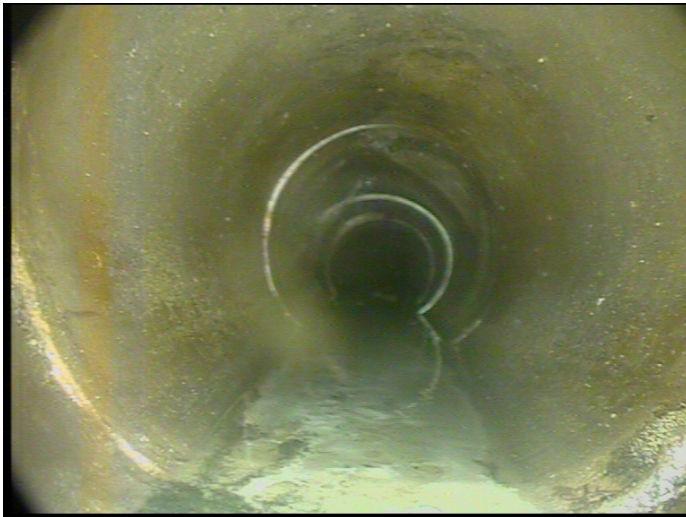
Code: **MWL**  
Description: **Water Level**

Distance (ft): **.0**  
Structural Grade: **0**  
O&M Grade: **0**  
Clock Start/From:  
Clock To:  
1st Value:  
2nd Value:  
Value Percent: **5.000**  
Continuous Index:  
Within 8" of Joint: **NO**  
Remarks:

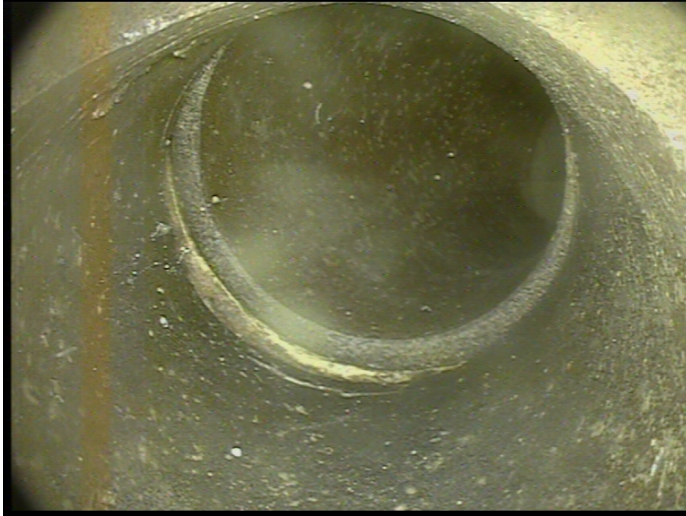
Code: **TF**  
Description: **Tap Factory**

Distance (ft): **2.7**  
Structural Grade: **0**  
O&M Grade: **0**  
Clock Start/From: **2**  
Clock To:  
1st Value: **4.000**  
2nd Value:  
Value Percent:  
Continuous Index:  
Within 8" of Joint: **NO**  
Remarks:

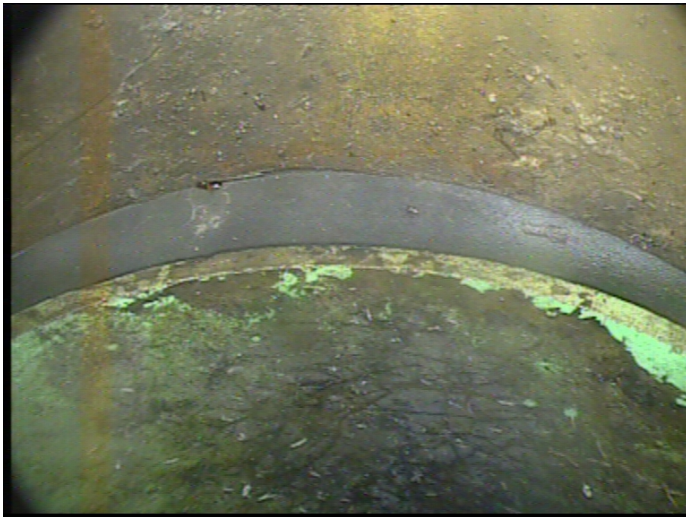
Code: **MMC**  
Description: **Material Change**

Distance (ft): **3.7**  
Structural Grade: **0**  
O&M Grade: **0**  
Clock Start/From:  
Clock To:  
1st Value:  
2nd Value:  
Value Percent:  
Continuous Index:  
Within 8" of Joint: **NO**  
Remarks: **pvc**

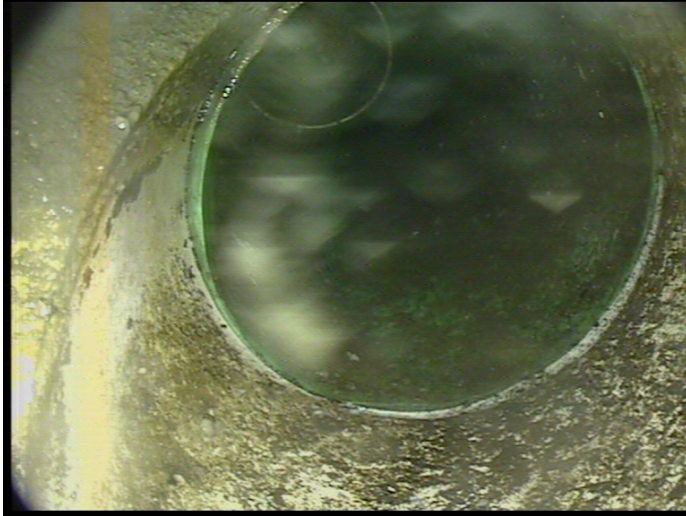
Code:	<b>TF</b>
Description:	<b>Tap Factory</b>
Distance (ft):	<b>4.7</b>
Structural Grade:	<b>0</b>
O&M Grade:	<b>0</b>
Clock Start/From:	<b>10</b>
Clock To:	
1st Value:	<b>4.000</b>
2nd Value:	
Value Percent:	
Continuous Index:	
Within 8" of Joint:	<b>NO</b>
Remarks:

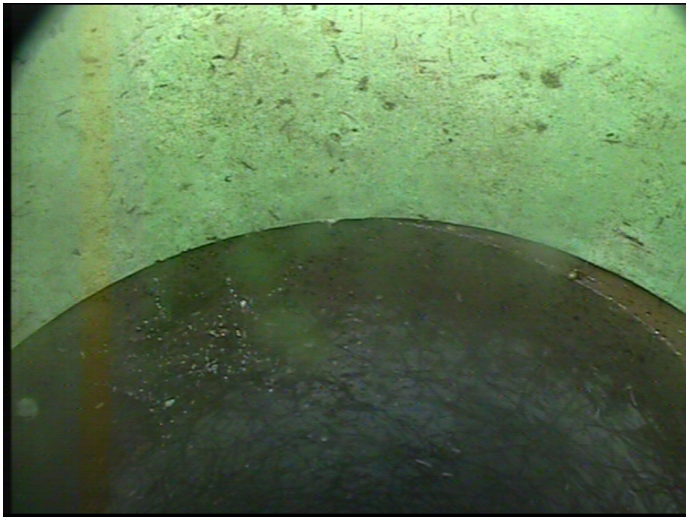
Code:	<b>MMC</b>
Description:	<b>Material Change</b>
Distance (ft):	<b>16.8</b>
Structural Grade:	<b>0</b>
O&M Grade:	<b>0</b>
Clock Start/From:	
Clock To:	
1st Value:	
2nd Value:	
Value Percent:	
Continuous Index:	
Within 8" of Joint:	<b>NO</b>
Remarks:	<b>vcp</b>

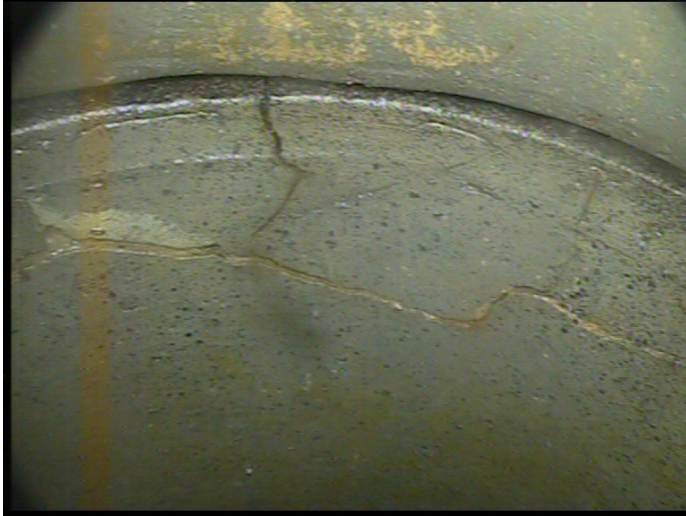
Code:	CM
Description:	Crack Multiple
Distance (ft):	20.4
Structural Grade:	3
O&M Grade:	0
Clock Start/From:	9
Clock To:	3
1st Value:	
2nd Value:	
Value Percent:	
Continuous Index:	
Within 8" of Joint:	YES
Remarks:

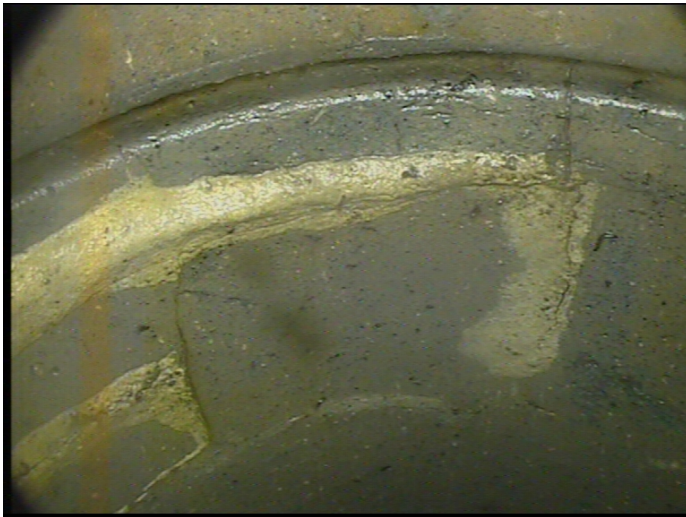
Code:	CM
Description:	Crack Multiple
Distance (ft):	24.6
Structural Grade:	3
O&M Grade:	0
Clock Start/From:	9
Clock To:	12
1st Value:	
2nd Value:	
Value Percent:	
Continuous Index:	S01
Within 8" of Joint:	YES
Remarks:

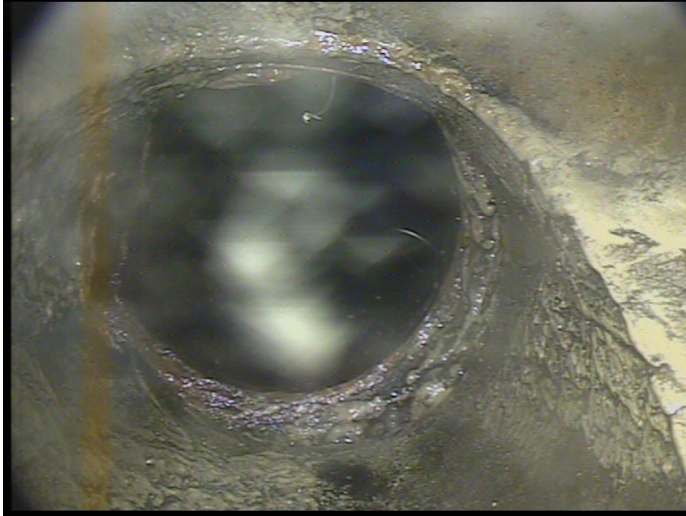
Code:	<b>TFA</b>
Description:	<b>Tap Factory Active</b>
Distance (ft):	<b>46.2</b>
Structural Grade:	<b>0</b>
O&M Grade:	<b>0</b>
Clock Start/From:	<b>9</b>
Clock To:	
1st Value:	<b>4.000</b>
2nd Value:	
Value Percent:	
Continuous Index:	
Within 8" of Joint:	<b>NO</b>
Remarks:

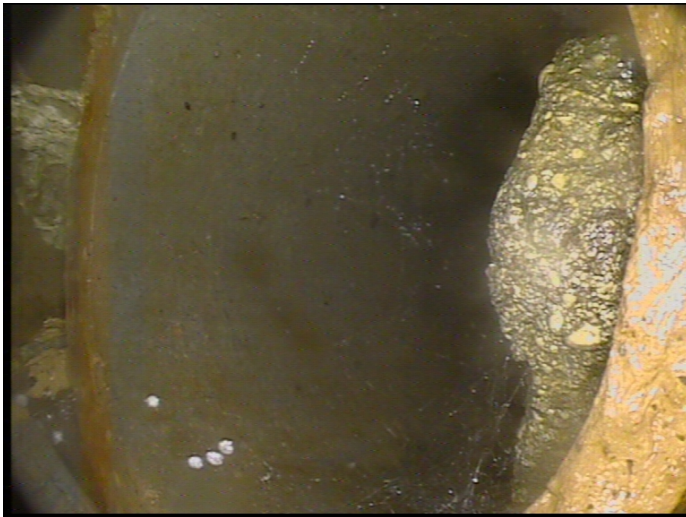
Code:	<b>TB</b>
Description:	<b>Tap Break-in</b>
Distance (ft):	<b>48.1</b>
Structural Grade:	<b>0</b>
O&M Grade:	<b>0</b>
Clock Start/From:	<b>3</b>
Clock To:	
1st Value:	<b>4.000</b>
2nd Value:	
Value Percent:	
Continuous Index:	
Within 8" of Joint:	<b>NO</b>
Remarks:

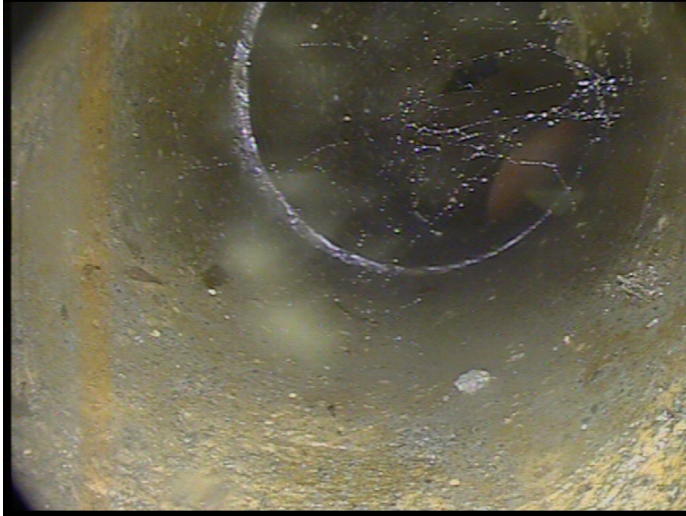
Code: **TF**  
Description: **Tap Factory**

Distance (ft): **71.3**  
Structural Grade: **0**  
O&M Grade: **0**  
Clock Start/From: **2**  
Clock To:  
1st Value: **4.000**  
2nd Value:  
Value Percent:  
Continuous Index:  
Within 8" of Joint: **NO**  
Remarks:

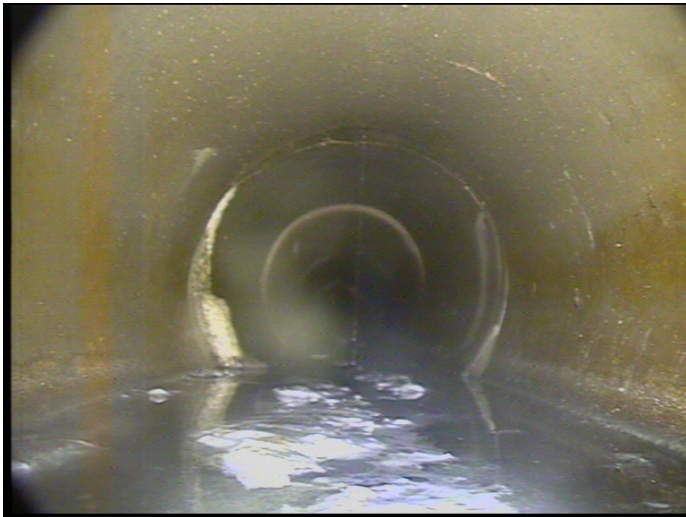
Code: **DSF**  
Description: **Deposits Settled Fine**

Distance (ft): **89.9**  
Structural Grade: **0**  
O&M Grade: **2**  
Clock Start/From: **4**  
Clock To: **8**  
1st Value:  
2nd Value:  
Value Percent: **10.000**  
Continuous Index:  
Within 8" of Joint: **NO**  
Remarks:

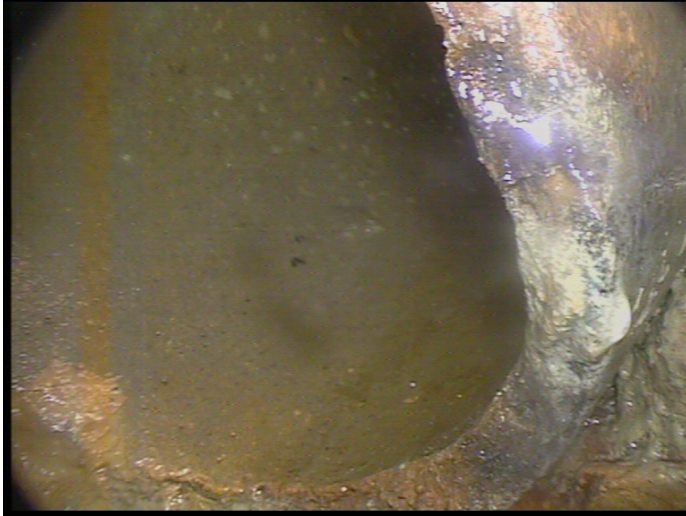
Code: **TB**  
Description: **Tap Break-in**

Distance (ft): **102.5**  
Structural Grade: **0**  
O&M Grade: **0**  
Clock Start/From: **2**  
Clock To:  
1st Value: **4.000**  
2nd Value:  
Value Percent:  
Continuous Index:  
Within 8" of Joint: **NO**  
Remarks:

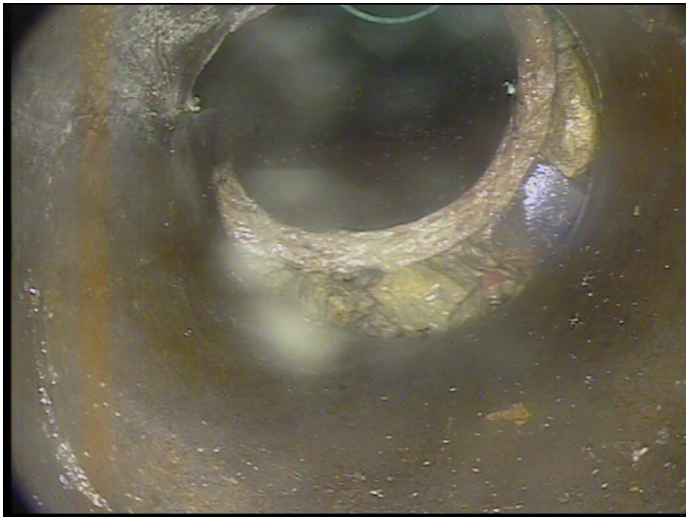
Code: **TF**  
Description: **Tap Factory**

Distance (ft): **106.2**  
Structural Grade: **0**  
O&M Grade: **0**  
Clock Start/From: **10**  
Clock To:  
1st Value: **4.000**  
2nd Value:  
Value Percent:  
Continuous Index:  
Within 8" of Joint: **NO**  
Remarks:

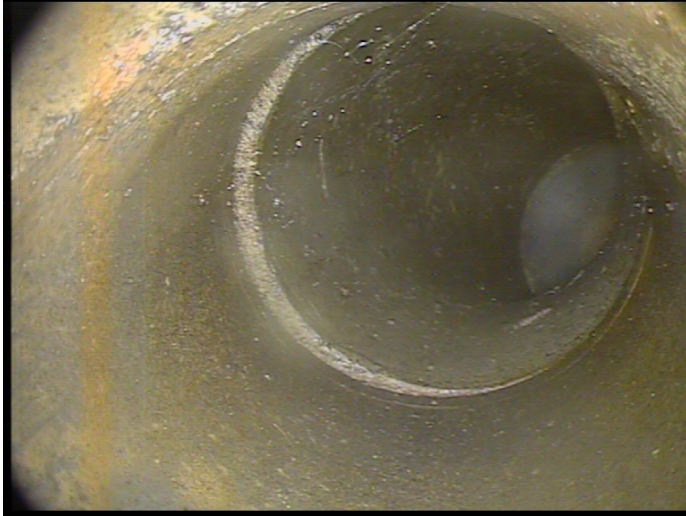
Code: **TF**  
Description: **Tap Factory**

Distance (ft): **107.9**  
Structural Grade: **0**  
O&M Grade: **0**  
Clock Start/From: **2**  
Clock To:  
1st Value: **4.000**  
2nd Value:  
Value Percent:  
Continuous Index:  
Within 8" of Joint: **NO**  
Remarks:

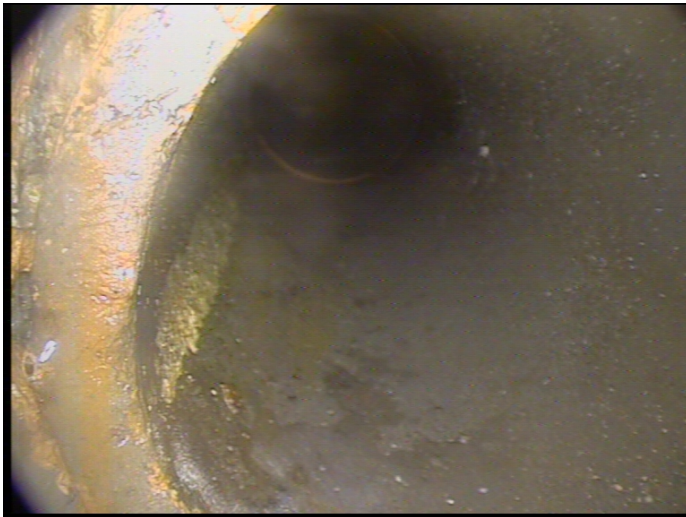
Code: **TB**  
Description: **Tap Break-in**

Distance (ft): **149.2**  
Structural Grade: **0**  
O&M Grade: **0**  
Clock Start/From: **10**  
Clock To:  
1st Value: **4.000**  
2nd Value:  
Value Percent:  
Continuous Index:  
Within 8" of Joint: **NO**  
Remarks:

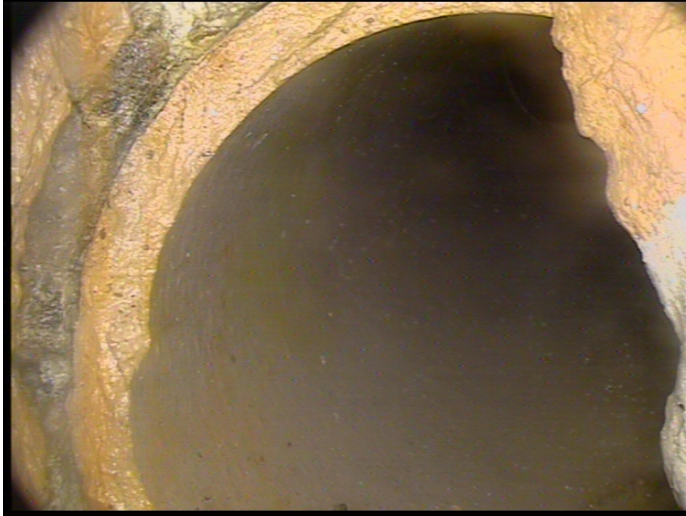
Code: **TB**  
Description: **Tap Break-in**

Distance (ft): **150.1**  
Structural Grade: **0**  
O&M Grade: **0**  
Clock Start/From: **2**  
Clock To:  
1st Value: **4.000**  
2nd Value:  
Value Percent:  
Continuous Index:  
Within 8" of Joint: **NO**  
Remarks:

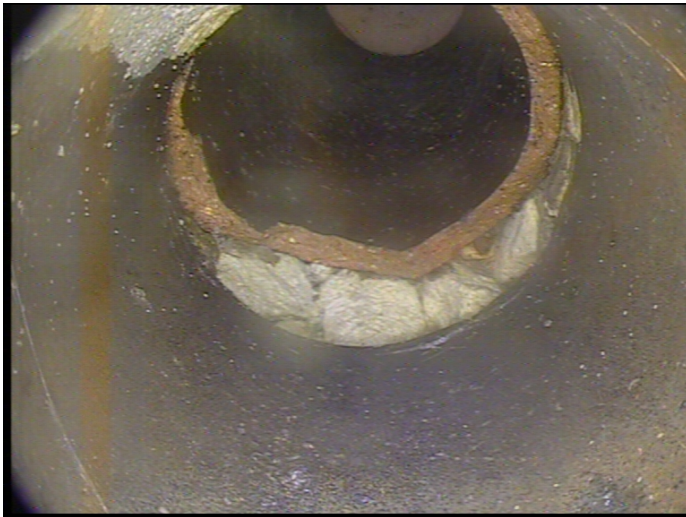
Code: **TF**  
Description: **Tap Factory**

Distance (ft): **152.6**  
Structural Grade: **0**  
O&M Grade: **0**  
Clock Start/From: **10**  
Clock To:  
1st Value: **4.000**  
2nd Value:  
Value Percent:  
Continuous Index:  
Within 8" of Joint: **NO**  
Remarks:

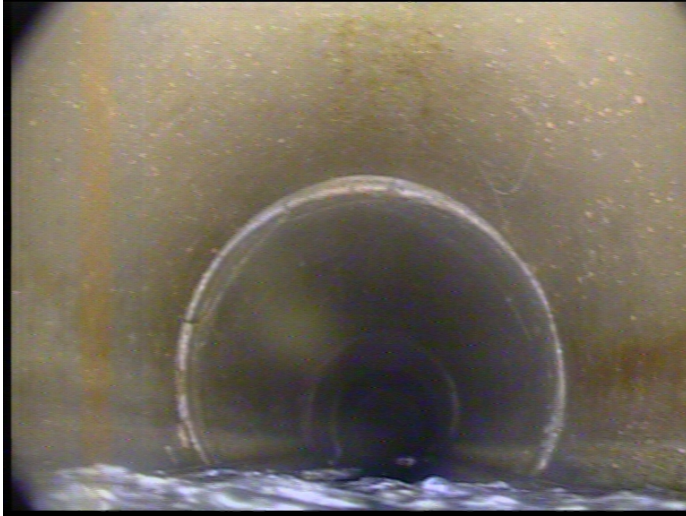
Code: **DSF**  
Description: **Deposits Settled Fine**

Distance (ft): **171.1**  
Structural Grade: **0**  
O&M Grade: **2**  
Clock Start/From: **4**  
Clock To: **8**  
1st Value:  
2nd Value:  
Value Percent: **10.000**  
Continuous Index: **S02**  
Within 8" of Joint: **YES**  
Remarks:

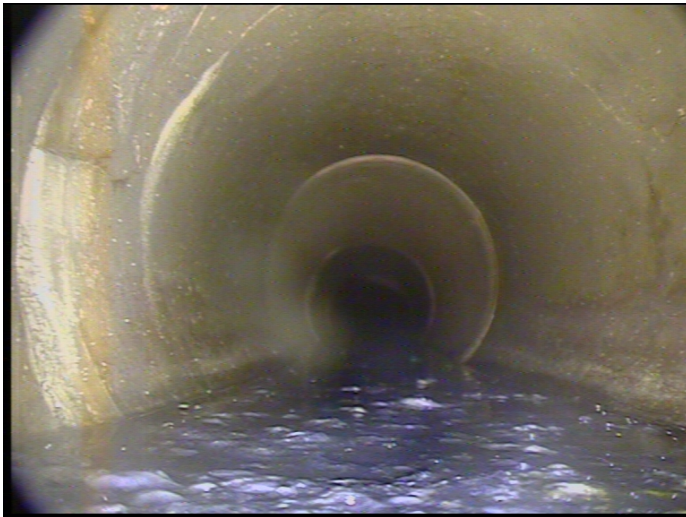
Code: **DSF**  
Description: **Deposits Settled Fine**

Distance (ft): **178.3**  
Structural Grade: **0**  
O&M Grade: **2**  
Clock Start/From: **4**  
Clock To: **8**  
1st Value:  
2nd Value:  
Value Percent: **10.000**  
Continuous Index: **F02**  
Within 8" of Joint: **NO**  
Remarks:

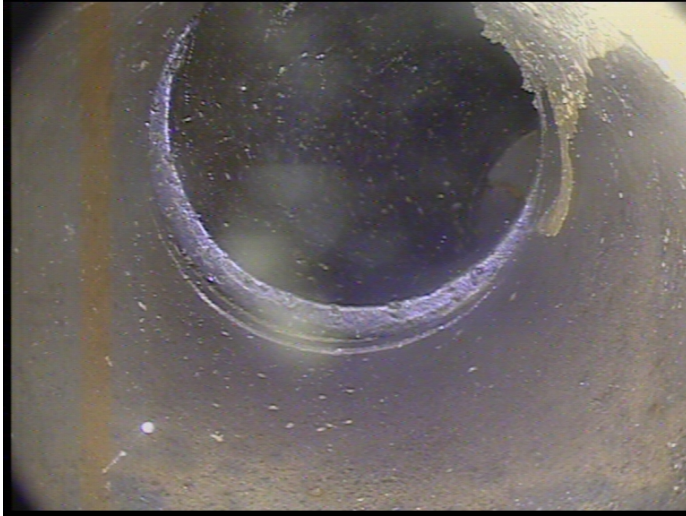
Code: **TF**  
Description: **Tap Factory**

Distance (ft): **187.2**  
Structural Grade: **0**  
O&M Grade: **0**  
Clock Start/From: **2**  
Clock To:  
1st Value: **4.000**  
2nd Value:  
Value Percent:  
Continuous Index:  
Within 8" of Joint: **NO**  
Remarks:

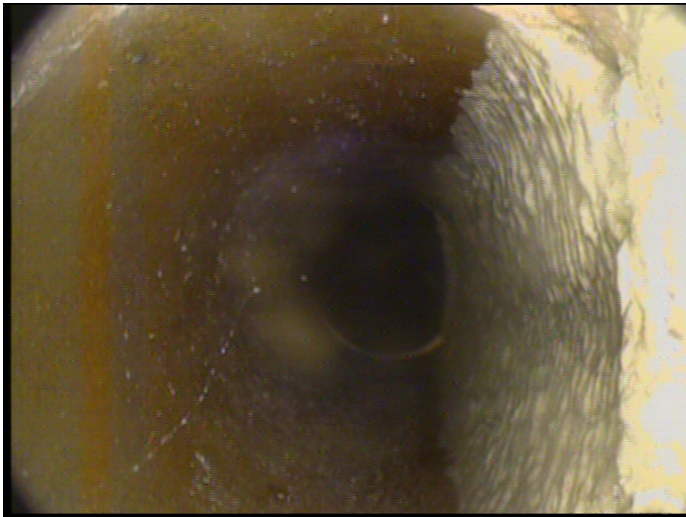
Code: **TB**  
Description: **Tap Break-in**

Distance (ft): **203.4**  
Structural Grade: **0**  
O&M Grade: **0**  
Clock Start/From: **3**  
Clock To:  
1st Value: **4.000**  
2nd Value:  
Value Percent:  
Continuous Index:  
Within 8" of Joint: **NO**  
Remarks:

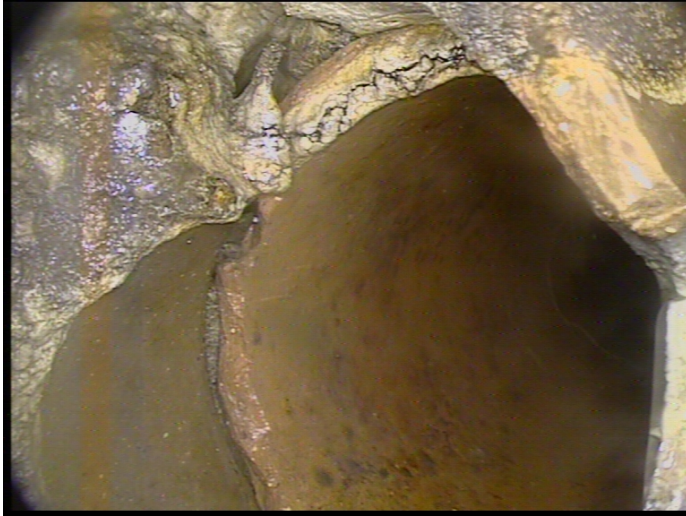
Code: **TB**  
Description: **Tap Break-in**

Distance (ft): **211.7**  
Structural Grade: **0**  
O&M Grade: **0**  
Clock Start/From: **3**  
Clock To:  
1st Value: **4.000**  
2nd Value:  
Value Percent:  
Continuous Index:  
Within 8" of Joint: **NO**  
Remarks:

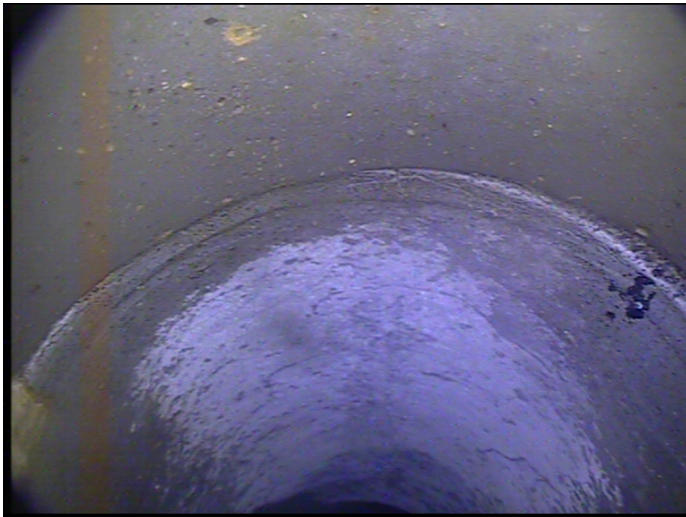
Code: **CM**  
Description: **Crack Multiple**

Distance (ft): **218.8**  
Structural Grade: **3**  
O&M Grade: **0**  
Clock Start/From: **9**  
Clock To: **12**  
1st Value:  
2nd Value:  
Value Percent:  
Continuous Index: **F01**  
Within 8" of Joint: **NO**  
Remarks:

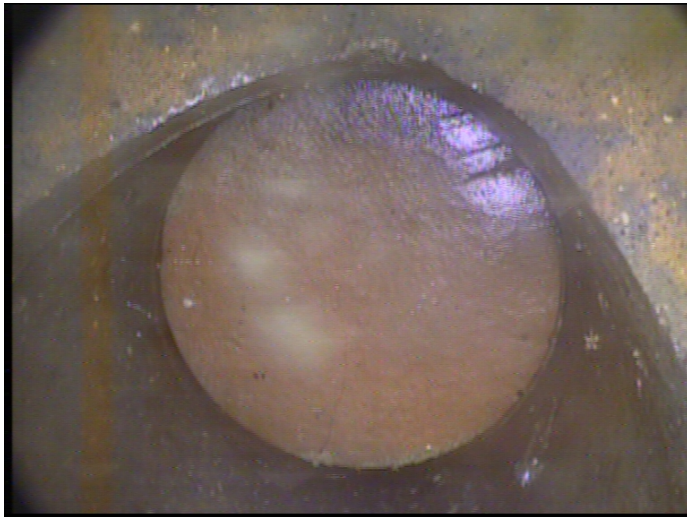
Code: **TFC**  
Description: **Tap Factory Capped**

Distance (ft): **227.6**  
Structural Grade: **0**  
O&M Grade: **0**  
Clock Start/From: **2**  
Clock To:  
1st Value: **4.000**  
2nd Value:  
Value Percent:  
Continuous Index:  
Within 8" of Joint: **NO**  
Remarks:

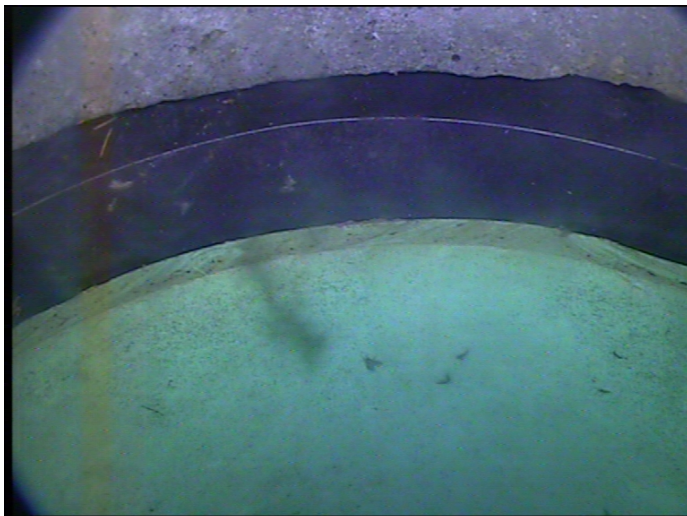
Code: **MMC**  
Description: **Material Change**

Distance (ft): **230.2**  
Structural Grade: **0**  
O&M Grade: **0**  
Clock Start/From:  
Clock To:  
1st Value:  
2nd Value:  
Value Percent:  
Continuous Index:  
Within 8" of Joint: **NO**  
Remarks: **pvc**

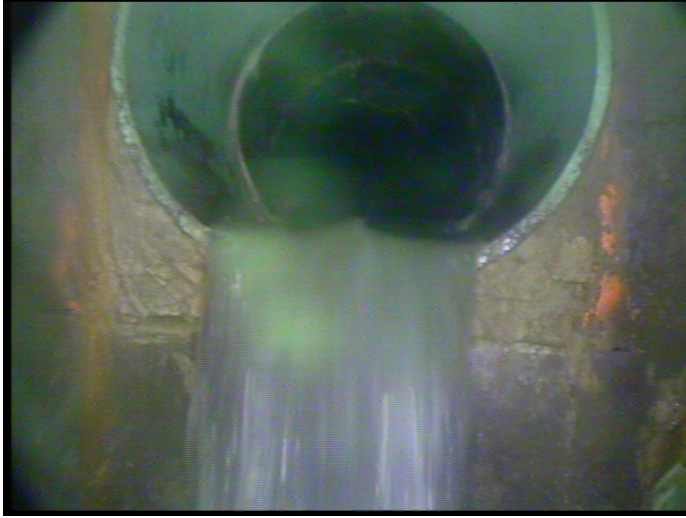
Code:	<b>AMH</b>
Description:	<b>Manhole</b>
Distance (ft):	<b>236.6</b>
Structural Grade:	<b>0</b>
O&M Grade:	<b>0</b>
Clock Start/From:	
Clock To:	
1st Value:	
2nd Value:	
Value Percent:	
Continuous Index:	
Within 8" of Joint:	<b>NO</b>
Remarks:	<b>M-705-55</b>
