Profile/Photo Observation Report

Date:	04/25/2018	Weather:		Coding:	PACP 6.0
Pipe Length (ft):	212.9	Owner:	NA	Pre Clean:	Not Known
P.O.#:		Surveyor:	Jen Costello	PSR:	P-605-072-008
Customer:		Clean Date:	01/01/1900	Shape:	C

Street:	S ASH ST & COURT ST	Flow Control:	Not Controlled
City:	Hobart, IN	Year Renewed:	
Location:	Other	Tape/Media #:	
Purpose:	Not Known	Dia/Height:	12"
Use:	Sanitary	Material:	VCP
Drain Area:	NA	Lining:	
Category:	NA		
Comment:	Flow direction wrong. Reverse setup.		
Location Details:		Direction of Survey:	Upstream
US MH:	M-605-008	DS MH:	M-605-072
		Total Length Surveyed (ft):	34.2

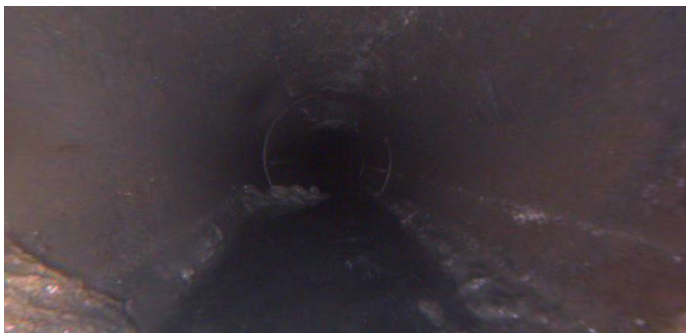
Code: **AMH**
Description: **Manhole**

Distance (ft): **.0**
Structural Grade: **0**
O&M Grade: **0**
Clock Start/From:
Clock To:
1st Value:
2nd Value:
Value Percent:
Continuous Index:
Within 8" of Joint: **NO**
Remarks: **M-605-072**

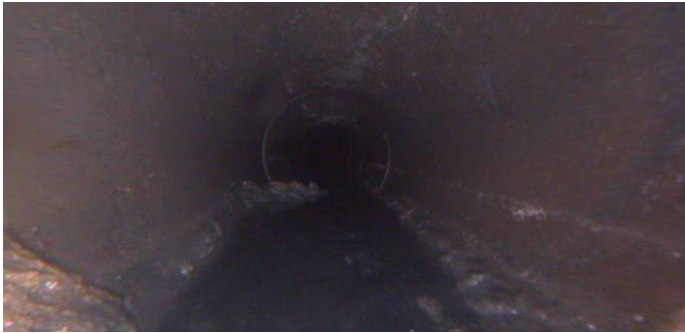
Code:	MWL
Description:	Water Level

Distance (ft):	.0
Structural Grade:	0
O&M Grade:	0
Clock Start/From:	
Clock To:	
1st Value:	
2nd Value:	
Value Percent:	5.000
Continuous Index:	
Within 8" of Joint:	NO
Remarks:

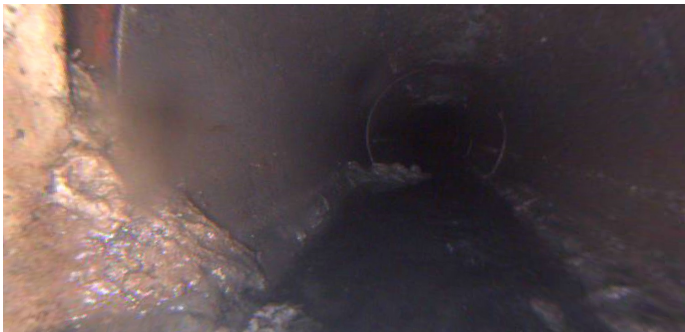
Code:	DAGS
Description:	Deposits Attached Grease

Distance (ft):	.0
Structural Grade:	0
O&M Grade:	2
Clock Start/From:	8
Clock To:	9
1st Value:	
2nd Value:	
Value Percent:	5.000
Continuous Index:	
Within 8" of Joint:	YES
Remarks:

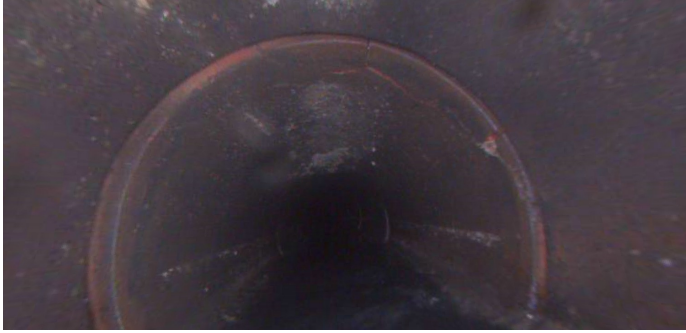
Code: **FM**
Description: **Fracture Multiple**

Distance (ft): **2.6**
Structural Grade: **4**
O&M Grade: **0**
Clock Start/From: **12**
Clock To: **4**
1st Value:
2nd Value:
Value Percent:
Continuous Index:
Within 8" of Joint: **YES**
Remarks:

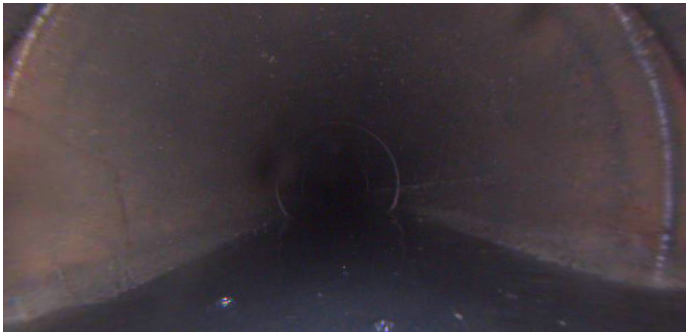
Code: **FS**
Description: **Fracture Spiral**

Distance (ft): **4.6**
Structural Grade: **3**
O&M Grade: **0**
Clock Start/From: **7**
Clock To: **9**
1st Value:
2nd Value:
Value Percent:
Continuous Index:
Within 8" of Joint: **YES**
Remarks:

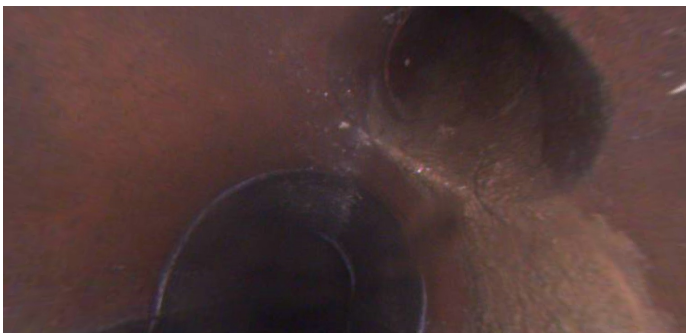
Code: **TF**
Description: **Tap Factory**

Distance (ft): **20.7**
Structural Grade: **0**
O&M Grade: **0**
Clock Start/From: **10**
Clock To:
1st Value: **4.000**
2nd Value:
Value Percent:
Continuous Index:
Within 8" of Joint:
Remarks:

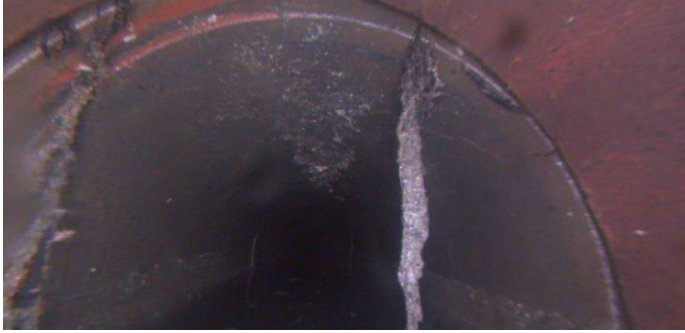
Code: **RFJ**
Description: **Roots Fine Joint**

Distance (ft): **21.0**
Structural Grade: **0**
O&M Grade: **1**
Clock Start/From: **10**
Clock To: **12**
1st Value:
2nd Value:
Value Percent:
Continuous Index:
Within 8" of Joint: **YES**
Remarks:

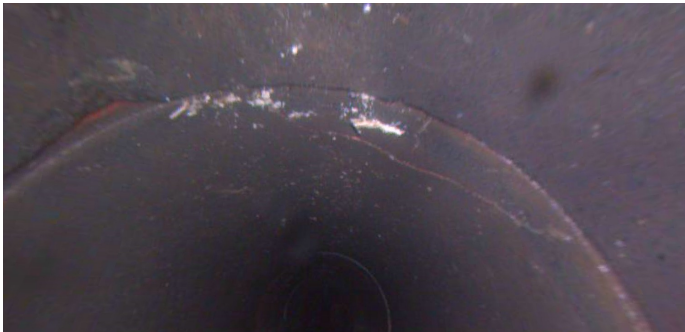
Code: **FM**
Description: **Fracture Multiple**

Distance (ft): **23.1**
Structural Grade: **4**
O&M Grade: **0**
Clock Start/From: **12**
Clock To: **2**
1st Value:
2nd Value:
Value Percent:
Continuous Index:
Within 8" of Joint: **YES**
Remarks:

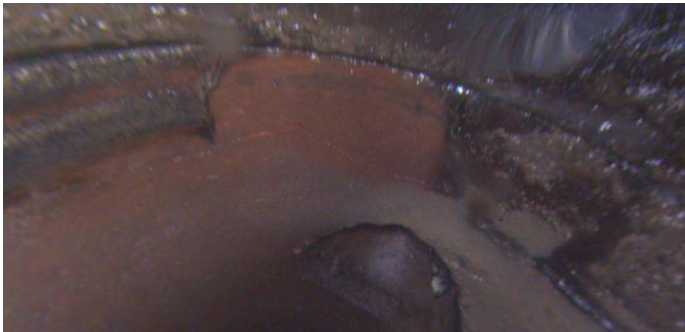
Code: **FM**
Description: **Fracture Multiple**

Distance (ft): **29.3**
Structural Grade: **4**
O&M Grade: **0**
Clock Start/From: **8**
Clock To: **4**
1st Value:
2nd Value:
Value Percent:
Continuous Index:
Within 8" of Joint: **YES**
Remarks:

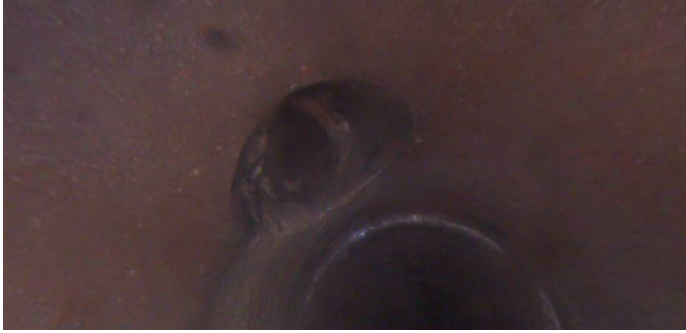
Code: **TF**
Description: **Tap Factory**

Distance (ft): **31.2**
Structural Grade: **0**
O&M Grade: **0**
Clock Start/From: **1**
Clock To:
1st Value: **4.000**
2nd Value:
Value Percent:
Continuous Index:
Within 8" of Joint:
Remarks:

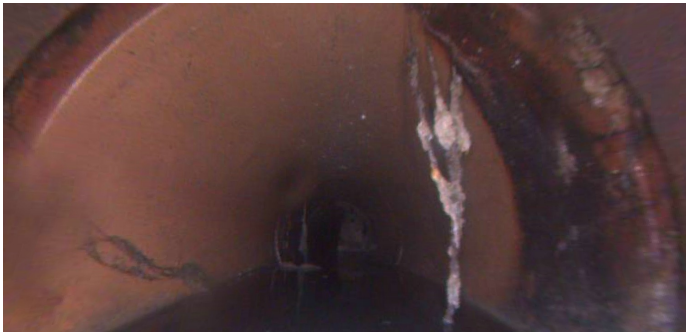
Code: **RFJ**
Description: **Roots Fine Joint**

Distance (ft): **31.2**
Structural Grade: **0**
O&M Grade: **1**
Clock Start/From: **8**
Clock To: **4**
1st Value:
2nd Value:
Value Percent:
Continuous Index:
Within 8" of Joint: **YES**
Remarks:

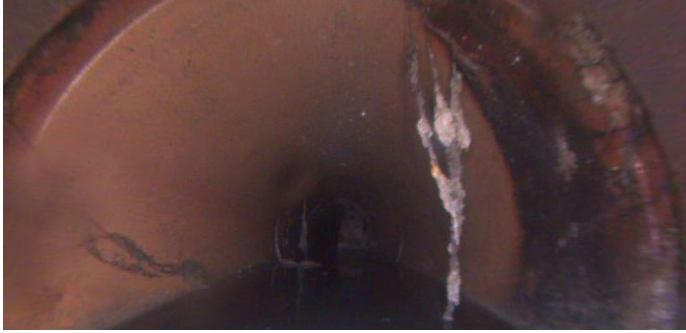
Code: **IW**
Description: **Infil Weeper**

Distance (ft): **31.2**
Structural Grade: **0**
O&M Grade: **2**
Clock Start/From: **12**
Clock To: **4**
1st Value:
2nd Value:
Value Percent:
Continuous Index:
Within 8" of Joint: **YES**
Remarks:

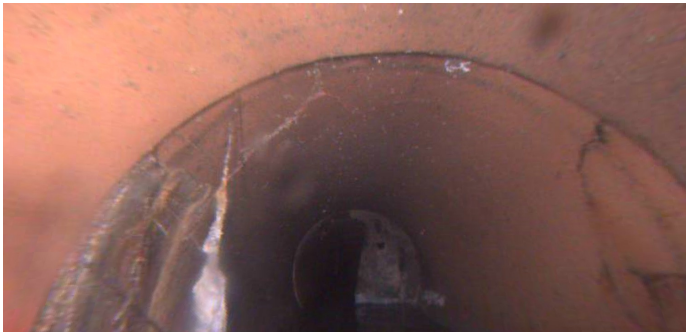
Code: **FM**
Description: **Fracture Multiple**

Distance (ft): **33.3**
Structural Grade: **4**
O&M Grade: **0**
Clock Start/From: **8**
Clock To: **4**
1st Value:
2nd Value:
Value Percent:
Continuous Index:
Within 8" of Joint: **YES**
Remarks:

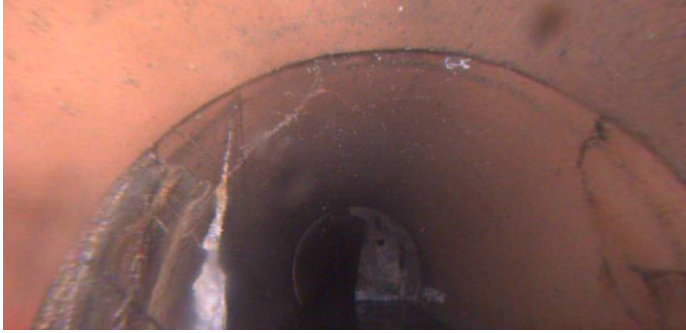
Code: **RFJ**
Description: **Roots Fine Joint**

Distance (ft): **33.3**
Structural Grade: **0**
O&M Grade: **1**
Clock Start/From: **8**
Clock To: **12**
1st Value:
2nd Value:
Value Percent:
Continuous Index:
Within 8" of Joint: **YES**
Remarks:

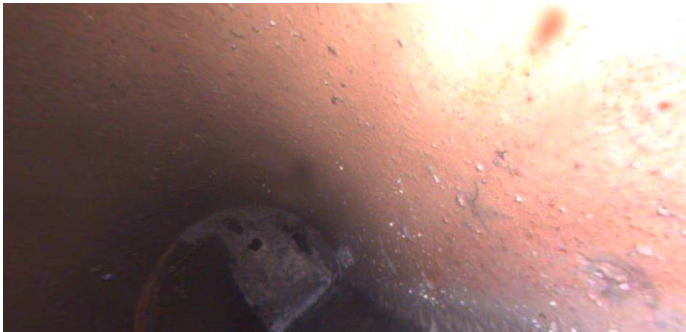
Code: **MSA**
Description: **Abandoned Survey**

Distance (ft): **34.2**
Structural Grade: **0**
O&M Grade: **0**
Clock Start/From:
Clock To:
1st Value:
2nd Value:
Value Percent:
Continuous Index:
Within 8" of Joint: **NO**
Remarks: **overturned**
