## Profile/Photo Observation Report

Date:	<b>04/25/2018</b>	Weather:		Coding:	<b>PACP 6.0</b>
Pipe Length (ft):	<b>165.1</b>	Owner:	<b>NA</b>	Pre Clean:	<b>Not Known</b>
P.O.#:		Surveyor:	<b>Jen Costello</b>	PSR:	<b>P-605-075-008</b>
Customer:		Clean Date:	<b>01/01/1900</b>	Shape:	<b>C</b>

Street:	<b>Ash</b>	Flow Control:	<b>Not Controlled</b>
City:	<b>Hobart, IN</b>	Year Renewed:	
Location:	<b>Other</b>	Tape/Media #:	
Purpose:	<b>Not Known</b>	Dia/Height:	<b>12"</b>
Use:	<b>Sanitary</b>	Material:	<b>VCP</b>
Drain Area:	<b>NA</b>	Lining:	
Category:	<b>NA</b>		
Comment:	<b>Flow direction wrong. Debris at 8'.</b>		
Location Details:		Direction of Survey:	<b>Upstream</b>
US MH:	<b>M-605-008</b>	DS MH:	<b>M-605-075</b>
		Total Length Surveyed (ft):	<b>10.4</b>

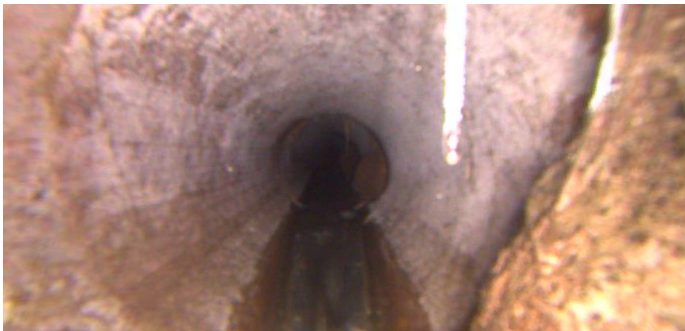
Code: **AMH**  
Description: **Manhole**

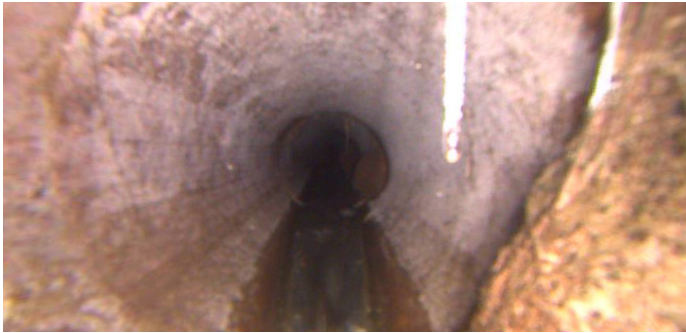
Code:	<b>MWL</b>
Description:	<b>Water Level</b>

Distance (ft):	<b>.0</b>
Structural Grade:	<b>0</b>
O&M Grade:	<b>0</b>
Clock Start/From:	
Clock To:	
1st Value:	
2nd Value:	
Value Percent:	<b>5.000</b>
Continuous Index:	
Within 8" of Joint:	<b>NO</b>
Remarks:

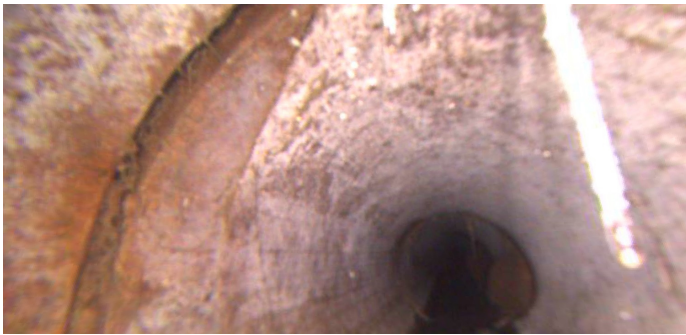
Code:	<b>FC</b>
Description:	<b>Fracture Circumferential</b>

Distance (ft):	<b>.0</b>
Structural Grade:	<b>2</b>
O&M Grade:	<b>0</b>
Clock Start/From:	<b>7</b>
Clock To:	<b>11</b>
1st Value:	
2nd Value:	
Value Percent:	
Continuous Index:	
Within 8" of Joint:	<b>YES</b>
Remarks:

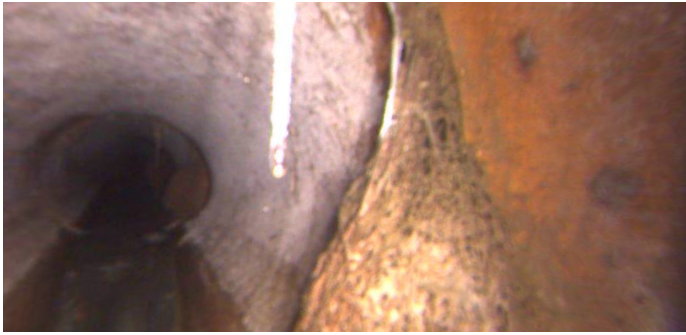
Code: **RMJ**  
Description: **Roots Medium Joint**

Distance (ft): **.0**  
Structural Grade: **0**  
O&M Grade: **3**  
Clock Start/From: **1**  
Clock To: **4**  
1st Value:  
2nd Value:  
Value Percent: **10.000**  
Continuous Index:  
Within 8" of Joint: **YES**  
Remarks:

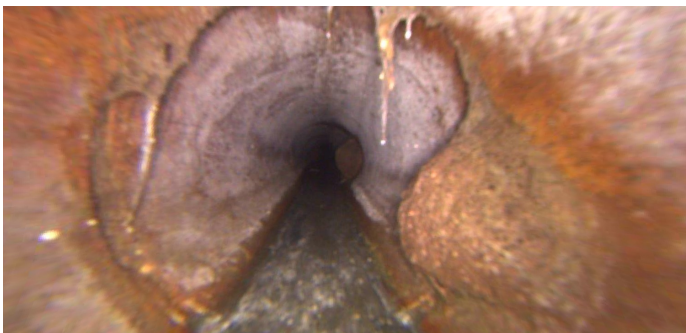
Code: **RMJ**  
Description: **Roots Medium Joint**

Distance (ft): **2.8**  
Structural Grade: **0**  
O&M Grade: **3**  
Clock Start/From: **8**  
Clock To: **4**  
1st Value:  
2nd Value:  
Value Percent: **15.000**  
Continuous Index:  
Within 8" of Joint: **YES**  
Remarks:

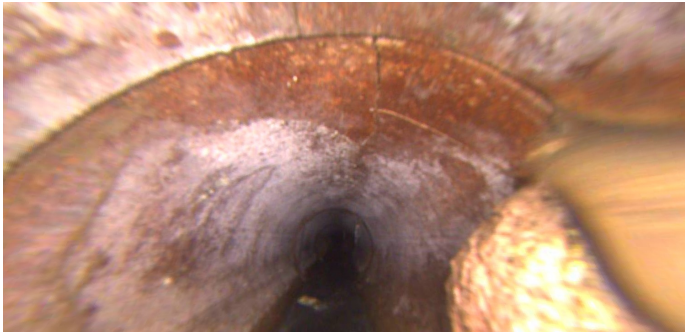
Code: **FM**  
Description: **Fracture Multiple**

Distance (ft): **4.9**  
Structural Grade: **4**  
O&M Grade: **0**  
Clock Start/From: **8**  
Clock To: **4**  
1st Value:  
2nd Value:  
Value Percent:  
Continuous Index:  
Within 8" of Joint: **YES**  
Remarks:

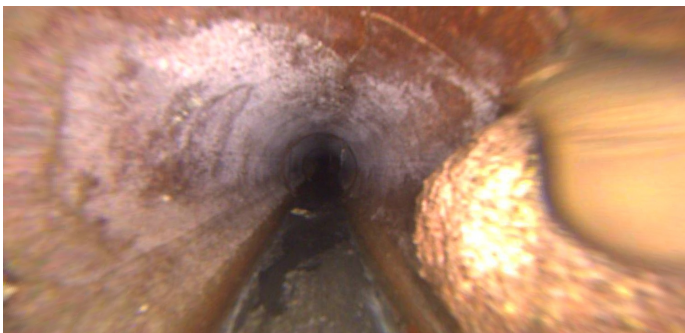
Code: **RMJ**  
Description: **Roots Medium Joint**

Distance (ft): **4.9**  
Structural Grade: **0**  
O&M Grade: **3**  
Clock Start/From: **2**  
Clock To: **4**  
1st Value:  
2nd Value:  
Value Percent: **10.000**  
Continuous Index:  
Within 8" of Joint: **YES**  
Remarks:

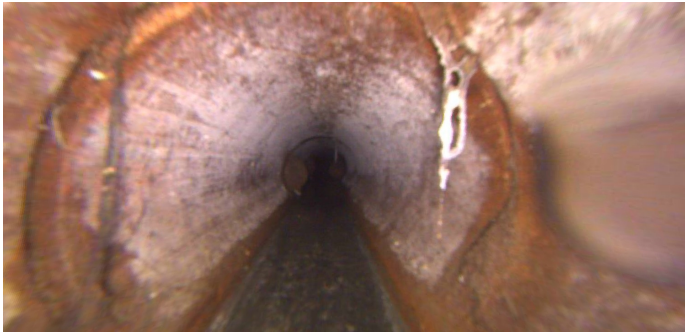
Code: **RFJ**  
Description: **Roots Fine Joint**

Distance (ft): **6.8**  
Structural Grade: **0**  
O&M Grade: **1**  
Clock Start/From: **8**  
Clock To: **4**  
1st Value:  
2nd Value:  
Value Percent:  
Continuous Index:  
Within 8" of Joint: **YES**  
Remarks:

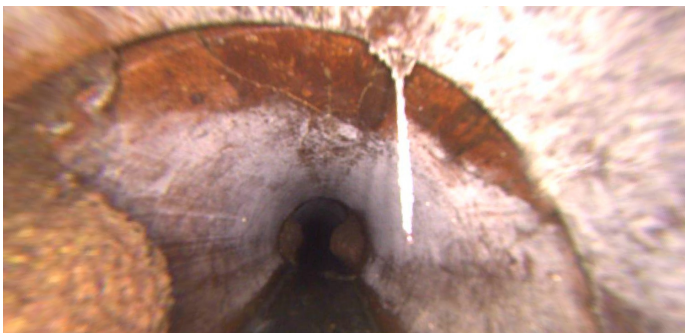
Code: **FM**  
Description: **Fracture Multiple**

Distance (ft): **8.8**  
Structural Grade: **4**  
O&M Grade: **0**  
Clock Start/From: **12**  
Clock To: **4**  
1st Value:  
2nd Value:  
Value Percent:  
Continuous Index:  
Within 8" of Joint: **YES**  
Remarks:

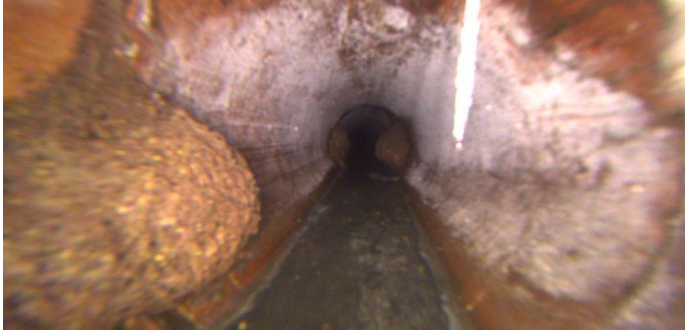
Code: **RFJ**  
Description: **Roots Fine Joint**

Distance (ft): **8.8**  
Structural Grade: **0**  
O&M Grade: **1**  
Clock Start/From: **12**  
Clock To:  
1st Value:  
2nd Value:  
Value Percent:  
Continuous Index:  
Within 8" of Joint: **YES**  
Remarks:

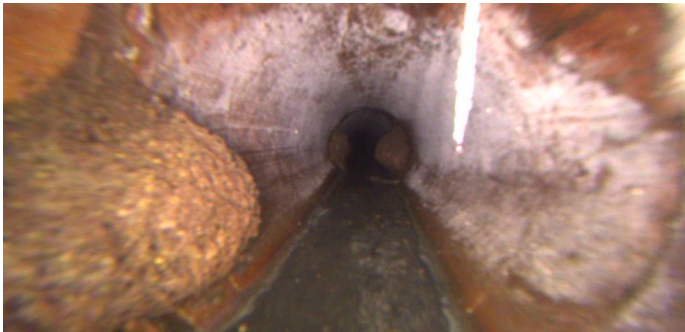
Code: **DAZ**  
Description: **Deposits Attached Other**

Distance (ft): **8.8**  
Structural Grade: **0**  
O&M Grade: **2**  
Clock Start/From: **8**  
Clock To: **9**  
1st Value:  
2nd Value:  
Value Percent: **10.000**  
Continuous Index:  
Within 8" of Joint: **YES**  
Remarks:

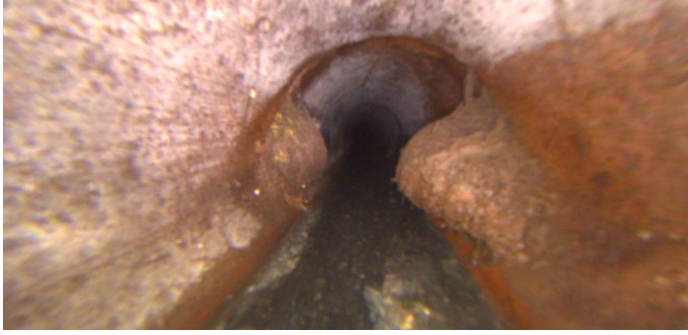
Code:	<b>MSA</b>
Description:	<b>Abandoned Survey</b>
Distance (ft):	<b>10.4</b>
Structural Grade:	<b>0</b>
O&M Grade:	<b>0</b>
Clock Start/From:	
Clock To:	
1st Value:	
2nd Value:	
Value Percent:	
Continuous Index:	
Within 8" of Joint:	<b>NO</b>
Remarks:	<b>roots</b>
