Profile/Photo Observation Report

Street:	S ASH ST	Flow Control:	Not Controlled
City:	Hobart, IN	Year Renewed:	
Location:	Other	Tape/Media #:	
Purpose:	Not Known	Dia/Height:	12"
Use:	Sanitary	Material:	VCP
Drain Area:	NA	Lining:	
Category:	NA		
Comment:	Flow direction wrong. Reverse setup.		
Location Details:		Direction of Survey:	Downstream
US MH:	M-605-008	DS MH:	M-605-075
		Total Length Surveyed (ft):	163.0

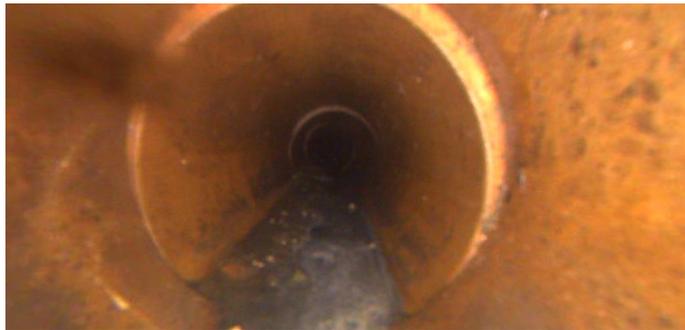
Code: **AMH**
Description: **Manhole**
Distance (ft): **.0**
Structural Grade: **0**
O&M Grade: **0**
Clock Start/From:
Clock To:
1st Value:
2nd Value:
Value Percent:
Continuous Index:
Within 8" of Joint: **NO**
Remarks: **M-605-008**

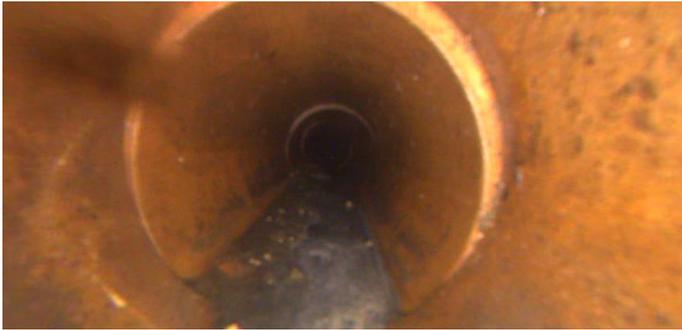
Code: **MWL**
Description: **Water Level**

Distance (ft): **.0**
Structural Grade: **0**
O&M Grade: **0**
Clock Start/From:
Clock To:
1st Value:
2nd Value:
Value Percent: **5.000**
Continuous Index:
Within 8" of Joint: **NO**
Remarks:

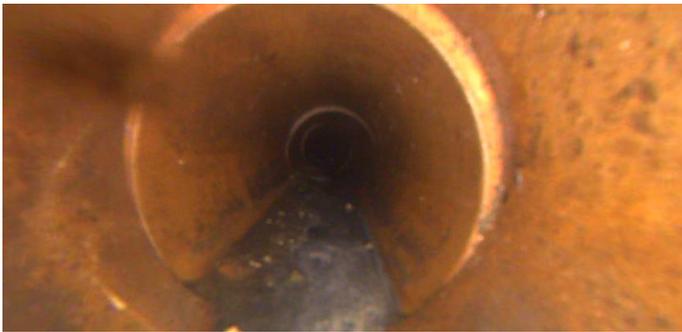
Code: **FC**
Description: **Fracture Circumferential**

Distance (ft): **.0**
Structural Grade: **2**
O&M Grade: **0**
Clock Start/From: **7**
Clock To: **9**
1st Value:
2nd Value:
Value Percent:
Continuous Index:
Within 8" of Joint: **YES**
Remarks:

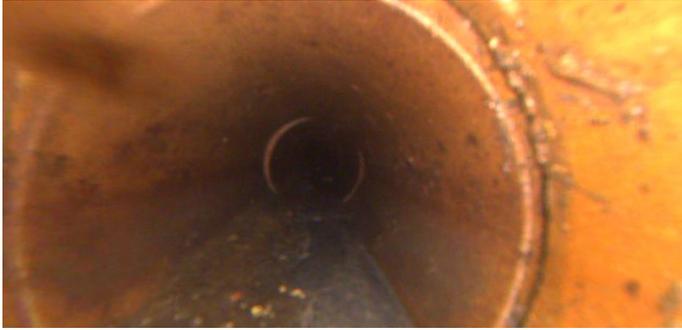
Code: **DSF**
Description: **Deposits Settled Fine**

Distance (ft): **3.1**
Structural Grade: **0**
O&M Grade: **2**
Clock Start/From: **6**
Clock To: **7**
1st Value:
2nd Value:
Value Percent: **5.000**
Continuous Index: **S01**
Within 8" of Joint: **NO**
Remarks:

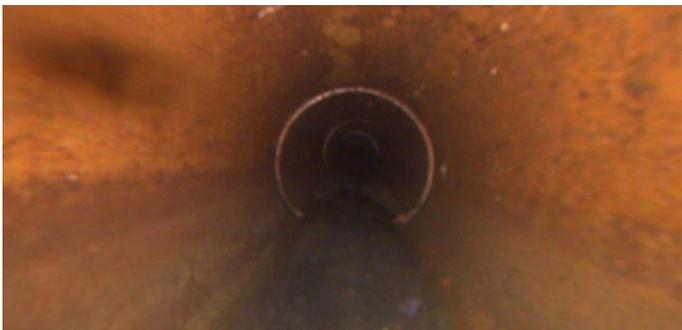
Code: **DSF**
Description: **Deposits Settled Fine**

Distance (ft): **14.0**
Structural Grade: **0**
O&M Grade: **2**
Clock Start/From: **6**
Clock To: **7**
1st Value:
2nd Value:
Value Percent: **5.000**
Continuous Index: **F01**
Within 8" of Joint: **NO**
Remarks:

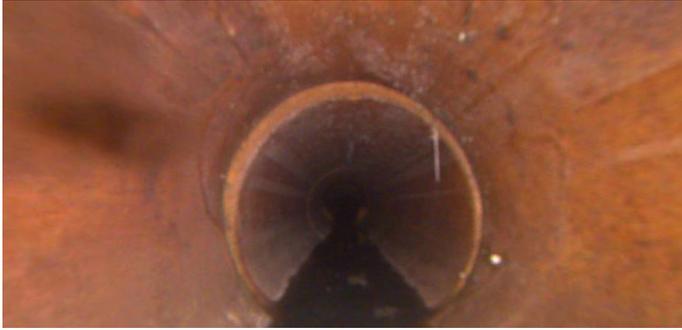
Code: **CM**
Description: **Crack Multiple**

Distance (ft): **59.0**
Structural Grade: **3**
O&M Grade: **0**
Clock Start/From: **8**
Clock To: **4**
1st Value:
2nd Value:
Value Percent:
Continuous Index:
Within 8" of Joint: **YES**
Remarks:

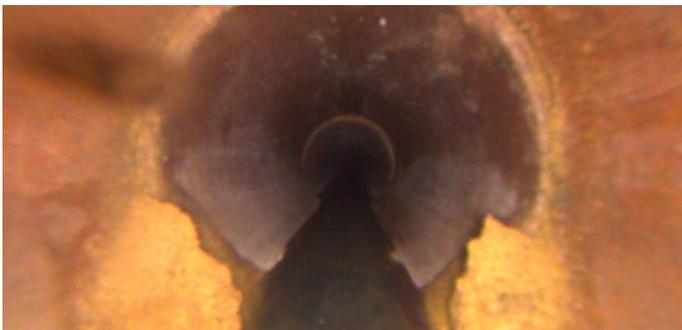
Code: **DAE**
Description: **Deposits Attached Encrustation**

Distance (ft): **63.4**
Structural Grade: **0**
O&M Grade: **2**
Clock Start/From: **7**
Clock To: **5**
1st Value:
2nd Value:
Value Percent: **10.000**
Continuous Index:
Within 8" of Joint: **YES**
Remarks:

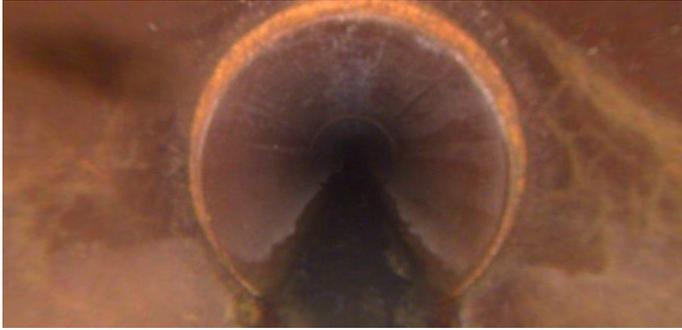
Code: **CM**
Description: **Crack Multiple**

Distance (ft): **65.4**
Structural Grade: **3**
O&M Grade: **0**
Clock Start/From: **8**
Clock To: **4**
1st Value:
2nd Value:
Value Percent:
Continuous Index:
Within 8" of Joint: **YES**
Remarks:

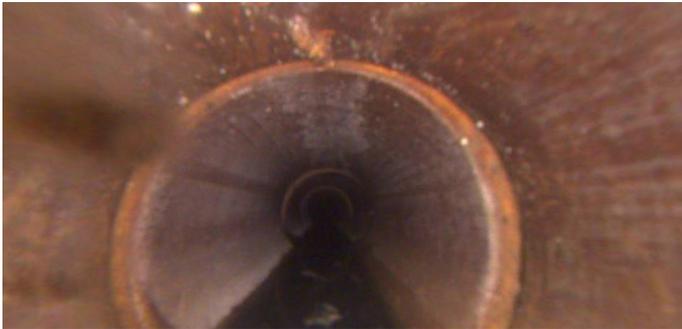
Code: **FM**
Description: **Fracture Multiple**

Distance (ft): **71.5**
Structural Grade: **4**
O&M Grade: **0**
Clock Start/From: **8**
Clock To: **4**
1st Value:
2nd Value:
Value Percent:
Continuous Index: **S02**
Within 8" of Joint: **YES**
Remarks:

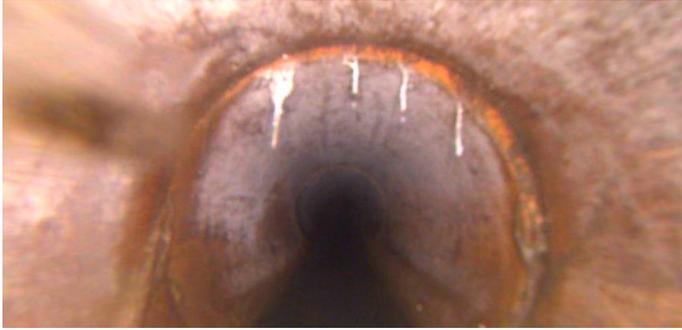
Code: **RFJ**
Description: **Roots Fine Joint**

Distance (ft): **140.7**
Structural Grade: **0**
O&M Grade: **1**
Clock Start/From: **8**
Clock To: **4**
1st Value:
2nd Value:
Value Percent:
Continuous Index:
Within 8" of Joint: **YES**
Remarks:

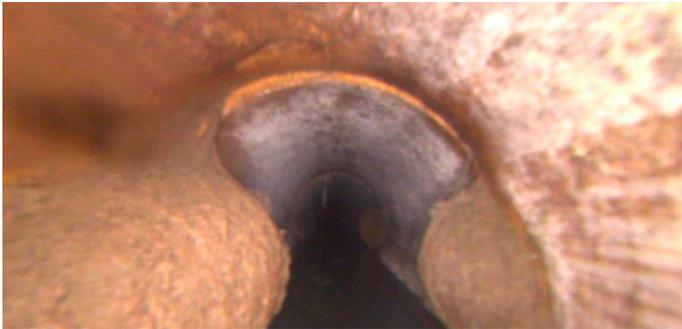
Code: **DAZ**
Description: **Deposits Attached Other**

Distance (ft): **148.8**
Structural Grade: **0**
O&M Grade: **5**
Clock Start/From: **7**
Clock To: **5**
1st Value:
2nd Value:
Value Percent: **40.000**
Continuous Index:
Within 8" of Joint: **YES**
Remarks:

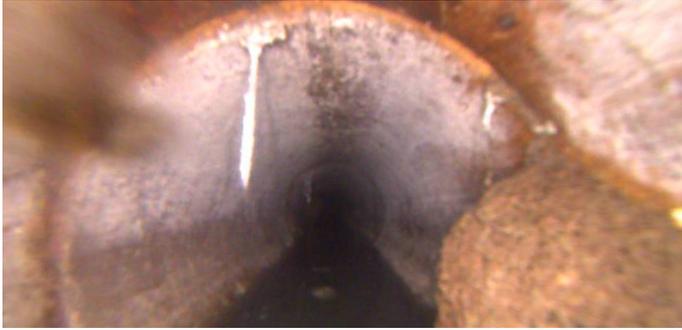
Code: **DAZ**
Description: **Deposits Attached Other**

Distance (ft): **151.1**
Structural Grade: **0**
O&M Grade: **2**
Clock Start/From: **3**
Clock To: **4**
1st Value:
2nd Value:
Value Percent: **10.000**
Continuous Index:
Within 8" of Joint: **YES**
Remarks:

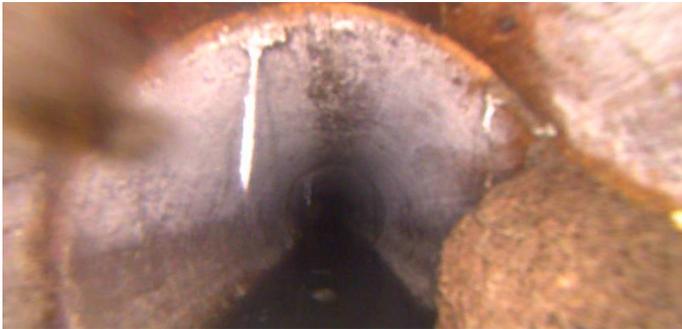
Code: **RFJ**
Description: **Roots Fine Joint**

Distance (ft): **151.1**
Structural Grade: **0**
O&M Grade: **1**
Clock Start/From: **12**
Clock To:
1st Value:
2nd Value:
Value Percent:
Continuous Index:
Within 8" of Joint: **YES**
Remarks:

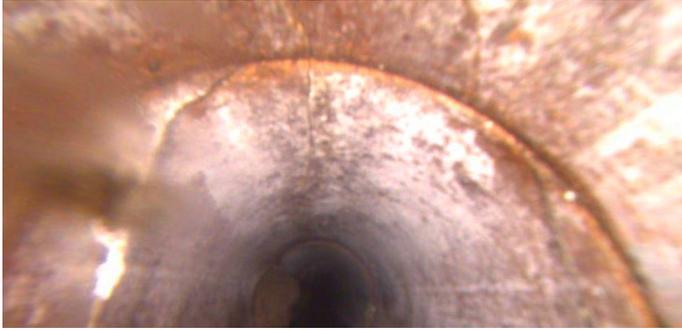
Code: **RFJ**
Description: **Roots Fine Joint**

Distance (ft): **153.2**
Structural Grade: **0**
O&M Grade: **1**
Clock Start/From: **11**
Clock To:
1st Value:
2nd Value:
Value Percent:
Continuous Index:
Within 8" of Joint: **YES**
Remarks:

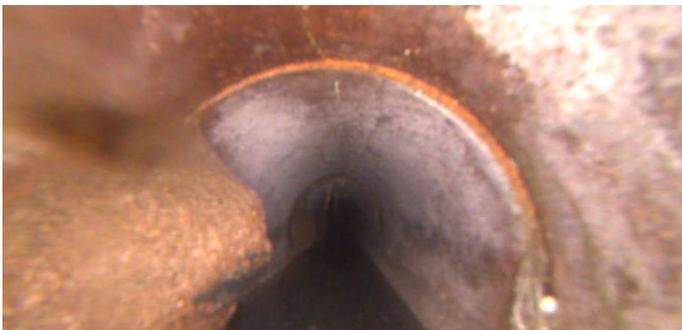
Code: **DAZ**
Description: **Deposits Attached Other**

Distance (ft): **155.0**
Structural Grade: **0**
O&M Grade: **3**
Clock Start/From: **7**
Clock To: **9**
1st Value:
2nd Value:
Value Percent: **15.000**
Continuous Index:
Within 8" of Joint: **YES**
Remarks:

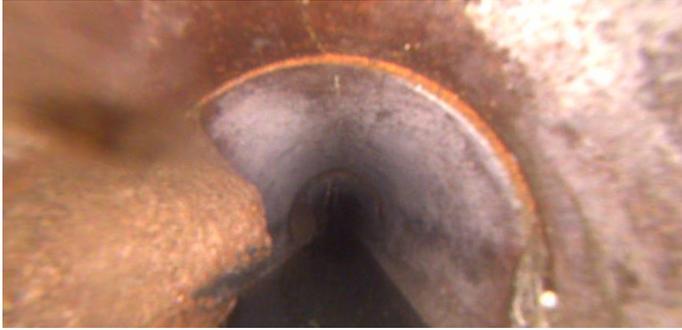
Code: **RFJ**
Description: **Roots Fine Joint**

Distance (ft): **155.0**
Structural Grade: **0**
O&M Grade: **1**
Clock Start/From: **3**
Clock To:
1st Value:
2nd Value:
Value Percent:
Continuous Index:
Within 8" of Joint: **YES**
Remarks:

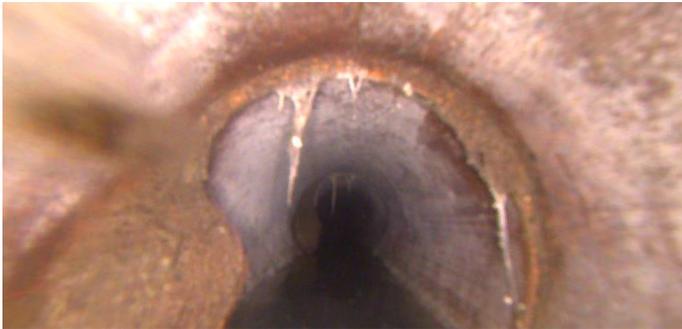
Code: **RMJ**
Description: **Roots Medium Joint**

Distance (ft): **157.0**
Structural Grade: **0**
O&M Grade: **3**
Clock Start/From: **8**
Clock To: **4**
1st Value:
2nd Value:
Value Percent: **10.000**
Continuous Index:
Within 8" of Joint: **YES**
Remarks:

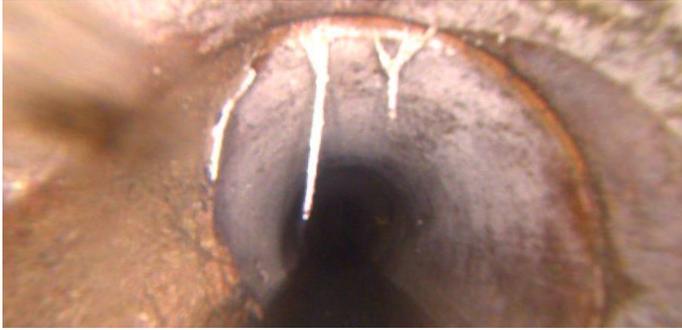
Code: **RMJ**
Description: **Roots Medium Joint**

Distance (ft): **159.2**
Structural Grade: **0**
O&M Grade: **3**
Clock Start/From: **8**
Clock To: **4**
1st Value:
2nd Value:
Value Percent: **20.000**
Continuous Index:
Within 8" of Joint: **YES**
Remarks:

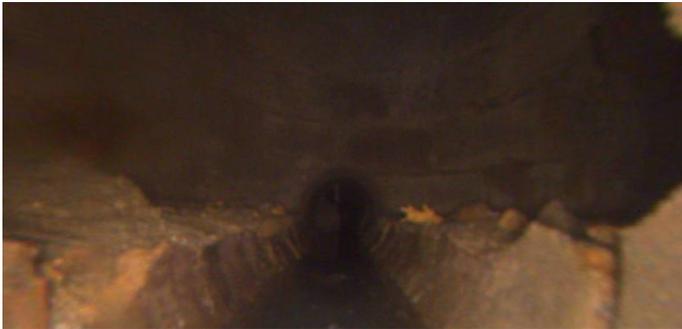
Code: **FM**
Description: **Fracture Multiple**

Distance (ft): **161.3**
Structural Grade: **4**
O&M Grade: **0**
Clock Start/From: **8**
Clock To: **4**
1st Value:
2nd Value:
Value Percent:
Continuous Index: **F02**
Within 8" of Joint: **YES**
Remarks:

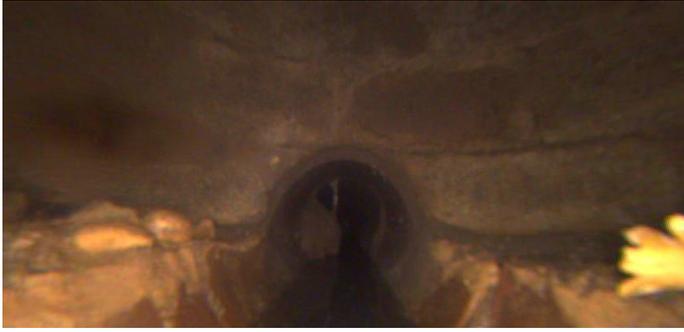
Code: **AMH**
Description: **Manhole**

Distance (ft): **163.0**
Structural Grade: **0**
O&M Grade: **0**
Clock Start/From:
Clock To:
1st Value:
2nd Value:
Value Percent:
Continuous Index:
Within 8" of Joint: **NO**
Remarks: **M-605-075**
