Profile/Photo Observation Report

Date:	04/26/2018	Weather:		Coding:	PACP 6.0
Pipe Length (ft):	114.1	Owner:	NA	Pre Clean:	Not Known
P.O.#:		Surveyor:	Mark Ruby	PSR:	P-605-014-013
Customer:		Clean Date:	01/01/1900	Shape:	C

Street:	ELLENDALE ST & COURT ST	Flow Control:	Not Controlled
City:	Hobart, IN	Year Renewed:	
Location:	Other	Tape/Media #:	
Purpose:	Not Known	Dia/Height:	12"
Use:	Sanitary	Material:	VCP
Drain Area:	NA	Lining:	
Category:	NA		
Comment:	Flow direction wrong.

Location Details:		Direction of Survey:	Downstream
US MH:	M-605-013	DS MH:	M-605-014
		Total Length Surveyed (ft):	85.4

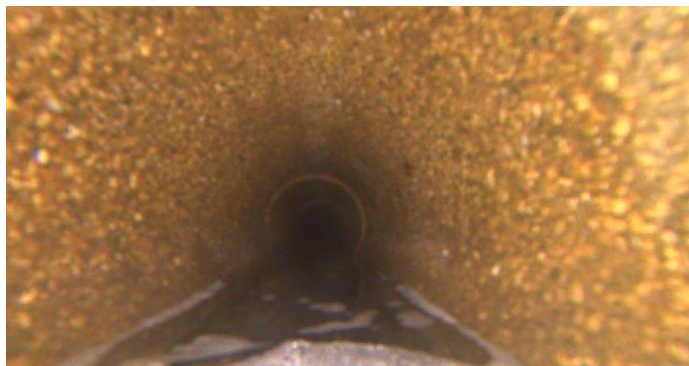
Code: **AMH**
 Description: **Manhole**

Distance (ft): **.0**
 Structural Grade: **0**
 O&M Grade: **0**
 Clock Start/From:
 Clock To:
 1st Value:
 2nd Value:
 Value Percent:
 Continuous Index:
 Within 8" of Joint: **NO**
 Remarks: **M-605-013**

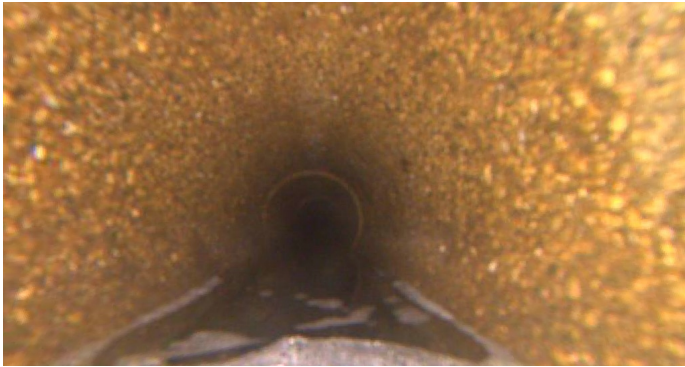
Code:	MWL
Description:	Water Level

Distance (ft):	.0
Structural Grade:	0
O&M Grade:	0
Clock Start/From:	
Clock To:	
1st Value:	
2nd Value:	
Value Percent:	10.000
Continuous Index:	
Within 8" of Joint:	NO
Remarks:

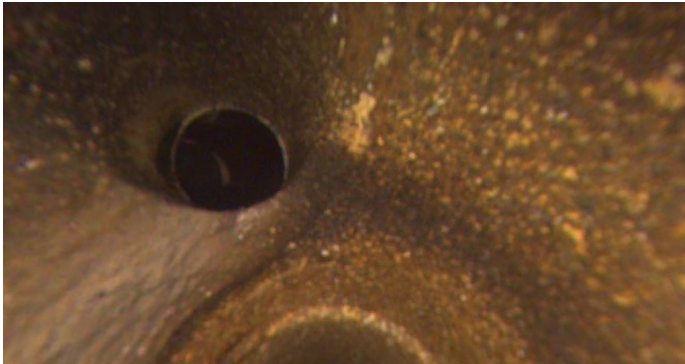
Code:	TF
Description:	Tap Factory

Distance (ft):	21.2
Structural Grade:	0
O&M Grade:	0
Clock Start/From:	11
Clock To:	
1st Value:	4.000
2nd Value:	
Value Percent:	
Continuous Index:	
Within 8" of Joint:	
Remarks:

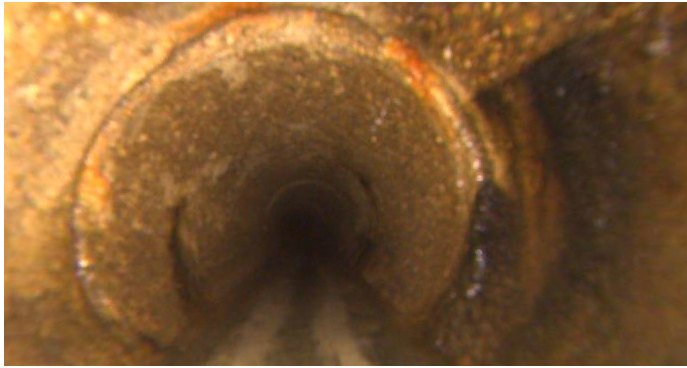
Code: **CL**
Description: **Crack Longitudinal**

Distance (ft): **27.9**
Structural Grade: **2**
O&M Grade: **0**
Clock Start/From: **3**
Clock To:
1st Value:
2nd Value:
Value Percent:
Continuous Index:
Within 8" of Joint: **YES**
Remarks:

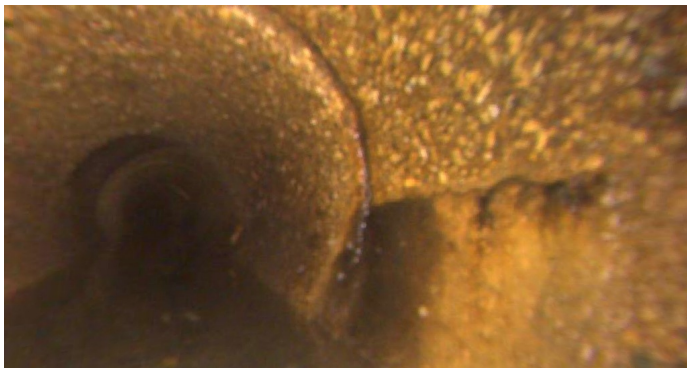
Code: **CL**
Description: **Crack Longitudinal**

Distance (ft): **69.7**
Structural Grade: **2**
O&M Grade: **0**
Clock Start/From: **4**
Clock To:
1st Value:
2nd Value:
Value Percent:
Continuous Index:
Within 8" of Joint:
Remarks:

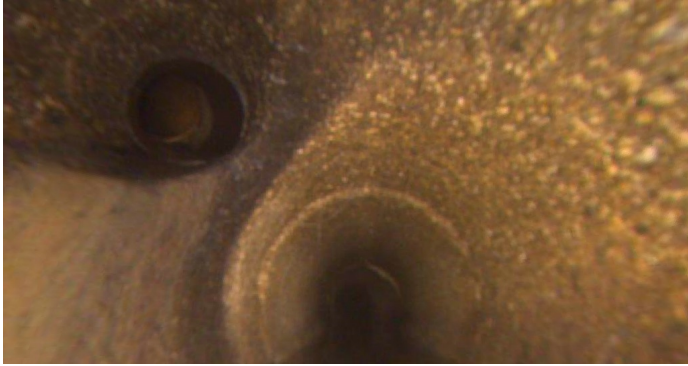
Code: **TF**
Description: **Tap Factory**

Distance (ft): **71.9**
Structural Grade: **0**
O&M Grade: **0**
Clock Start/From: **2**
Clock To:
1st Value: **4.000**
2nd Value:
Value Percent:
Continuous Index:
Within 8" of Joint:
Remarks:

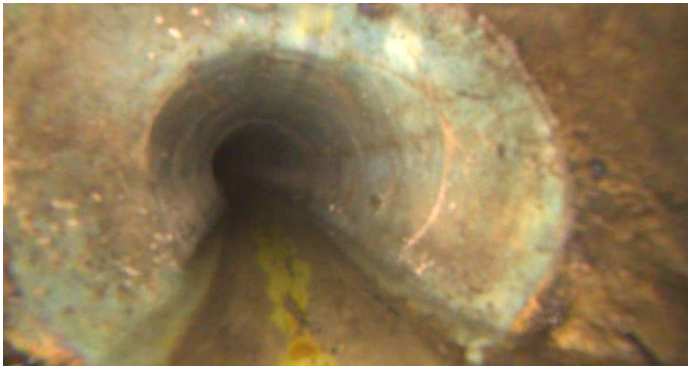
Code: **AMH**
Description: **Manhole**

Distance (ft): **85.4**
Structural Grade: **0**
O&M Grade: **0**
Clock Start/From:
Clock To:
1st Value:
2nd Value:
Value Percent:
Continuous Index:
Within 8" of Joint: **NO**
Remarks: **M-605-014**
