## Profile/Photo Observation Report

Street:	<b>W 2ND ST</b>	Flow Control:	<b>Not Controlled</b>
City:	<b>Hobart, IN</b>	Year Renewed:	
Location:	<b>Other</b>	Tape/Media #:	
Purpose:	<b>Not Known</b>	Dia/Height:	<b>12"</b>
Use:	<b>Sanitary</b>	Material:	<b>VCP</b>
Drain Area:	<b>NA</b>	Lining:	<b>Cured in Place</b>
Category:	<b>NA</b>		
Comment:	<b>Flow direction wrong. Redeployment. Debris at 24'.</b>		
Location Details:		Direction of Survey:	<b>Upstream</b>
US MH:	<b>M-605-015</b>	DS MH:	<b>M-605-016</b>
		Total Length Surveyed (ft):	<b>25.6</b>

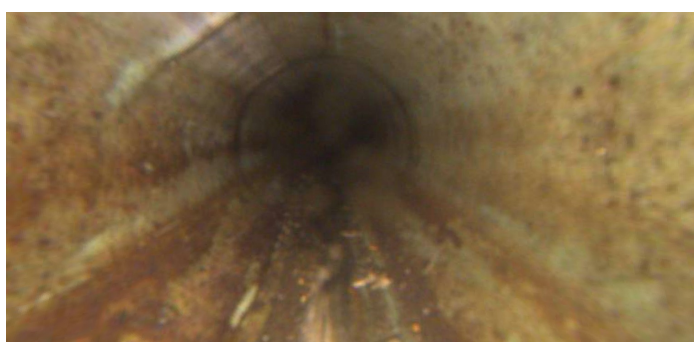
Code: **AMH**  
Description: **Manhole**

Distance (ft): **.0**  
Structural Grade: **0**  
O&M Grade: **0**  
Clock Start/From:  
Clock To:  
1st Value:  
2nd Value:  
Value Percent:  
Continuous Index:  
Within 8" of Joint: **NO**  
Remarks: **M-605-016**

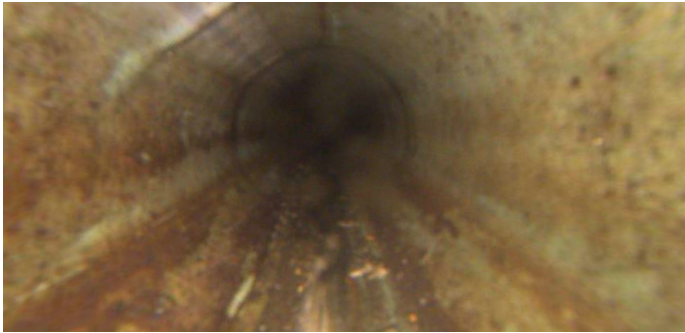
Code:	<b>MWL</b>
Description:	<b>Water Level</b>

Distance (ft):	<b>.0</b>
Structural Grade:	<b>0</b>
O&M Grade:	<b>0</b>
Clock Start/From:	
Clock To:	
1st Value:	
2nd Value:	
Value Percent:	<b>5.000</b>
Continuous Index:	
Within 8" of Joint:	<b>NO</b>
Remarks:

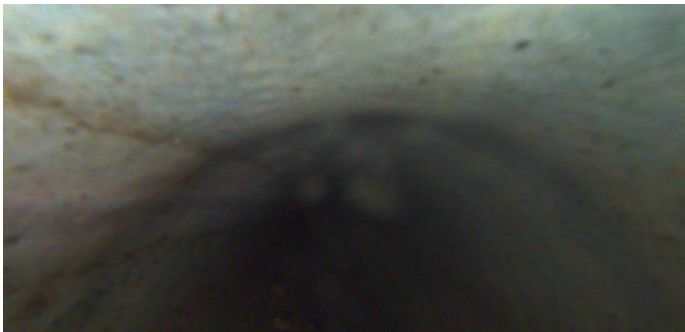
Code:	<b>MSA</b>
Description:	<b>Abandoned Survey</b>

Distance (ft):	<b>25.6</b>
Structural Grade:	<b>0</b>
O&M Grade:	<b>0</b>
Clock Start/From:	
Clock To:	
1st Value:	
2nd Value:	
Value Percent:	
Continuous Index:	
Within 8" of Joint:	<b>NO</b>
Remarks:	<b>unknown</b>
