# Profile/Photo Observation Report

Date:	<b>11/16/2021</b>	Weather:		Coding:	<b>PACP 7.0</b>
Pipe Length (ft):	<b>333.0</b>	Owner:	<b>City of Hobart</b>	Pre Clean:	<b>Heavy Cleaning</b>
P.O.#:	<b>YES502259</b>	Surveyor:	<b>S. Bucklin</b>	PSR:	<b>P-605-018-017</b>
Customer:	<b>City of Hobart</b>	Clean Date:	<b>11/16/2021</b>	Shape:	<b>C</b>

Street:	<b>Court Street</b>	Flow Control:	<b>Not Controlled</b>
City:	<b>Hobart, IN</b>	Year Renewed:	
Location:	<b>Local rural streets with light traffic, t</b>	Tape/Media #:	
Purpose:	<b>Routine Assessment</b>	Dia/Height:	<b>12"</b>
Use:	<b>Sanitary Sewage Pipe</b>	Material:	<b>VCP</b>
Drain Area:		Lining:	<b>None</b>
Category:	<b>NA</b>		
Comment:			
Location Details:		Direction of Survey:	<b>Downstream</b>
US MH:	<b>M-605-017</b>	DS MH:	<b>M-605-018</b>
		Total Length Surveyed (ft):	<b>333.0</b>

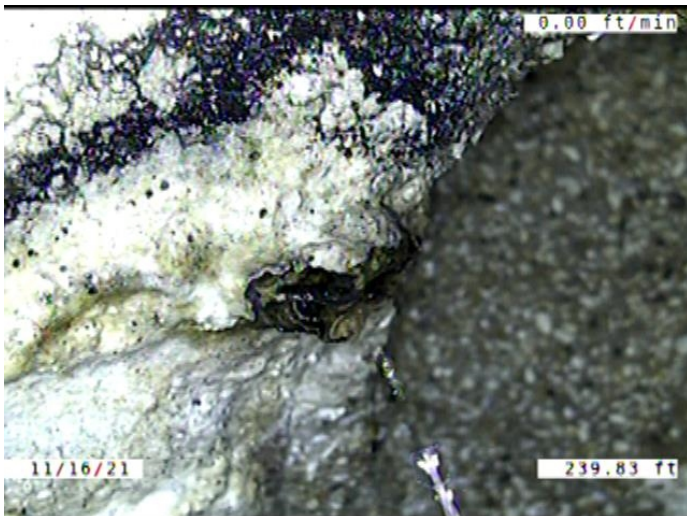
Code: **IDL**  
 Description: **Infiltration Dripper Lateral**

Distance (ft): **239.8**  
 Structural Grade: **0**  
 O&M Grade: **3**  
 Clock Start/From: **12**  
 Clock To:  
 1st Value:  
 2nd Value:  
 Value Percent:  
 Continuous Index:  
 Within 8" of Joint: **YES**  
 Remarks:
