Profile/Photo Observation Report

Street:	W 2ND ST & HENRY ST	Flow Control:	Not Controlled
City:	Hobart, IN	Year Renewed:	
Location:	Other	Tape/Media #:	
Purpose:	Not Known	Dia/Height:	12"
Use:	Sanitary	Material:	VCP
Drain Area:	NA	Lining:	
Category:	NA		
Comment:

Location Details:		Direction of Survey:	Downstream
US MH:	M-605-021	DS MH:	M-605-023
		Total Length Surveyed (ft):	11.1

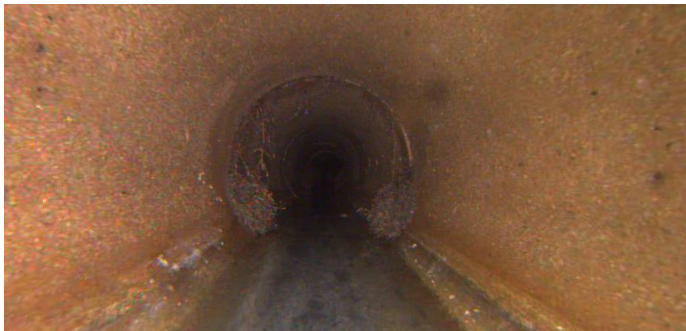
Code: **AMH**
Description: **Manhole**

Distance (ft): **.0**
Structural Grade: **0**
O&M Grade: **0**
Clock Start/From:
Clock To:
1st Value:
2nd Value:
Value Percent:
Continuous Index:
Within 8" of Joint: **NO**
Remarks: **M-605-021**

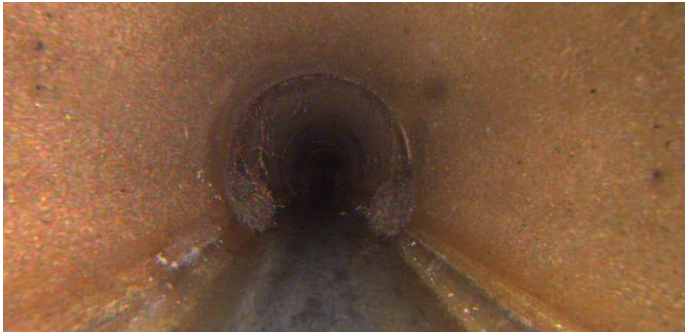
Code:	MWL
Description:	Water Level

Distance (ft):	.0
Structural Grade:	0
O&M Grade:	0
Clock Start/From:	
Clock To:	
1st Value:	
2nd Value:	
Value Percent:	5.000
Continuous Index:	
Within 8" of Joint:	NO
Remarks:

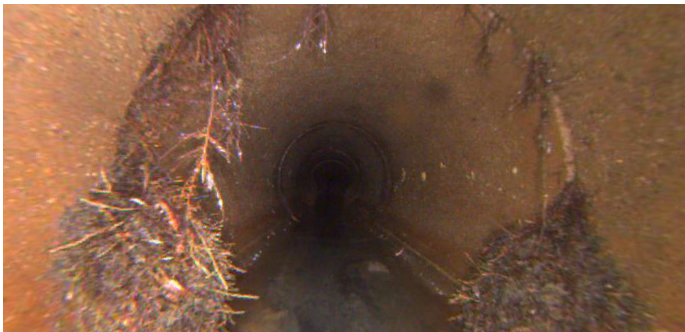
Code:	RMJ
Description:	Roots Medium Joint

Distance (ft):	2.3
Structural Grade:	0
O&M Grade:	3
Clock Start/From:	8
Clock To:	4
1st Value:	
2nd Value:	
Value Percent:	10.000
Continuous Index:	
Within 8" of Joint:	YES
Remarks:

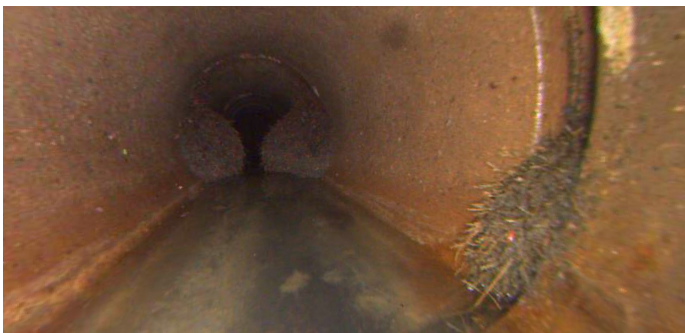
Code: **RFJ**
Description: **Roots Fine Joint**

Distance (ft): **8.3**
Structural Grade: **0**
O&M Grade: **1**
Clock Start/From: **3**
Clock To: **4**
1st Value:
2nd Value:
Value Percent:
Continuous Index:
Within 8" of Joint: **YES**
Remarks:

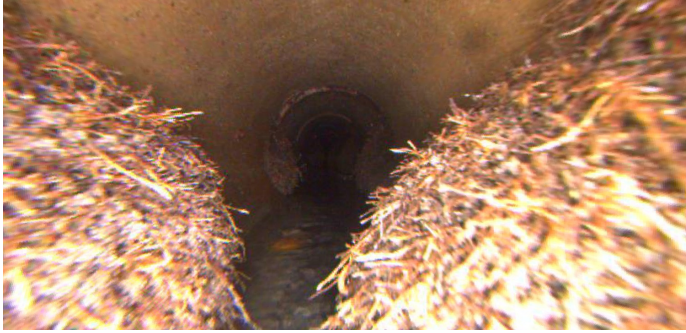
Code: **RMJ**
Description: **Roots Medium Joint**

Distance (ft): **10.4**
Structural Grade: **0**
O&M Grade: **3**
Clock Start/From: **7**
Clock To: **5**
1st Value:
2nd Value:
Value Percent: **40.000**
Continuous Index:
Within 8" of Joint: **YES**
Remarks:

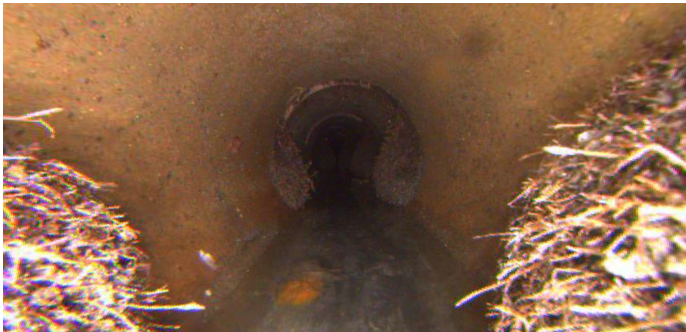
Code: **MSA**
Description: **Abandoned Survey**

Distance (ft): **11.1**
Structural Grade: **0**
O&M Grade: **0**
Clock Start/From:
Clock To:
1st Value:
2nd Value:
Value Percent:
Continuous Index:
Within 8" of Joint: **NO**
Remarks: **roots**
