Profile/Photo Observation Report

Street:	Henry St.	Flow Control:	Not Controlled
City:	Hobart, IN	Year Renewed:	
Location:	Other	Tape/Media #:	
Purpose:	Not Known	Dia/Height:	12"
Use:	Sanitary	Material:	VCP
Drain Area:	NA	Lining:	
Category:	NA		
Comment:

Location Details:		Direction of Survey:	Downstream
US MH:	M-605-021	DS MH:	M-605-023
		Total Length Surveyed (ft):	11.1

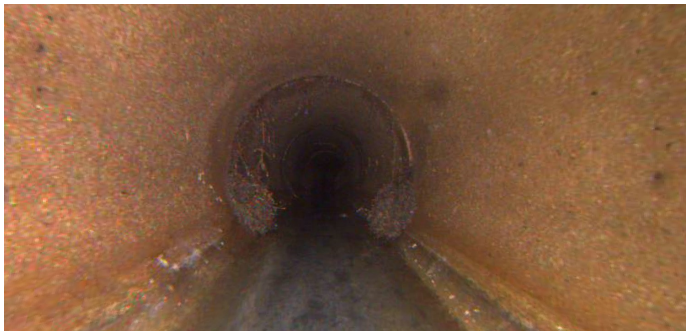
Code: **AMH**
Description: **Manhole**

Distance (ft): **.0**
Structural Grade: **0**
O&M Grade: **0**
Clock Start/From:
Clock To:
1st Value:
2nd Value:
Value Percent:
Continuous Index:
Within 8" of Joint: **NO**
Remarks: **M-605-021**

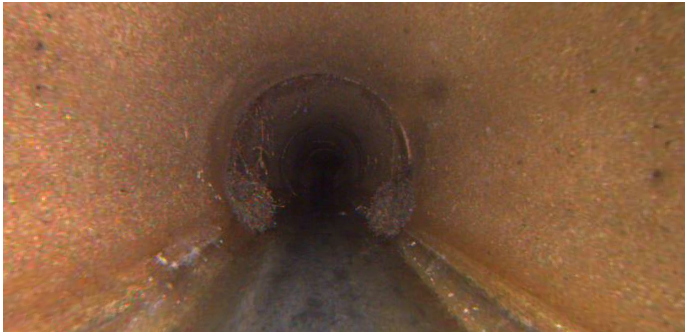
Code:	MWL
Description:	Water Level

Distance (ft):	.0
Structural Grade:	0
O&M Grade:	0
Clock Start/From:	
Clock To:	
1st Value:	
2nd Value:	
Value Percent:	5.000
Continuous Index:	
Within 8" of Joint:	NO
Remarks:

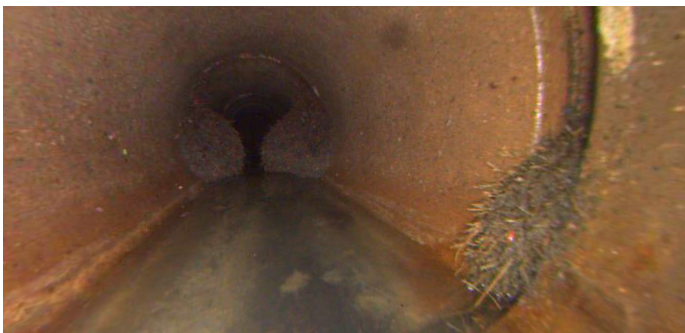
Code: **RFJ**
Description: **Roots Fine Joint**

Distance (ft): **8.3**
Structural Grade: **0**
O&M Grade: **1**
Clock Start/From: **3**
Clock To: **4**
1st Value:
2nd Value:
Value Percent:
Continuous Index:
Within 8" of Joint: **YES**
Remarks:

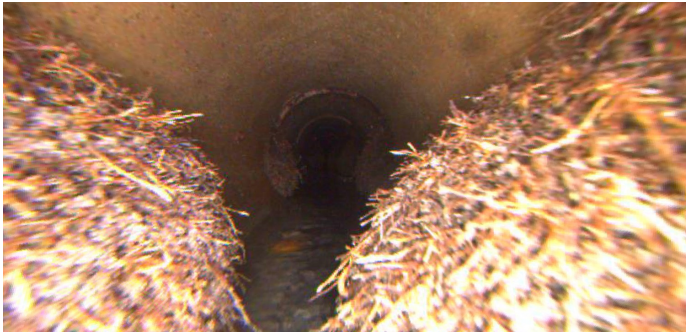
Code: **RMJ**
Description: **Roots Medium Joint**

Distance (ft): **10.4**
Structural Grade: **0**
O&M Grade: **3**
Clock Start/From: **7**
Clock To: **5**
1st Value:
2nd Value:
Value Percent: **40.000**
Continuous Index:
Within 8" of Joint: **YES**
Remarks:

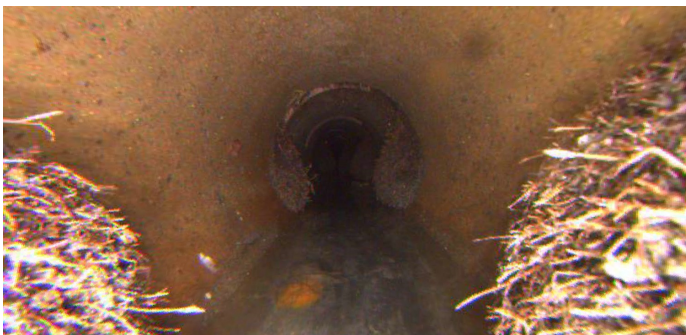
Code: **MSA**
Description: **Abandoned Survey**

Distance (ft): **11.1**
Structural Grade: **0**
O&M Grade: **0**
Clock Start/From:
Clock To:
1st Value:
2nd Value:
Value Percent:
Continuous Index:
Within 8" of Joint: **NO**
Remarks: **roots**
