Profile/Photo Observation Report

Date:	04/25/2018	Weather:		Coding:	PACP 6.0
Pipe Length (ft):	235.5	Owner:	NA	Pre Clean:	Not Known
P.O.#:		Surveyor:	Jen Costello	PSR:	P-605-027-026
Customer:		Clean Date:	01/01/1900	Shape:	C

Street:	W 2ND ST & S ASH ST	Flow Control:	Not Controlled
City:	Hobart, IN	Year Renewed:	
Location:	Other	Tape/Media #:	
Purpose:	Not Known	Dia/Height:	12"
Use:	Sanitary	Material:	VCP
Drain Area:	NA	Lining:	
Category:	NA		
Comment:			
Location Details:		Direction of Survey:	Upstream
US MH:	M-605-026	DS MH:	M-605-027
		Total Length Surveyed (ft):	183.0

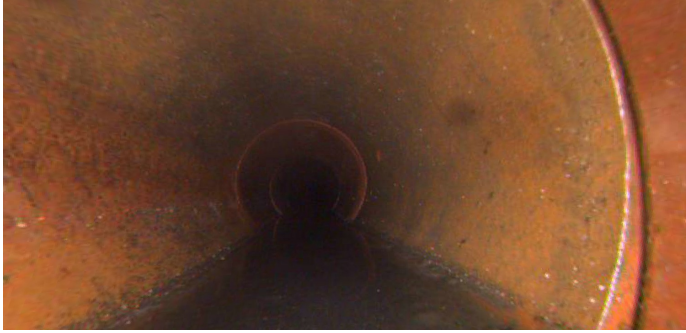
Code: **AMH**
Description: **Manhole**

Distance (ft): **.0**
Structural Grade: **0**
O&M Grade: **0**
Clock Start/From:
Clock To:
1st Value:
2nd Value:
Value Percent:
Continuous Index:
Within 8" of Joint: **NO**
Remarks: **M-605-027**

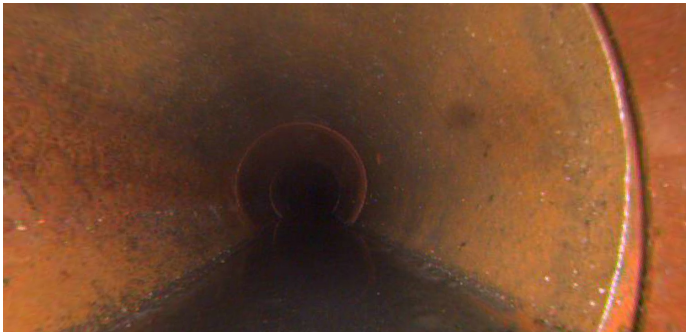
Code: **MWL**
Description: **Water Level**

Distance (ft): **.0**
Structural Grade: **0**
O&M Grade: **0**
Clock Start/From:
Clock To:
1st Value:
2nd Value:
Value Percent: **10.000**
Continuous Index:
Within 8" of Joint: **NO**
Remarks:

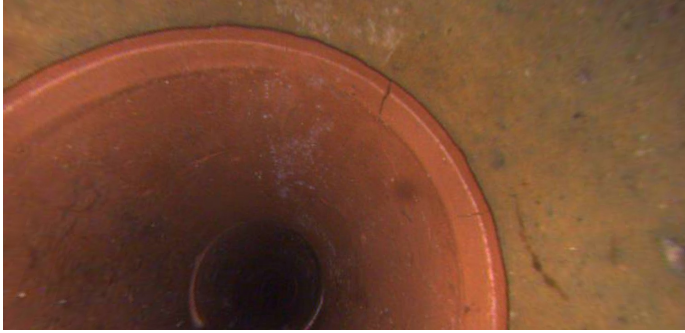
Code: **FM**
Description: **Fracture Multiple**

Distance (ft): **2.8**
Structural Grade: **4**
O&M Grade: **0**
Clock Start/From: **1**
Clock To: **3**
1st Value:
2nd Value:
Value Percent:
Continuous Index:
Within 8" of Joint: **YES**
Remarks:

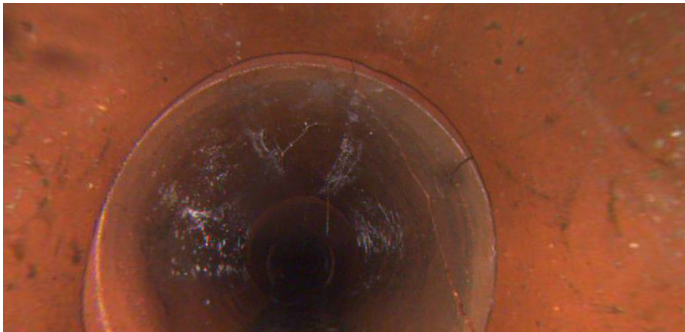
Code: **FM**
Description: **Fracture Multiple**

Distance (ft): **12.6**
Structural Grade: **4**
O&M Grade: **0**
Clock Start/From: **1**
Clock To: **4**
1st Value:
2nd Value:
Value Percent:
Continuous Index:
Within 8" of Joint: **YES**
Remarks:

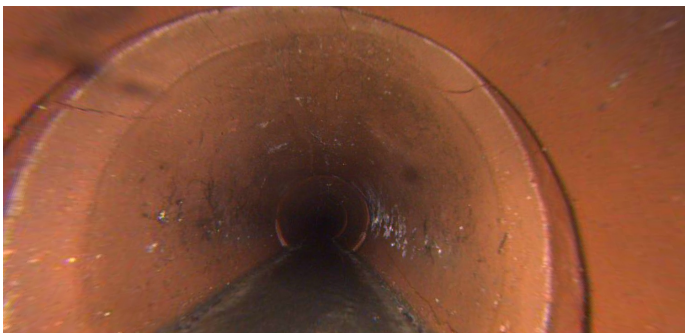
Code: **FM**
Description: **Fracture Multiple**

Distance (ft): **17.1**
Structural Grade: **4**
O&M Grade: **0**
Clock Start/From: **8**
Clock To: **4**
1st Value:
2nd Value:
Value Percent:
Continuous Index: **S01**
Within 8" of Joint: **YES**
Remarks:

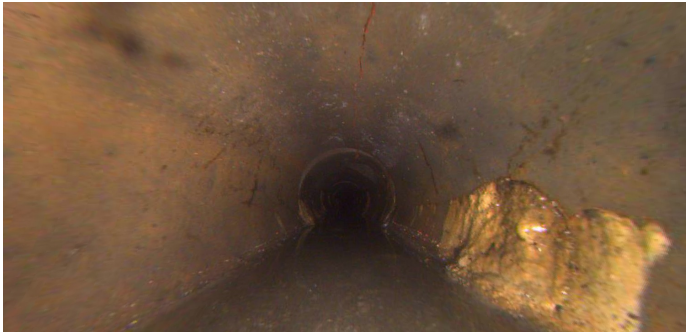
Code: **DAE**
Description: **Deposits Attached Encrustation**

Distance (ft): **35.7**
Structural Grade: **0**
O&M Grade: **2**
Clock Start/From: **3**
Clock To: **4**
1st Value:
2nd Value:
Value Percent: **5.000**
Continuous Index:
Within 8" of Joint: **NO**
Remarks:

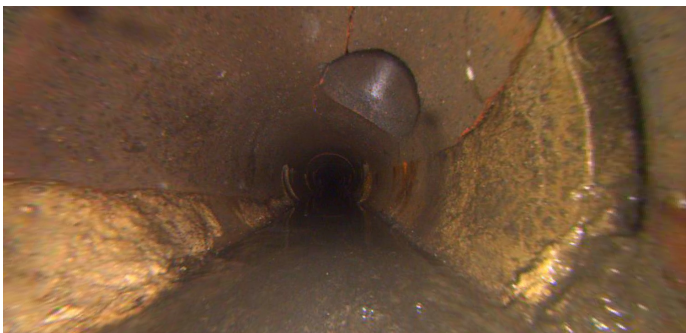
Code: **DAE**
Description: **Deposits Attached Encrustation**

Distance (ft): **37.5**
Structural Grade: **0**
O&M Grade: **2**
Clock Start/From: **8**
Clock To: **9**
1st Value:
2nd Value:
Value Percent: **5.000**
Continuous Index:
Within 8" of Joint: **YES**
Remarks:

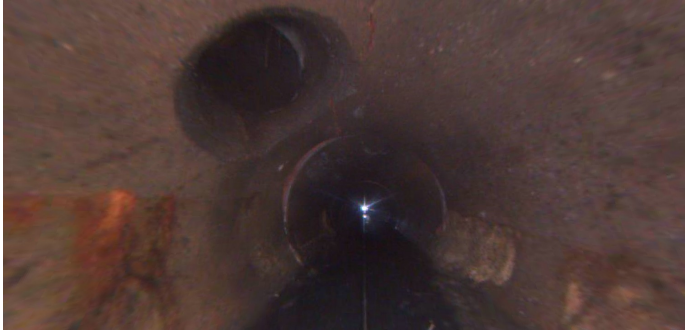
Code: **TF**
Description: **Tap Factory**

Distance (ft): **39.1**
Structural Grade: **0**
O&M Grade: **0**
Clock Start/From: **1**
Clock To:
1st Value: **4.000**
2nd Value:
Value Percent:
Continuous Index:
Within 8" of Joint:
Remarks:

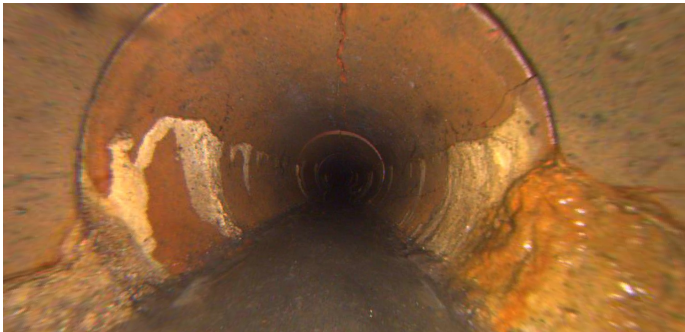
Code: **DAE**
Description: **Deposits Attached Encrustation**

Distance (ft): **39.3**
Structural Grade: **0**
O&M Grade: **2**
Clock Start/From: **8**
Clock To: **4**
1st Value:
2nd Value:
Value Percent: **5.000**
Continuous Index: **S02**
Within 8" of Joint: **YES**
Remarks:

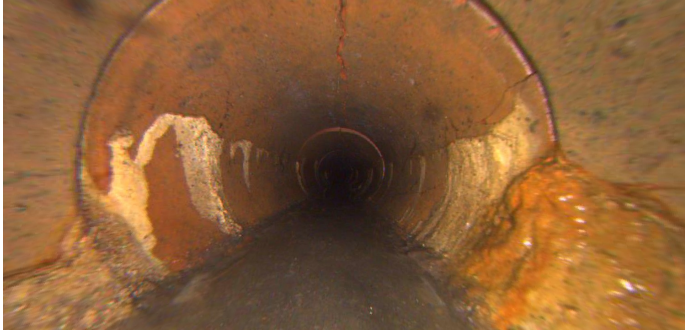
Code: **IW**
Description: **Infil Weeper**

Distance (ft): **39.3**
Structural Grade: **0**
O&M Grade: **2**
Clock Start/From: **8**
Clock To: **4**
1st Value:
2nd Value:
Value Percent:
Continuous Index: **S03**
Within 8" of Joint: **YES**
Remarks:

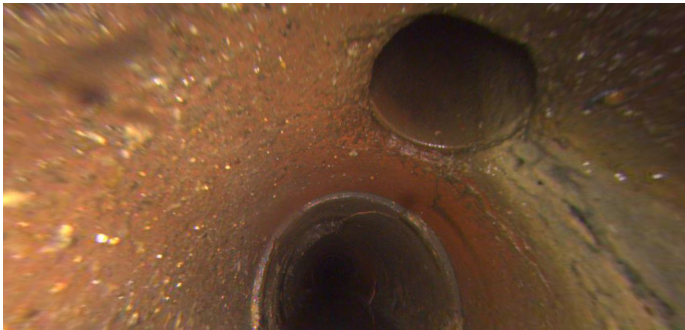
Code: **TBA**
Description: **Tap Break-in Active**

Distance (ft): **60.3**
Structural Grade: **0**
O&M Grade: **0**
Clock Start/From: **1**
Clock To:
1st Value: **4.000**
2nd Value:
Value Percent:
Continuous Index:
Within 8" of Joint:
Remarks:

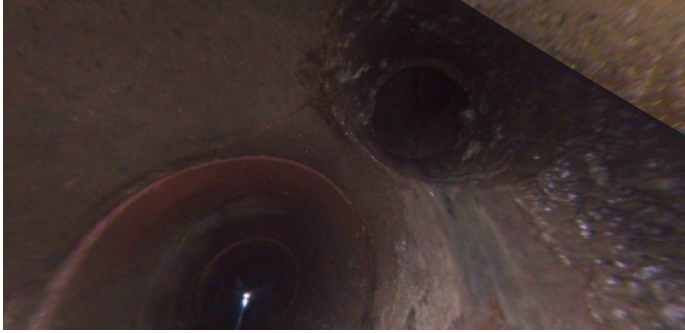
Code: **TF**
Description: **Tap Factory**

Distance (ft): **62.5**
Structural Grade: **0**
O&M Grade: **0**
Clock Start/From: **11**
Clock To:
1st Value: **4.000**
2nd Value:
Value Percent:
Continuous Index:
Within 8" of Joint:
Remarks:

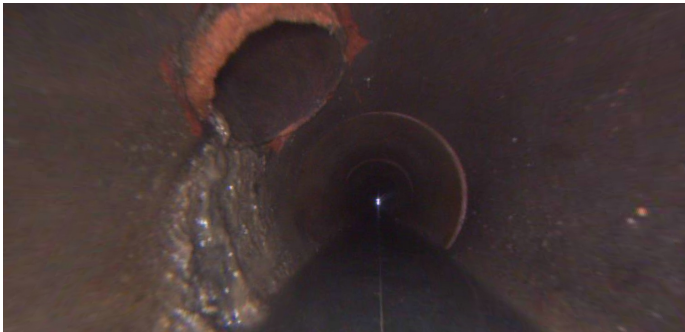
Code: **TBI**
Description: **Tap Break-in Intruding**

Distance (ft): **79.1**
Structural Grade: **0**
O&M Grade: **2**
Clock Start/From: **1**
Clock To:
1st Value: **4.000**
2nd Value: **1.000**
Value Percent:
Continuous Index:
Within 8" of Joint:
Remarks:

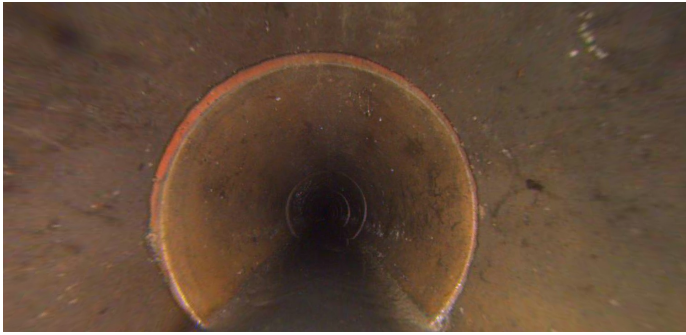
Code: **DAE**
Description: **Deposits Attached Encrustation**

Distance (ft): **79.1**
Structural Grade: **0**
O&M Grade: **2**
Clock Start/From: **8**
Clock To: **4**
1st Value:
2nd Value:
Value Percent: **5.000**
Continuous Index: **F02**
Within 8" of Joint: **YES**
Remarks:

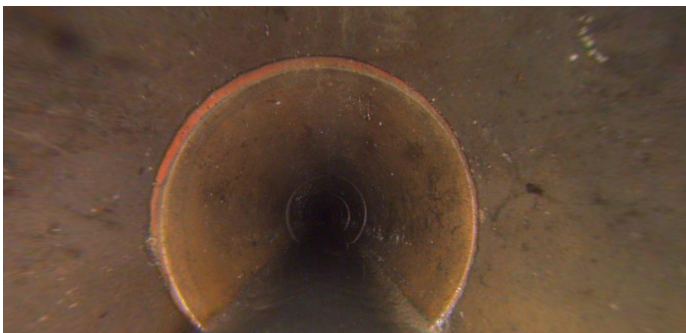
Code: **IW**
Description: **Infil Weeper**

Distance (ft): **79.1**
Structural Grade: **0**
O&M Grade: **2**
Clock Start/From: **8**
Clock To: **4**
1st Value:
2nd Value:
Value Percent:
Continuous Index: **F03**
Within 8" of Joint: **YES**
Remarks:

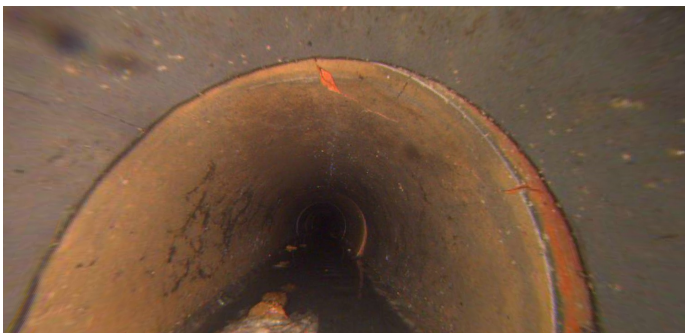
Code: **FM**
Description: **Fracture Multiple**

Distance (ft): **87.3**
Structural Grade: **4**
O&M Grade: **0**
Clock Start/From: **12**
Clock To: **3**
1st Value:
2nd Value:
Value Percent:
Continuous Index:
Within 8" of Joint: **YES**
Remarks:

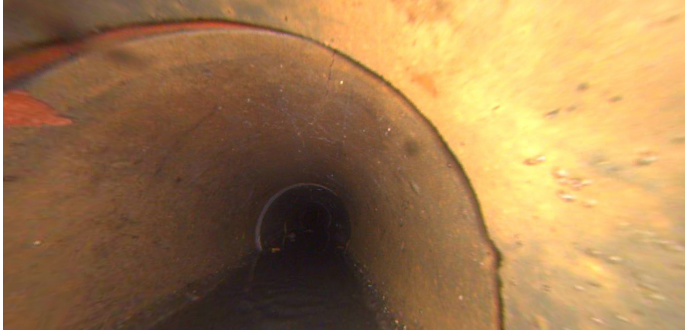
Code: **FL**
Description: **Fracture Longitudinal**

Distance (ft): **93.4**
Structural Grade: **3**
O&M Grade: **0**
Clock Start/From: **1**
Clock To:
1st Value:
2nd Value:
Value Percent:
Continuous Index:
Within 8" of Joint: **YES**
Remarks:

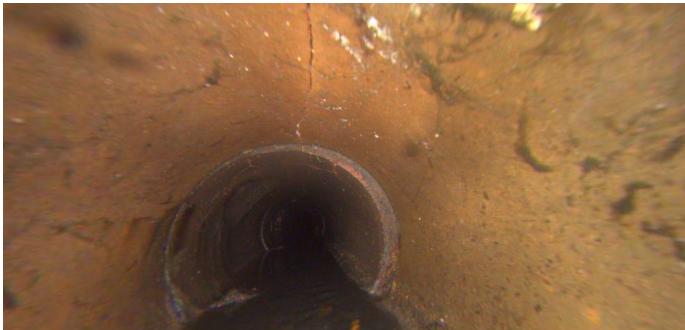
Code: **FM**
Description: **Fracture Multiple**

Distance (ft): **98.7**
Structural Grade: **4**
O&M Grade: **0**
Clock Start/From: **8**
Clock To: **4**
1st Value:
2nd Value:
Value Percent:
Continuous Index: **S04**
Within 8" of Joint: **YES**
Remarks:

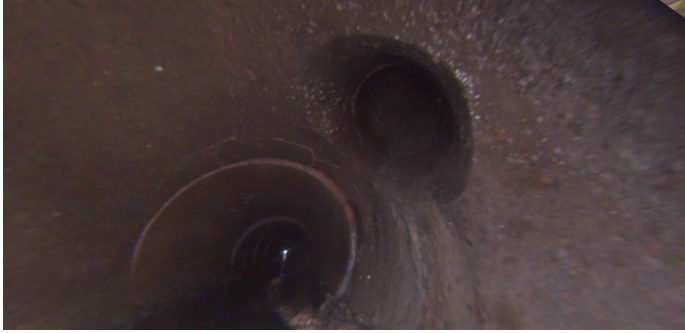
Code: **TF**
Description: **Tap Factory**

Distance (ft): **101.1**
Structural Grade: **0**
O&M Grade: **0**
Clock Start/From: **11**
Clock To:
1st Value: **4.000**
2nd Value:
Value Percent:
Continuous Index:
Within 8" of Joint:
Remarks:

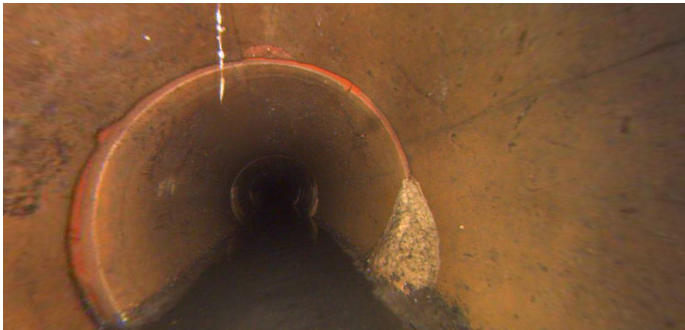
Code: **DAE**
Description: **Deposits Attached Encrustation**

Distance (ft): **109.1**
Structural Grade: **0**
O&M Grade: **2**
Clock Start/From: **8**
Clock To: **4**
1st Value:
2nd Value:
Value Percent: **5.000**
Continuous Index: **S05**
Within 8" of Joint: **YES**
Remarks:

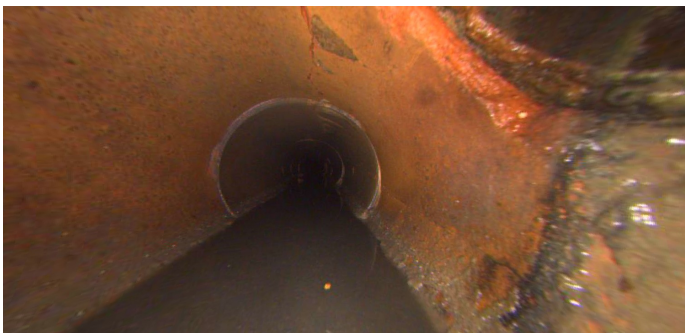
Code: **DAE**
Description: **Deposits Attached Encrustation**

Distance (ft): **120.5**
Structural Grade: **0**
O&M Grade: **2**
Clock Start/From: **8**
Clock To: **4**
1st Value:
2nd Value:
Value Percent: **5.000**
Continuous Index: **F05**
Within 8" of Joint: **YES**
Remarks:

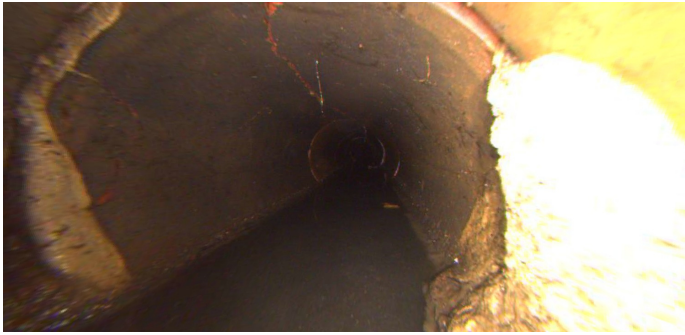
Code: **DAE**
Description: **Deposits Attached Encrustation**

Distance (ft): **127.6**
Structural Grade: **0**
O&M Grade: **2**
Clock Start/From: **8**
Clock To: **4**
1st Value:
2nd Value:
Value Percent: **5.000**
Continuous Index:
Within 8" of Joint: **YES**
Remarks:

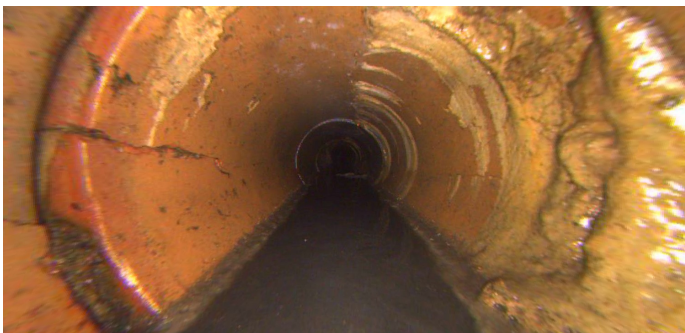
Code: **DAE**
Description: **Deposits Attached Encrustation**

Distance (ft): **135.5**
Structural Grade: **0**
O&M Grade: **2**
Clock Start/From: **12**
Clock To: **4**
1st Value:
2nd Value:
Value Percent: **10.000**
Continuous Index:
Within 8" of Joint: **YES**
Remarks:

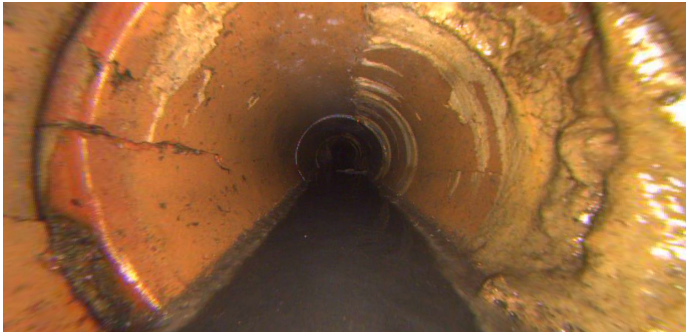
Code: **IW**
Description: **Infil Weeper**

Distance (ft): **135.5**
Structural Grade: **0**
O&M Grade: **2**
Clock Start/From: **12**
Clock To: **4**
1st Value:
2nd Value:
Value Percent:
Continuous Index:
Within 8" of Joint: **YES**
Remarks:

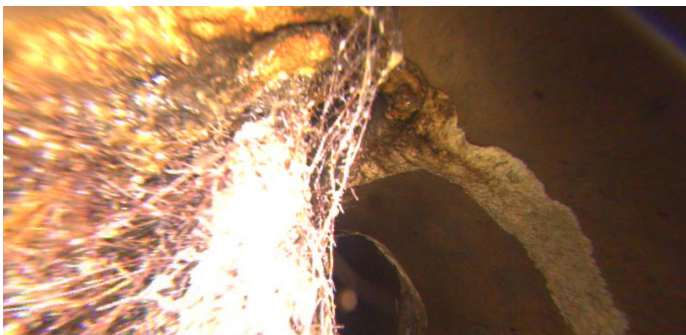
Code: **TBD**
Description: **Tap Break-in Defective**

Distance (ft): **140.4**
Structural Grade: **0**
O&M Grade: **3**
Clock Start/From: **11**
Clock To:
1st Value: **4.000**
2nd Value:
Value Percent:
Continuous Index:
Within 8" of Joint:
Remarks: **ROOTS**

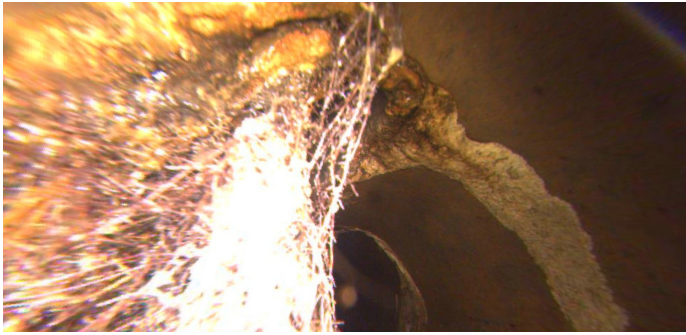
Code: **RML**
Description: **Roots Medium Lateral**

Distance (ft): **140.4**
Structural Grade: **0**
O&M Grade: **3**
Clock Start/From: **6**
Clock To: **11**
1st Value:
2nd Value:
Value Percent: **20.000**
Continuous Index:
Within 8" of Joint: **NO**
Remarks:

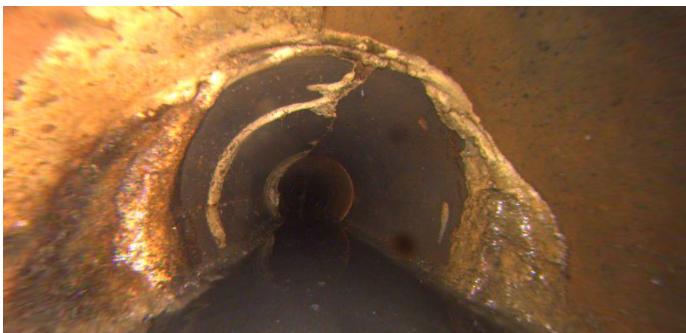
Code: **DAE**
Description: **Deposits Attached Encrustation**

Distance (ft): **141.3**
Structural Grade: **0**
O&M Grade: **2**
Clock Start/From: **8**
Clock To: **4**
1st Value:
2nd Value:
Value Percent: **10.000**
Continuous Index: **S06**
Within 8" of Joint: **YES**
Remarks:

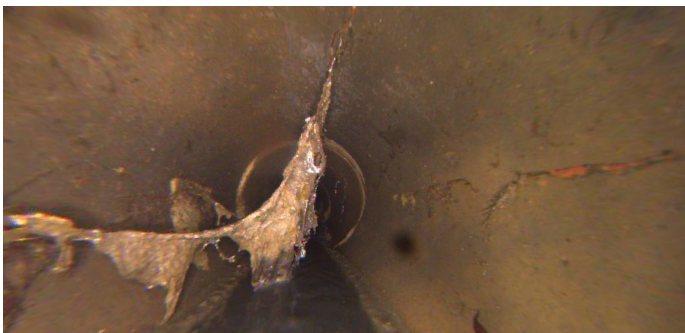
Code: **RMB**
Description: **Roots Medium Barrel**

Distance (ft): **148.2**
Structural Grade: **0**
O&M Grade: **4**
Clock Start/From: **9**
Clock To: **12**
1st Value:
2nd Value:
Value Percent: **10.000**
Continuous Index:
Within 8" of Joint: **NO**
Remarks:

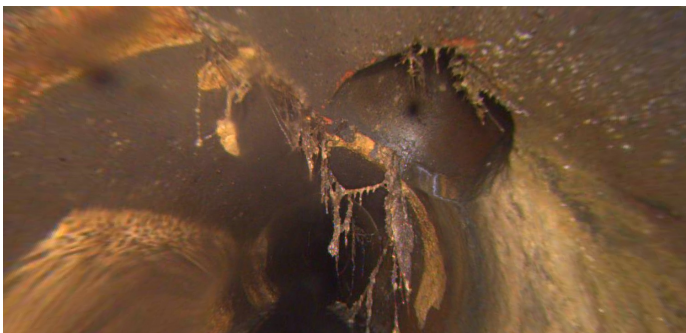
Code: **TBD**
Description: **Tap Break-in Defective**

Distance (ft): **158.3**
Structural Grade: **0**
O&M Grade: **3**
Clock Start/From: **1**
Clock To:
1st Value: **4.000**
2nd Value:
Value Percent:
Continuous Index:
Within 8" of Joint:
Remarks: **ROOTS**

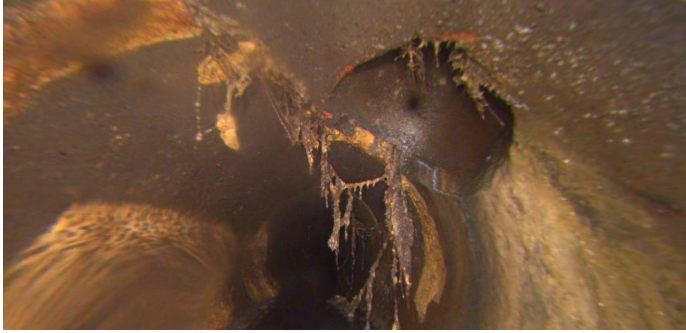
Code: **RFB**
Description: **Roots Fine Barrel**

Distance (ft): **158.3**
Structural Grade: **0**
O&M Grade: **2**
Clock Start/From: **12**
Clock To: **1**
1st Value:
2nd Value:
Value Percent:
Continuous Index:
Within 8" of Joint: **NO**
Remarks:

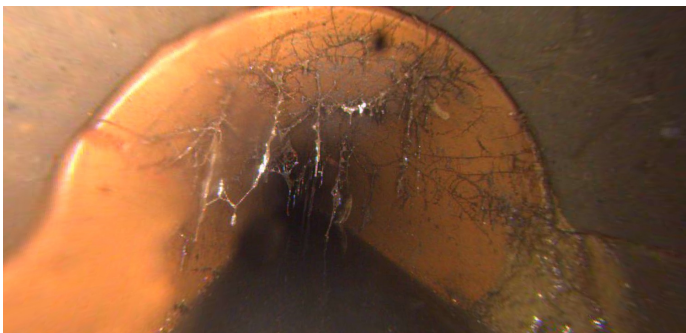
Code: **RFJ**
Description: **Roots Fine Joint**

Distance (ft): **171.8**
Structural Grade: **0**
O&M Grade: **1**
Clock Start/From: **8**
Clock To: **4**
1st Value:
2nd Value:
Value Percent:
Continuous Index:
Within 8" of Joint: **YES**
Remarks:

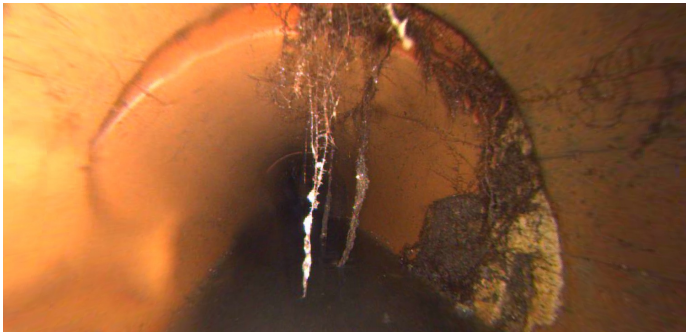
Code: **RMJ**
Description: **Roots Medium Joint**

Distance (ft): **173.7**
Structural Grade: **0**
O&M Grade: **3**
Clock Start/From: **12**
Clock To: **4**
1st Value:
2nd Value:
Value Percent: **5.000**
Continuous Index:
Within 8" of Joint: **YES**
Remarks:

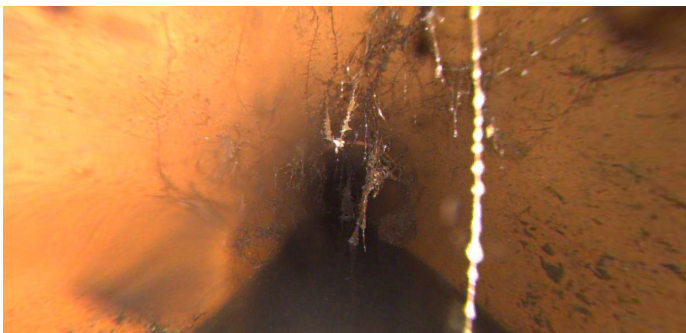
Code: **RFB**
Description: **Roots Fine Barrel**

Distance (ft): **176.5**
Structural Grade: **0**
O&M Grade: **2**
Clock Start/From: **12**
Clock To:
1st Value:
2nd Value:
Value Percent:
Continuous Index:
Within 8" of Joint: **NO**
Remarks:

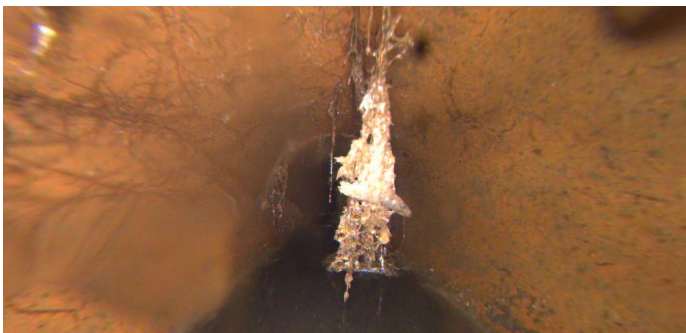
Code: **RMB**
Description: **Roots Medium Barrel**

Distance (ft): **178.6**
Structural Grade: **0**
O&M Grade: **4**
Clock Start/From: **12**
Clock To:
1st Value:
2nd Value:
Value Percent: **10.000**
Continuous Index:
Within 8" of Joint: **NO**
Remarks:
