Profile/Photo Observation Report

Date:	04/25/2018	Weather:		Coding:	PACP 6.0
Pipe Length (ft):	235.5	Owner:	NA	Pre Clean:	Not Known
P.O.#:		Surveyor:	Jen Costello	PSR:	P-605-027-026
Customer:		Clean Date:	01/01/1900	Shape:	C

Street:	S Ash St.	Flow Control:	Not Controlled
City:	Hobart, IN	Year Renewed:	
Location:	Other	Tape/Media #:	
Purpose:	Not Known	Dia/Height:	12"
Use:	Sanitary	Material:	VCP
Drain Area:	NA	Lining:	
Category:	NA		
Comment:			
Location Details:		Direction of Survey:	Upstream
US MH:	M-605-026	DS MH:	M-605-027
		Total Length Surveyed (ft):	183.0

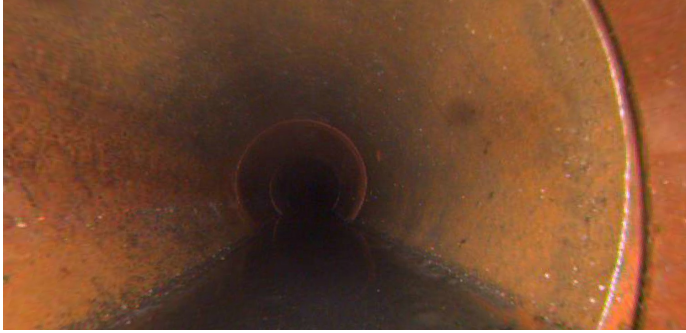
Code: **AMH**
Description: **Manhole**

Distance (ft): **.0**
Structural Grade: **0**
O&M Grade: **0**
Clock Start/From:
Clock To:
1st Value:
2nd Value:
Value Percent:
Continuous Index:
Within 8" of Joint: **NO**
Remarks: **M-605-027**

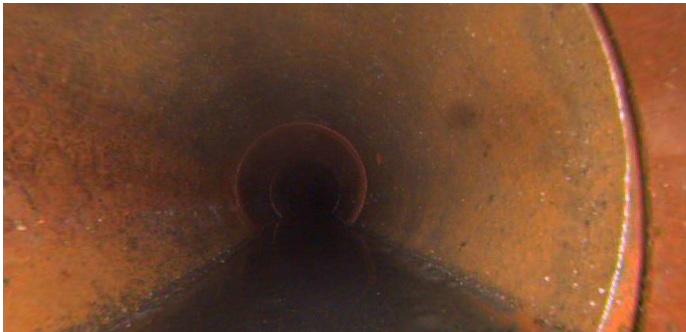
Code: **MWL**
Description: **Water Level**

Distance (ft): **.0**
Structural Grade: **0**
O&M Grade: **0**
Clock Start/From:
Clock To:
1st Value:
2nd Value:
Value Percent: **10.000**
Continuous Index:
Within 8" of Joint: **NO**
Remarks:

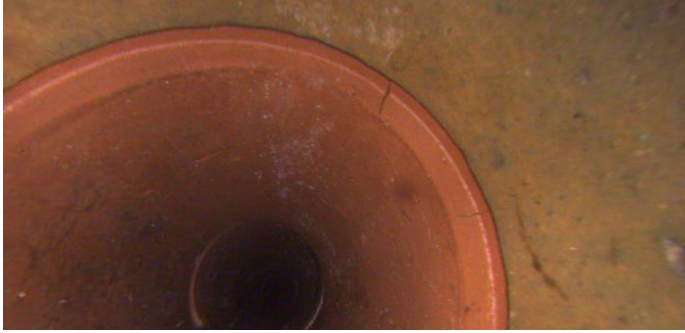
Code: **FM**
Description: **Fracture Multiple**

Distance (ft): **2.8**
Structural Grade: **4**
O&M Grade: **0**
Clock Start/From: **1**
Clock To: **3**
1st Value:
2nd Value:
Value Percent:
Continuous Index:
Within 8" of Joint: **YES**
Remarks:

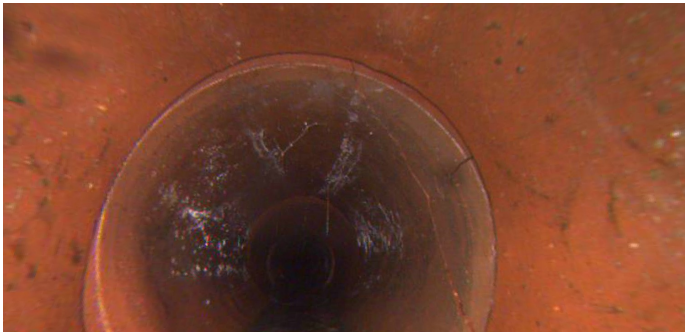
Code: **FM**
Description: **Fracture Multiple**

Distance (ft): **12.6**
Structural Grade: **4**
O&M Grade: **0**
Clock Start/From: **1**
Clock To: **4**
1st Value:
2nd Value:
Value Percent:
Continuous Index:
Within 8" of Joint: **YES**
Remarks:

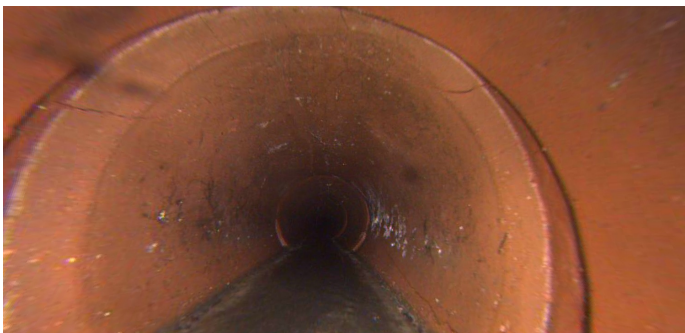
Code: **FM**
Description: **Fracture Multiple**

Distance (ft): **17.1**
Structural Grade: **4**
O&M Grade: **0**
Clock Start/From: **8**
Clock To: **4**
1st Value:
2nd Value:
Value Percent:
Continuous Index: **S01**
Within 8" of Joint: **YES**
Remarks:

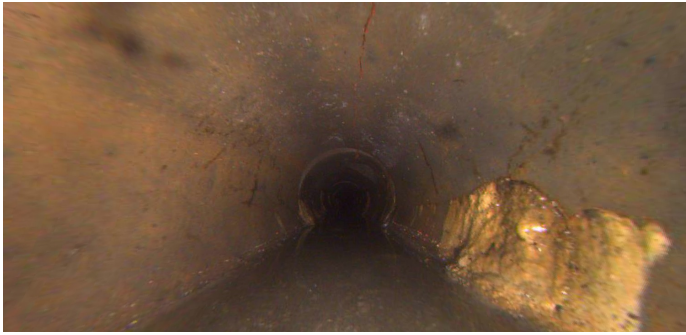
Code: **DAE**
Description: **Deposits Attached Encrustation**

Distance (ft): **35.7**
Structural Grade: **0**
O&M Grade: **2**
Clock Start/From: **3**
Clock To: **4**
1st Value:
2nd Value:
Value Percent: **5.000**
Continuous Index:
Within 8" of Joint: **NO**
Remarks:

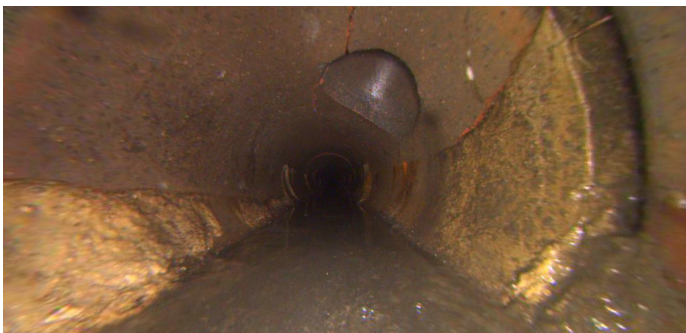
Code: **DAE**
Description: **Deposits Attached Encrustation**

Distance (ft): **37.5**
Structural Grade: **0**
O&M Grade: **2**
Clock Start/From: **8**
Clock To: **9**
1st Value:
2nd Value:
Value Percent: **5.000**
Continuous Index:
Within 8" of Joint: **YES**
Remarks:

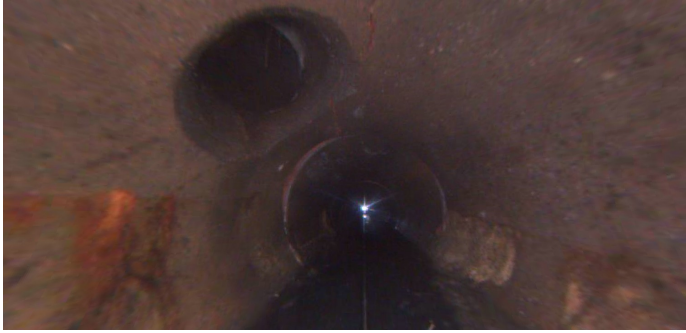
Code: **TF**
Description: **Tap Factory**

Distance (ft): **39.1**
Structural Grade: **0**
O&M Grade: **0**
Clock Start/From: **1**
Clock To:
1st Value: **4.000**
2nd Value:
Value Percent:
Continuous Index:
Within 8" of Joint:
Remarks:

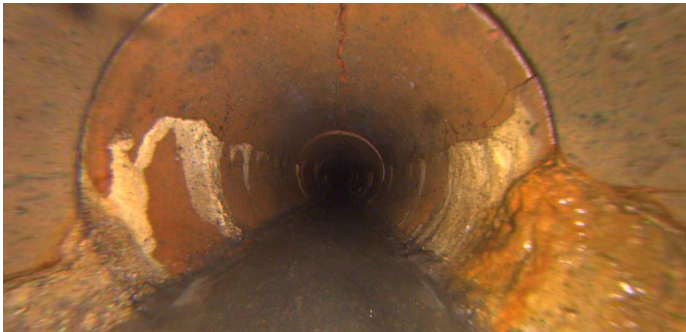
Code: **DAE**
Description: **Deposits Attached Encrustation**

Distance (ft): **39.3**
Structural Grade: **0**
O&M Grade: **2**
Clock Start/From: **8**
Clock To: **4**
1st Value:
2nd Value:
Value Percent: **5.000**
Continuous Index: **S02**
Within 8" of Joint: **YES**
Remarks:

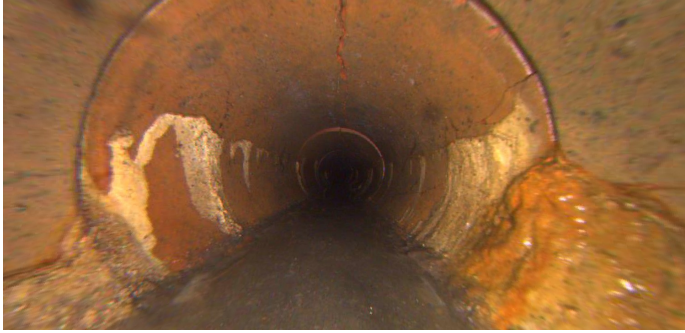
Code: **IW**
Description: **Infil Weeper**

Distance (ft): **39.3**
Structural Grade: **0**
O&M Grade: **2**
Clock Start/From: **8**
Clock To: **4**
1st Value:
2nd Value:
Value Percent:
Continuous Index: **S03**
Within 8" of Joint: **YES**
Remarks:

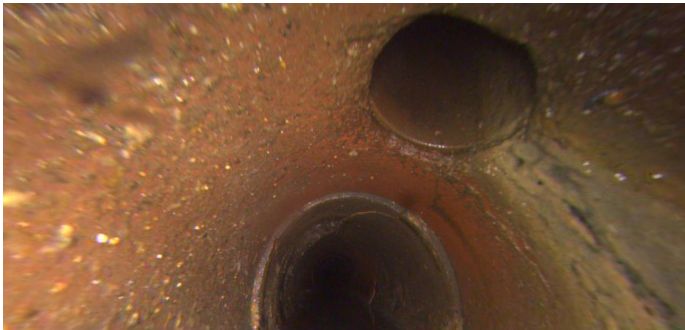
Code: **TBA**
Description: **Tap Break-in Active**

Distance (ft): **60.3**
Structural Grade: **0**
O&M Grade: **0**
Clock Start/From: **1**
Clock To:
1st Value: **4.000**
2nd Value:
Value Percent:
Continuous Index:
Within 8" of Joint:
Remarks:

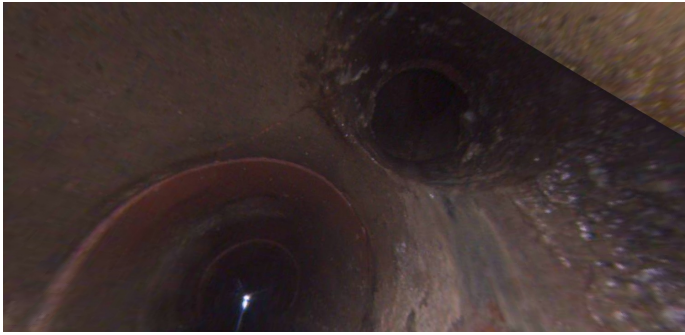
Code: **TF**
Description: **Tap Factory**

Distance (ft): **62.5**
Structural Grade: **0**
O&M Grade: **0**
Clock Start/From: **11**
Clock To:
1st Value: **4.000**
2nd Value:
Value Percent:
Continuous Index:
Within 8" of Joint:
Remarks:

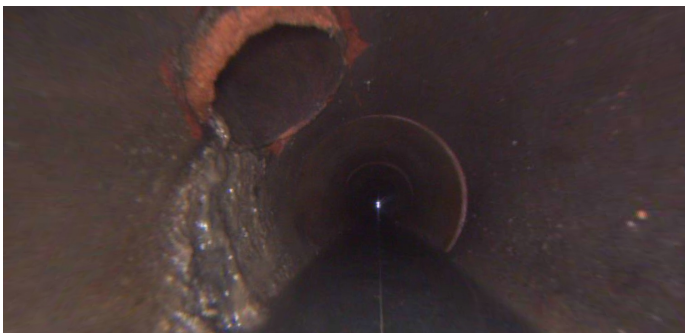
Code: **TBI**
Description: **Tap Break-in Intruding**

Distance (ft): **79.1**
Structural Grade: **0**
O&M Grade: **2**
Clock Start/From: **1**
Clock To:
1st Value: **4.000**
2nd Value: **1.000**
Value Percent:
Continuous Index:
Within 8" of Joint:
Remarks:

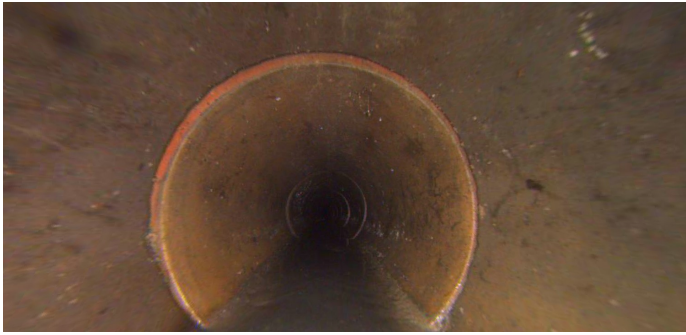
Code: **DAE**
Description: **Deposits Attached Encrustation**

Distance (ft): **79.1**
Structural Grade: **0**
O&M Grade: **2**
Clock Start/From: **8**
Clock To: **4**
1st Value:
2nd Value:
Value Percent: **5.000**
Continuous Index: **F02**
Within 8" of Joint: **YES**
Remarks:

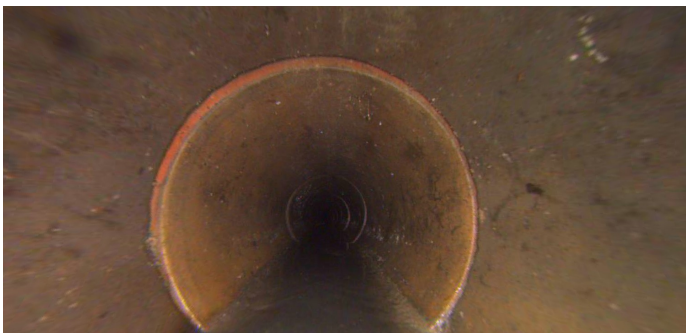
Code: **IW**
Description: **Infil Weeper**

Distance (ft): **79.1**
Structural Grade: **0**
O&M Grade: **2**
Clock Start/From: **8**
Clock To: **4**
1st Value:
2nd Value:
Value Percent:
Continuous Index: **F03**
Within 8" of Joint: **YES**
Remarks:

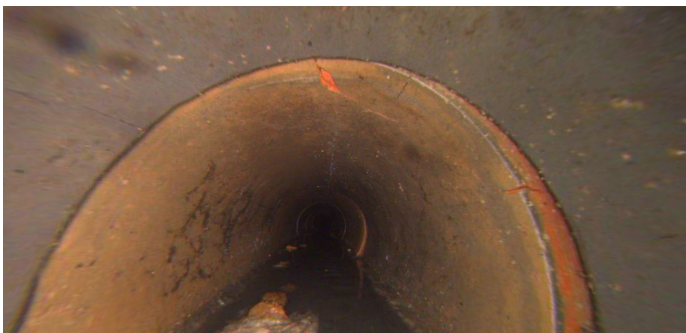
Code: **FM**
Description: **Fracture Multiple**

Distance (ft): **87.3**
Structural Grade: **4**
O&M Grade: **0**
Clock Start/From: **12**
Clock To: **3**
1st Value:
2nd Value:
Value Percent:
Continuous Index:
Within 8" of Joint: **YES**
Remarks:

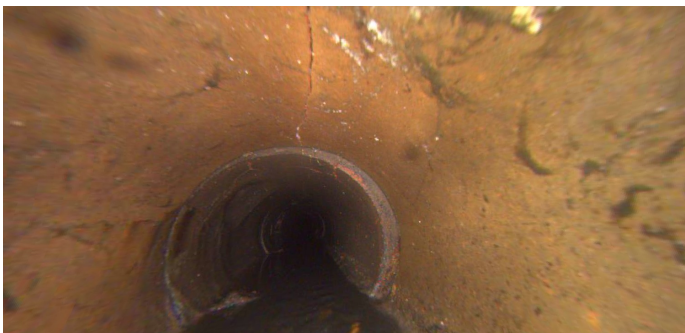
Code: **FM**
Description: **Fracture Multiple**

Distance (ft): **98.7**
Structural Grade: **4**
O&M Grade: **0**
Clock Start/From: **8**
Clock To: **4**
1st Value:
2nd Value:
Value Percent:
Continuous Index: **S04**
Within 8" of Joint: **YES**
Remarks:

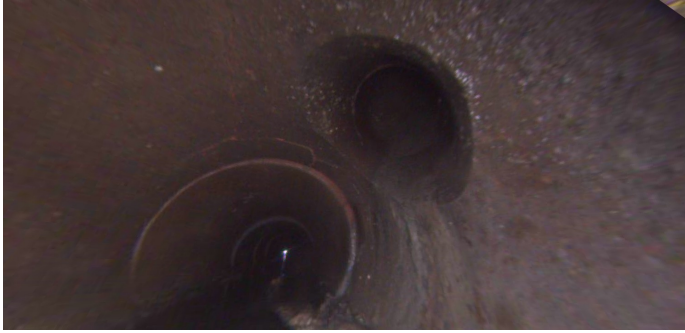
Code: **TF**
Description: **Tap Factory**

Distance (ft): **101.1**
Structural Grade: **0**
O&M Grade: **0**
Clock Start/From: **11**
Clock To:
1st Value: **4.000**
2nd Value:
Value Percent:
Continuous Index:
Within 8" of Joint:
Remarks:

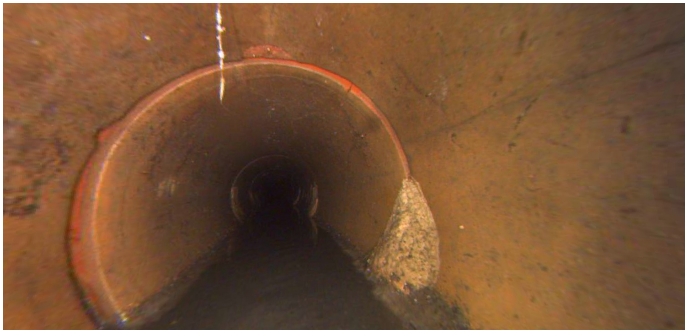
Code: **DAE**
Description: **Deposits Attached Encrustation**

Distance (ft): **109.1**
Structural Grade: **0**
O&M Grade: **2**
Clock Start/From: **8**
Clock To: **4**
1st Value:
2nd Value:
Value Percent: **5.000**
Continuous Index: **S05**
Within 8" of Joint: **YES**
Remarks:

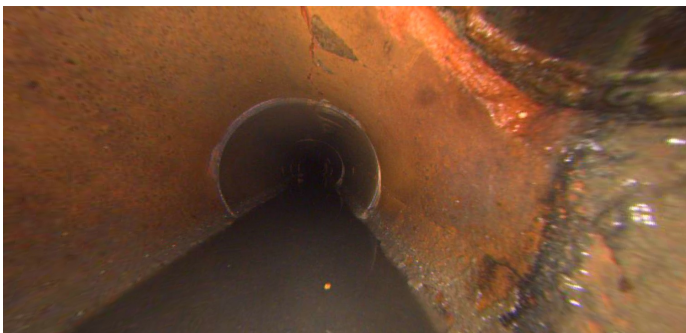
Code: **DAE**
Description: **Deposits Attached Encrustation**

Distance (ft): **120.5**
Structural Grade: **0**
O&M Grade: **2**
Clock Start/From: **8**
Clock To: **4**
1st Value:
2nd Value:
Value Percent: **5.000**
Continuous Index: **F05**
Within 8" of Joint: **YES**
Remarks:

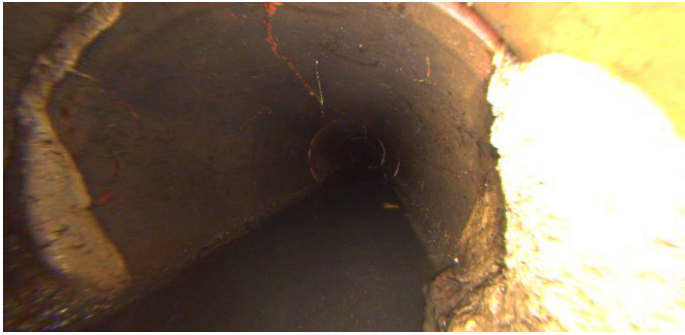
Code: **DAE**
Description: **Deposits Attached Encrustation**

Distance (ft): **127.6**
Structural Grade: **0**
O&M Grade: **2**
Clock Start/From: **8**
Clock To: **4**
1st Value:
2nd Value:
Value Percent: **5.000**
Continuous Index:
Within 8" of Joint: **YES**
Remarks:

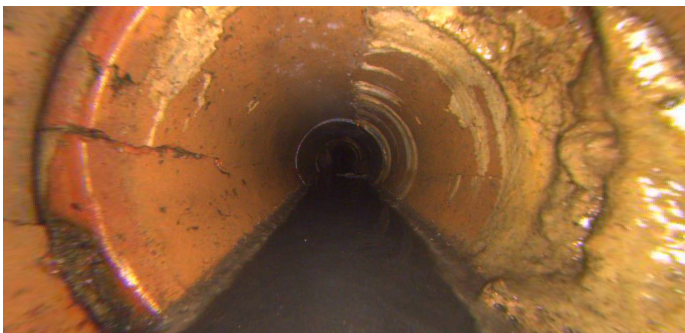
Code: **DAE**
Description: **Deposits Attached Encrustation**

Distance (ft): **135.5**
Structural Grade: **0**
O&M Grade: **2**
Clock Start/From: **12**
Clock To: **4**
1st Value:
2nd Value:
Value Percent: **10.000**
Continuous Index:
Within 8" of Joint: **YES**
Remarks:

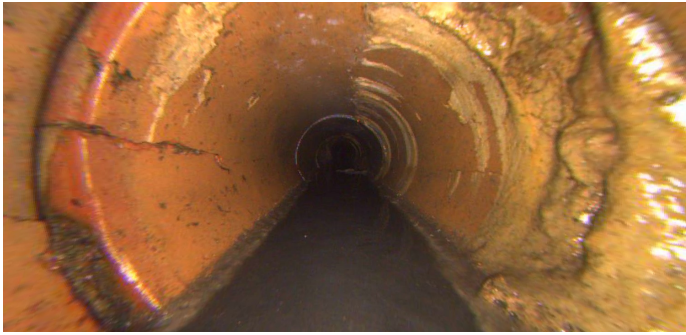
Code: **IW**
Description: **Infil Weeper**

Distance (ft): **135.5**
Structural Grade: **0**
O&M Grade: **2**
Clock Start/From: **12**
Clock To: **4**
1st Value:
2nd Value:
Value Percent:
Continuous Index:
Within 8" of Joint: **YES**
Remarks:

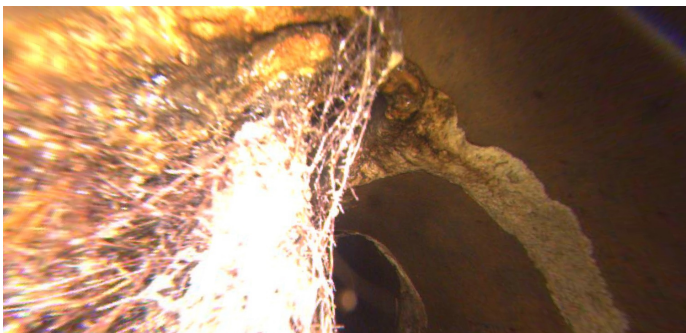
Code: **TBD**
Description: **Tap Break-in Defective**

Distance (ft): **140.4**
Structural Grade: **0**
O&M Grade: **3**
Clock Start/From: **11**
Clock To:
1st Value: **4.000**
2nd Value:
Value Percent:
Continuous Index:
Within 8" of Joint:
Remarks: **ROOTS**

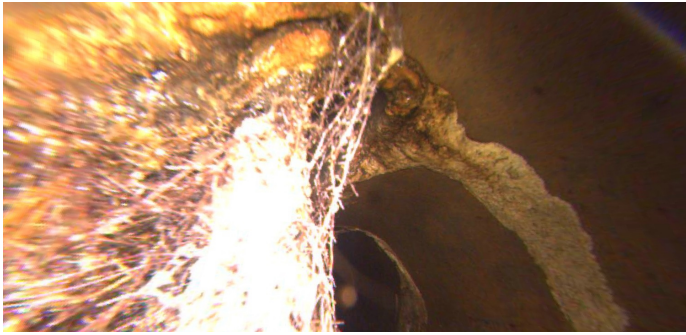
Code: **RML**
Description: **Roots Medium Lateral**

Distance (ft): **140.4**
Structural Grade: **0**
O&M Grade: **3**
Clock Start/From: **6**
Clock To: **11**
1st Value:
2nd Value:
Value Percent: **20.000**
Continuous Index:
Within 8" of Joint: **NO**
Remarks:

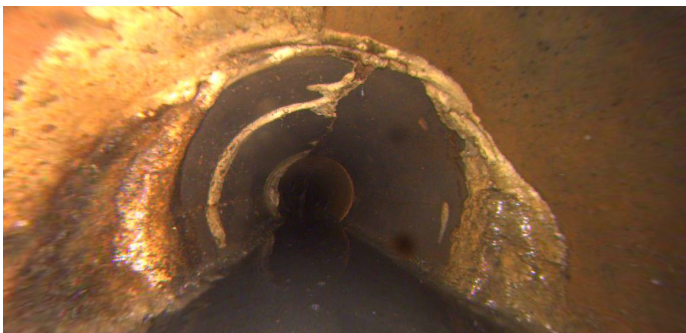
Code: **DAE**
Description: **Deposits Attached Encrustation**

Distance (ft): **141.3**
Structural Grade: **0**
O&M Grade: **2**
Clock Start/From: **8**
Clock To: **4**
1st Value:
2nd Value:
Value Percent: **10.000**
Continuous Index: **S06**
Within 8" of Joint: **YES**
Remarks:

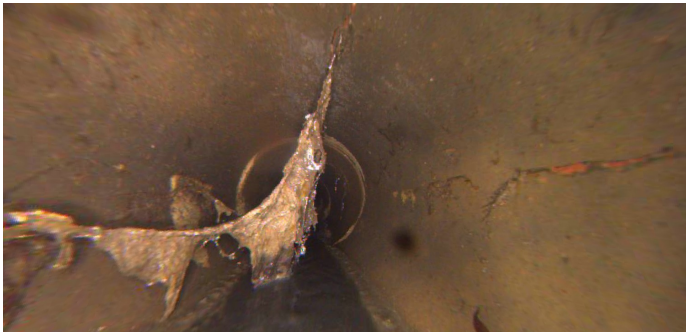
Code: **RMB**
Description: **Roots Medium Barrel**

Distance (ft): **148.2**
Structural Grade: **0**
O&M Grade: **4**
Clock Start/From: **9**
Clock To: **12**
1st Value:
2nd Value:
Value Percent: **10.000**
Continuous Index:
Within 8" of Joint: **NO**
Remarks:

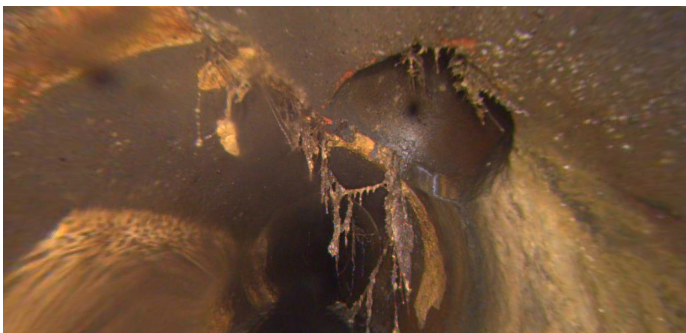
Code: **TBD**
Description: **Tap Break-in Defective**

Distance (ft): **158.3**
Structural Grade: **0**
O&M Grade: **3**
Clock Start/From: **1**
Clock To:
1st Value: **4.000**
2nd Value:
Value Percent:
Continuous Index:
Within 8" of Joint:
Remarks: **ROOTS**

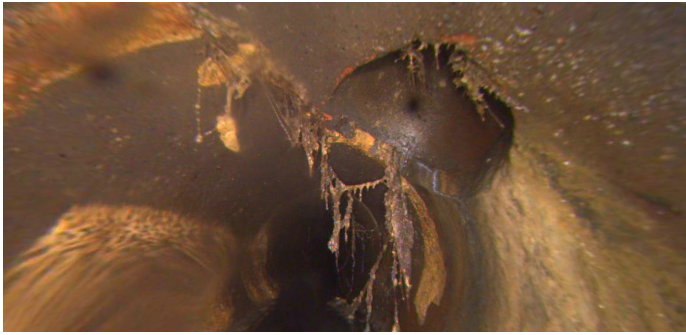
Code: **RFB**
Description: **Roots Fine Barrel**

Distance (ft): **158.3**
Structural Grade: **0**
O&M Grade: **2**
Clock Start/From: **12**
Clock To: **1**
1st Value:
2nd Value:
Value Percent:
Continuous Index:
Within 8" of Joint: **NO**
Remarks:

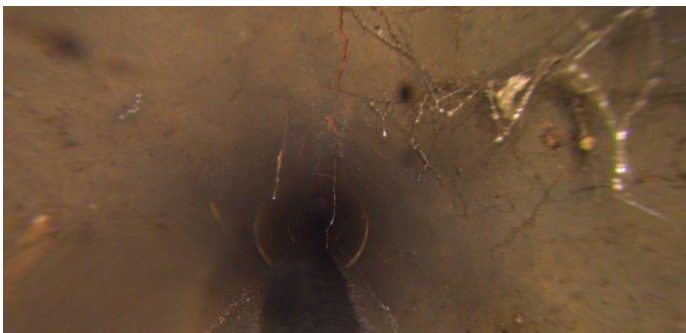
Code: **RFB**
Description: **Roots Fine Barrel**

Distance (ft): **160.0**
Structural Grade: **0**
O&M Grade: **2**
Clock Start/From: **12**
Clock To: **3**
1st Value:
2nd Value:
Value Percent:
Continuous Index:
Within 8" of Joint: **NO**
Remarks:

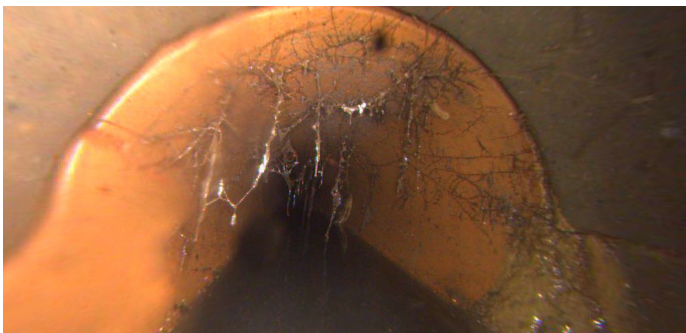
Code: **RFJ**
Description: **Roots Fine Joint**

Distance (ft): **171.8**
Structural Grade: **0**
O&M Grade: **1**
Clock Start/From: **8**
Clock To: **4**
1st Value:
2nd Value:
Value Percent:
Continuous Index:
Within 8" of Joint: **YES**
Remarks:

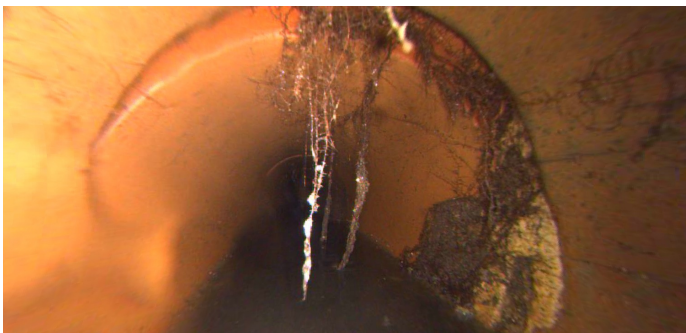
Code: **RMJ**
Description: **Roots Medium Joint**

Distance (ft): **173.7**
Structural Grade: **0**
O&M Grade: **3**
Clock Start/From: **12**
Clock To: **4**
1st Value:
2nd Value:
Value Percent: **5.000**
Continuous Index:
Within 8" of Joint: **YES**
Remarks:

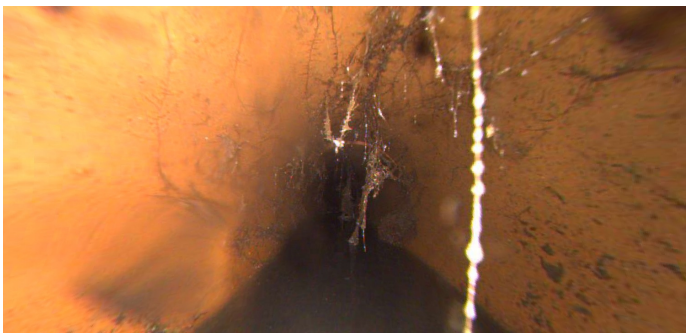
Code: **RFB**
Description: **Roots Fine Barrel**

Distance (ft): **176.5**
Structural Grade: **0**
O&M Grade: **2**
Clock Start/From: **12**
Clock To:
1st Value:
2nd Value:
Value Percent:
Continuous Index:
Within 8" of Joint: **NO**
Remarks:

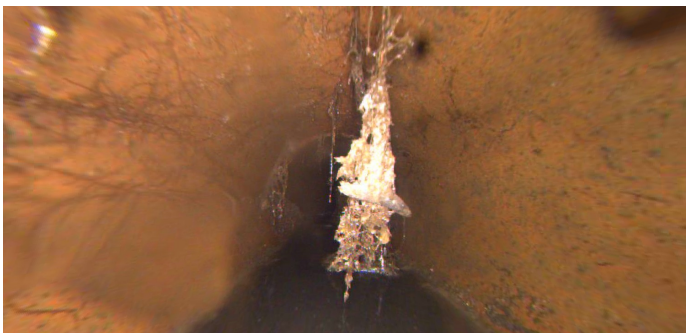
Code: **RMB**
Description: **Roots Medium Barrel**

Distance (ft): **178.6**
Structural Grade: **0**
O&M Grade: **4**
Clock Start/From: **12**
Clock To:
1st Value:
2nd Value:
Value Percent: **10.000**
Continuous Index:
Within 8" of Joint: **NO**
Remarks:
