Profile/Photo Observation Report

Street:	W 2ND ST & S ASH ST	Flow Control:	Not Controlled
City:	Hobart, IN	Year Renewed:	
Location:	Other	Tape/Media #:	
Purpose:	Not Known	Dia/Height:	12"
Use:	Sanitary	Material:	VCP
Drain Area:	NA	Lining:	
Category:	NA		
Comment:

Location Details:		Direction of Survey:	Upstream
US MH:	M-605-027	DS MH:	M-605-028
		Total Length Surveyed (ft):	.4

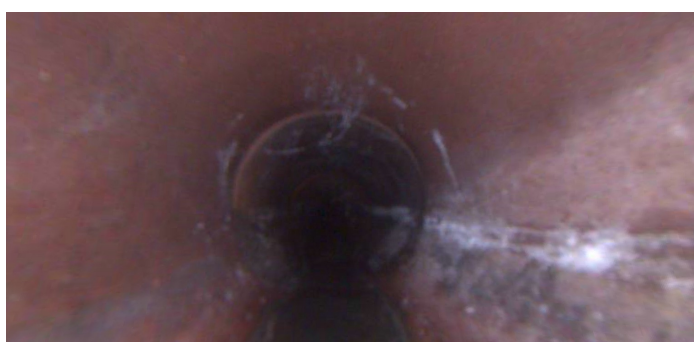
Code: **AMH**
Description: **Manhole**

Distance (ft): **.0**
Structural Grade: **0**
O&M Grade: **0**
Clock Start/From:
Clock To:
1st Value:
2nd Value:
Value Percent:
Continuous Index:
Within 8" of Joint: **NO**
Remarks: **M-605-028**

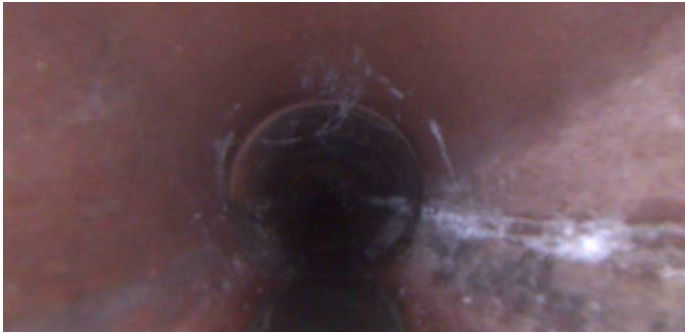
Code:	MWL
Description:	Water Level

Distance (ft):	.0
Structural Grade:	0
O&M Grade:	0
Clock Start/From:	
Clock To:	
1st Value:	
2nd Value:	
Value Percent:	5.000
Continuous Index:	
Within 8" of Joint:	NO
Remarks:

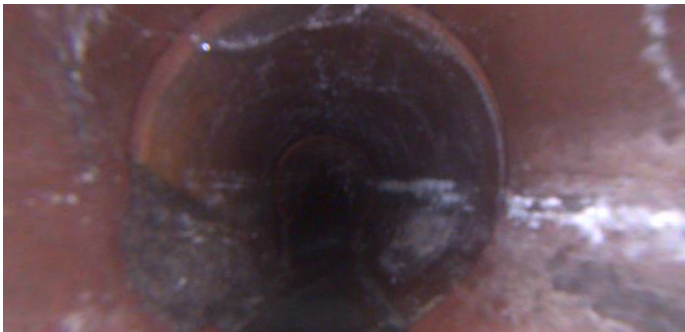
Code:	RMJ
Description:	Roots Medium Joint

Distance (ft):	.4
Structural Grade:	0
O&M Grade:	3
Clock Start/From:	8
Clock To:	4
1st Value:	
2nd Value:	
Value Percent:	10.000
Continuous Index:	
Within 8" of Joint:	YES
Remarks:

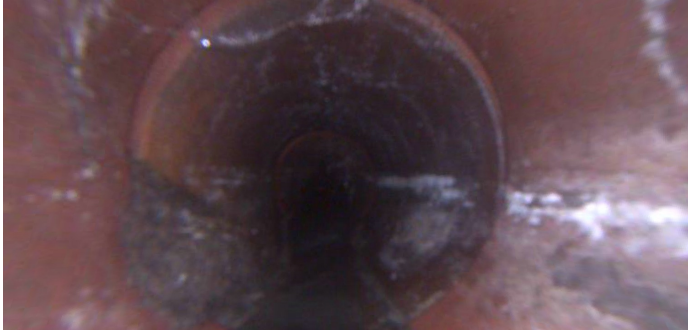
Code:	MSA
Description:	Abandoned Survey
Distance (ft):	.4
Structural Grade:	0
O&M Grade:	0
Clock Start/From:	
Clock To:	
1st Value:	
2nd Value:	
Value Percent:	
Continuous Index:	
Within 8" of Joint:	NO
Remarks:	debris
