## Profile/Photo Observation Report

Street:	<b>S Ash St.</b>	Flow Control:	<b>Not Controlled</b>
City:	<b>Hobart, IN</b>	Year Renewed:	
Location:	<b>Other</b>	Tape/Media #:	
Purpose:	<b>Not Known</b>	Dia/Height:	<b>12"</b>
Use:	<b>Sanitary</b>	Material:	<b>VCP</b>
Drain Area:	<b>NA</b>	Lining:	
Category:	<b>NA</b>		
Comment:

Location Details:		Direction of Survey:	<b>Upstream</b>
US MH:	<b>M-605-027</b>	DS MH:	<b>M-605-028</b>
		Total Length Surveyed (ft):	<b>.4</b>

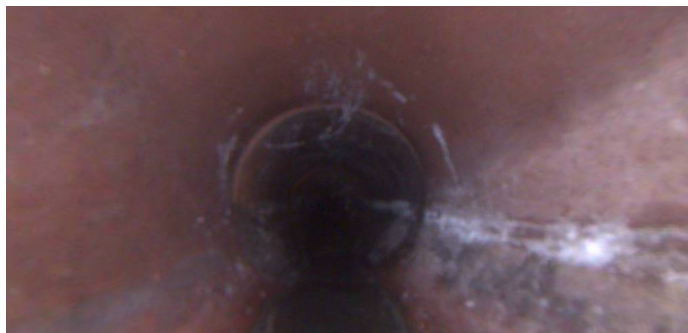
Code: **AMH**  
Description: **Manhole**

Distance (ft): **.0**  
Structural Grade: **0**  
O&M Grade: **0**  
Clock Start/From:  
Clock To:  
1st Value:  
2nd Value:  
Value Percent:  
Continuous Index:  
Within 8" of Joint: **NO**  
Remarks: **M-605-028**

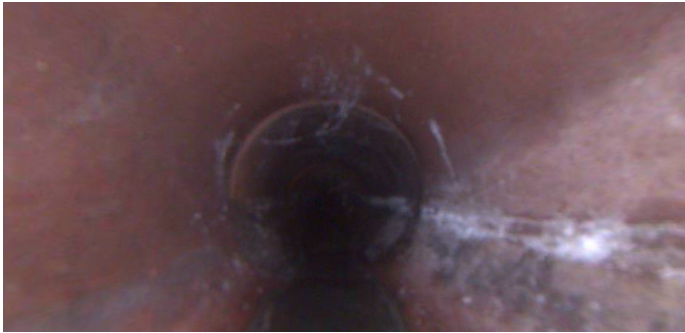
Code:	<b>MWL</b>
Description:	<b>Water Level</b>

Distance (ft):	<b>.0</b>
Structural Grade:	<b>0</b>
O&M Grade:	<b>0</b>
Clock Start/From:	
Clock To:	
1st Value:	
2nd Value:	
Value Percent:	<b>5.000</b>
Continuous Index:	
Within 8" of Joint:	<b>NO</b>
Remarks:

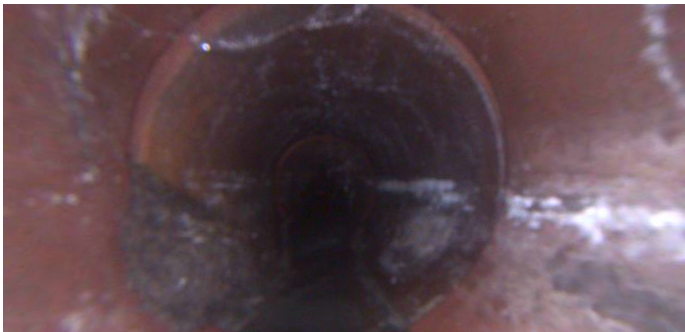
Code:	<b>RMJ</b>
Description:	<b>Roots Medium Joint</b>

Distance (ft):	<b>.4</b>
Structural Grade:	<b>0</b>
O&M Grade:	<b>3</b>
Clock Start/From:	<b>8</b>
Clock To:	<b>4</b>
1st Value:	
2nd Value:	
Value Percent:	<b>10.000</b>
Continuous Index:	
Within 8" of Joint:	<b>YES</b>
Remarks:

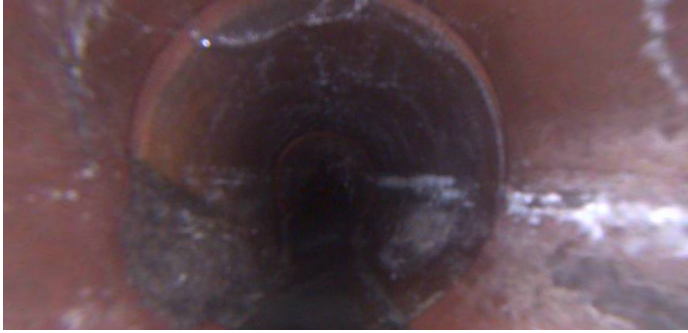
Code:	<b>MSA</b>
Description:	<b>Abandoned Survey</b>
Distance (ft):	<b>.4</b>
Structural Grade:	<b>0</b>
O&M Grade:	<b>0</b>
Clock Start/From:	
Clock To:	
1st Value:	
2nd Value:	
Value Percent:	
Continuous Index:	
Within 8" of Joint:	<b>NO</b>
Remarks:	<b>debris</b>
