## Profile/Photo Observation Report

Date:	<b>04/26/2018</b>	Weather:		Coding:	<b>PACP 6.0</b>
Pipe Length (ft):		Owner:	<b>City of Hobart</b>	Pre Clean:	<b>No Pre-Cleaning</b>
P.O.#:	<b>106</b>	Surveyor:	<b>M. Pielacha</b>	PSR:	<b>P-605-031-030</b>
Customer:	<b>City of Hobart</b>	Clean Date:		Shape:	<b>C</b>

Street:	<b>Connecticut Street</b>	Flow Control:	<b>Not Controlled</b>
City:	<b>Hobart, IN</b>	Year Renewed:	
Location:	<b>Light Highway</b>	Tape/Media #:	<b>DEP 106</b>
Purpose:	<b>Routine Assessment</b>	Dia/Height:	<b>18"</b>
Use:	<b>Sanitary</b>	Material:	<b>VCP</b>
Drain Area:		Lining:	
Category:	<b>NA</b>		
Comment:	<b>YES501824 Submittal 2</b>		
Location Details:		Direction of Survey:	<b>Upstream</b>
US MH:	<b>M-605-031</b>	DS MH:	<b>M-605-030</b>
		Total Length Surveyed (ft):	<b>276.8</b>

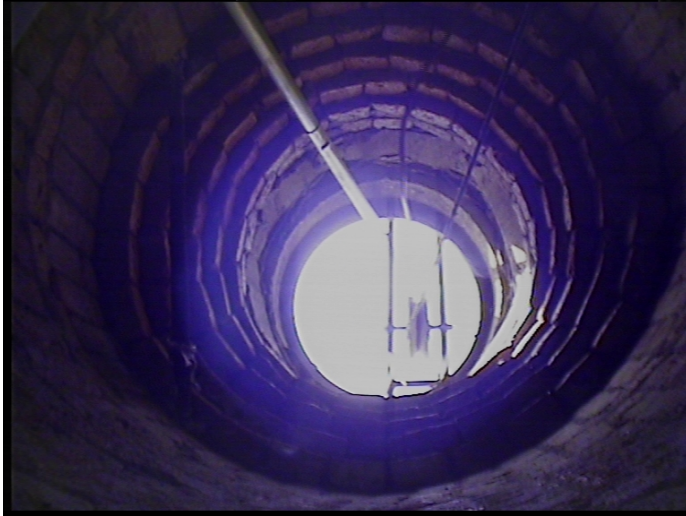
Code: **AMH**  
Description: **Manhole**

Distance (ft): **.0**  
Structural Grade: **0**  
O&M Grade: **0**  
Clock Start/From:  
Clock To:  
1st Value:  
2nd Value:  
Value Percent:  
Continuous Index:  
Within 8" of Joint: **NO**  
Remarks: **M-605-030**

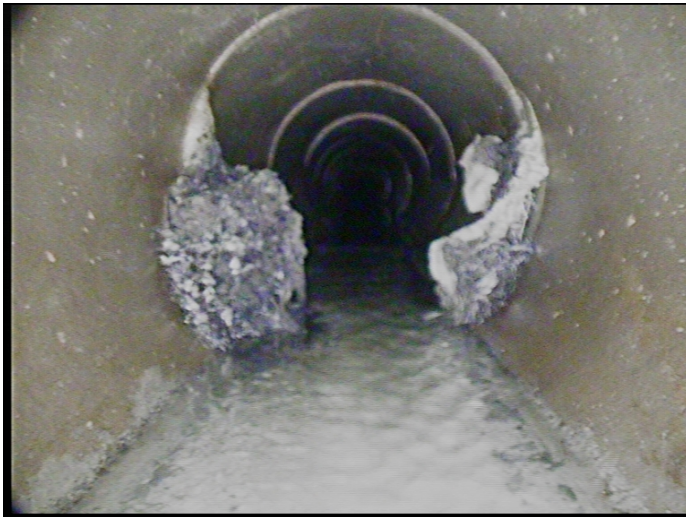
Code: **MWL**  
Description: **Water Level**

Distance (ft): **.0**  
Structural Grade: **0**  
O&M Grade: **0**  
Clock Start/From:  
Clock To:  
1st Value:  
2nd Value:  
Value Percent: **5.000**  
Continuous Index:  
Within 8" of Joint: **NO**  
Remarks:

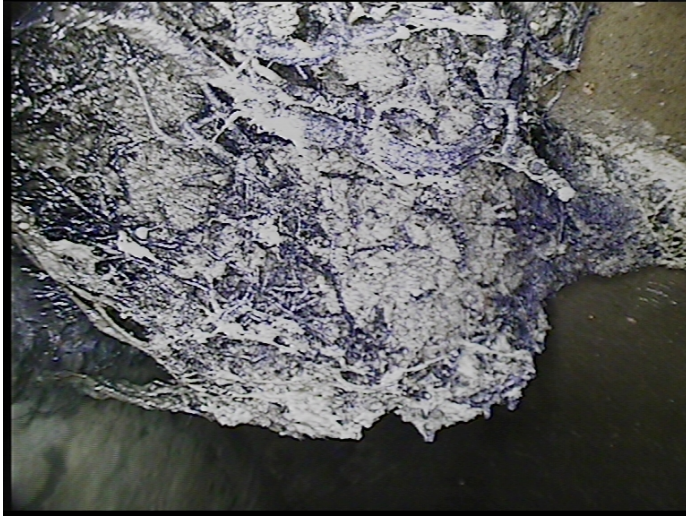
Code:	<b>RMJ</b>
Description:	<b>Roots Medium Joint</b>
Distance (ft):	<b>4.0</b>
Structural Grade:	<b>0</b>
O&M Grade:	<b>3</b>
Clock Start/From:	<b>8</b>
Clock To:	<b>4</b>
1st Value:	
2nd Value:	
Value Percent:	<b>20.000</b>
Continuous Index:	
Within 8" of Joint:	<b>YES</b>
Remarks:

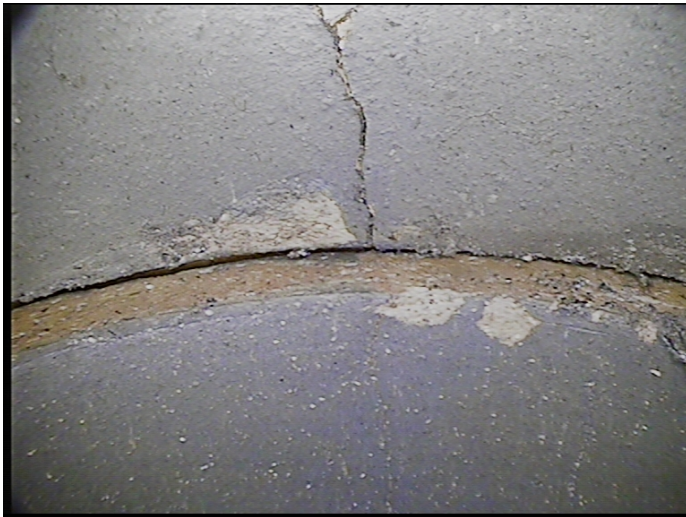
Code:	<b>FL</b>
Description:	<b>Fracture Longitudinal</b>
Distance (ft):	<b>6.2</b>
Structural Grade:	<b>3</b>
O&M Grade:	<b>0</b>
Clock Start/From:	<b>12</b>
Clock To:	
1st Value:	
2nd Value:	
Value Percent:	
Continuous Index:	<b>S01</b>
Within 8" of Joint:	<b>YES</b>
Remarks:

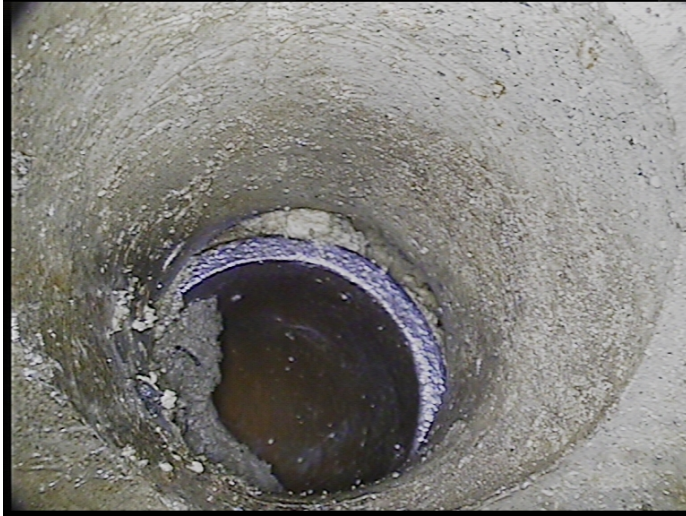
Code: **TF**  
Description: **Tap Factory**

Distance (ft): **23.4**  
Structural Grade: **0**  
O&M Grade: **0**  
Clock Start/From: **10**  
Clock To:  
1st Value: **4.000**  
2nd Value:  
Value Percent:  
Continuous Index:  
Within 8" of Joint: **NO**  
Remarks:

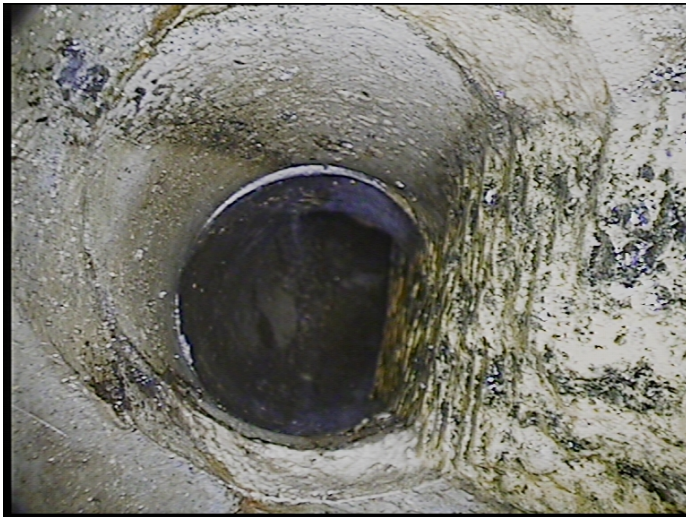
Code: **TF**  
Description: **Tap Factory**

Distance (ft): **26.1**  
Structural Grade: **0**  
O&M Grade: **0**  
Clock Start/From: **3**  
Clock To:  
1st Value: **4.000**  
2nd Value:  
Value Percent:  
Continuous Index:  
Within 8" of Joint: **NO**  
Remarks:

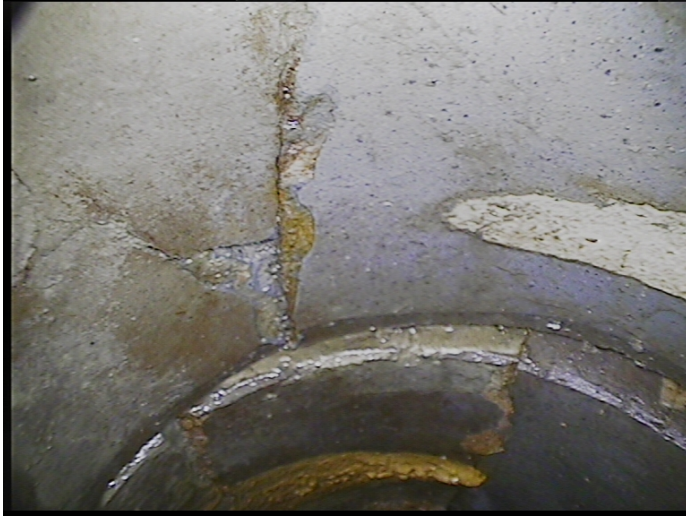
Code: **CL**  
Description: **Crack Longitudinal**

Distance (ft): **29.0**  
Structural Grade: **2**  
O&M Grade: **0**  
Clock Start/From: **9**  
Clock To:  
1st Value:  
2nd Value:  
Value Percent:  
Continuous Index: **S02**  
Within 8" of Joint: **YES**  
Remarks:

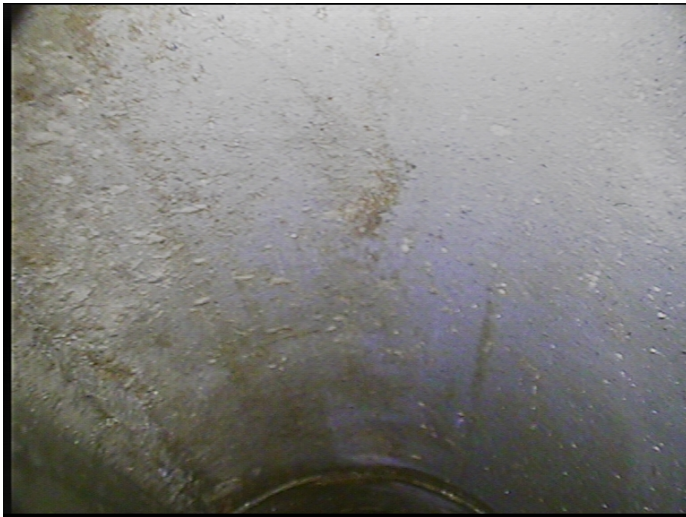
Code: **CL**  
Description: **Crack Longitudinal**

Distance (ft): **37.0**  
Structural Grade: **2**  
O&M Grade: **0**  
Clock Start/From: **9**  
Clock To:  
1st Value:  
2nd Value:  
Value Percent:  
Continuous Index: **F02**  
Within 8" of Joint: **NO**  
Remarks:

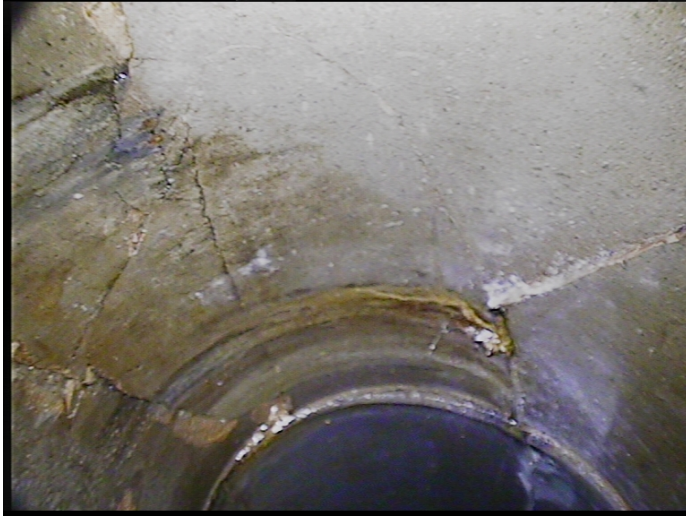
Code: **FM**  
Description: **Fracture Multiple**

Distance (ft): **40.7**  
Structural Grade: **4**  
O&M Grade: **0**  
Clock Start/From: **9**  
Clock To: **3**  
1st Value:  
2nd Value:  
Value Percent:  
Continuous Index:  
Within 8" of Joint: **YES**  
Remarks:

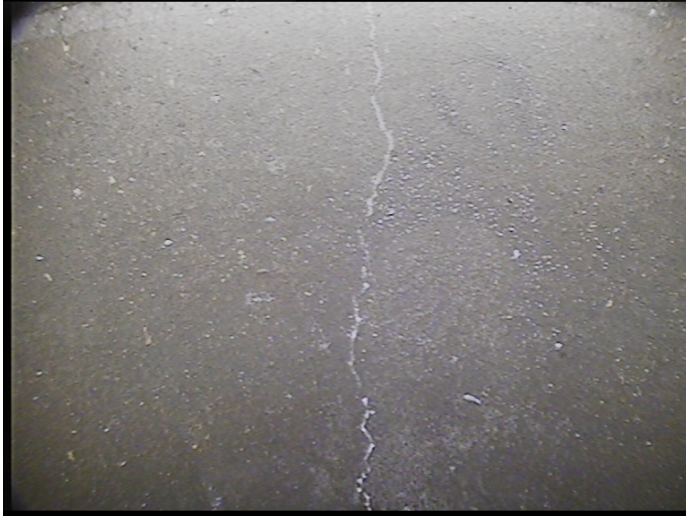
Code:	<b>CL</b>
Description:	<b>Crack Longitudinal</b>
Distance (ft):	<b>87.8</b>
Structural Grade:	<b>2</b>
O&M Grade:	<b>0</b>
Clock Start/From:	<b>12</b>
Clock To:	
1st Value:	
2nd Value:	
Value Percent:	
Continuous Index:	
Within 8" of Joint:	<b>YES</b>
Remarks:

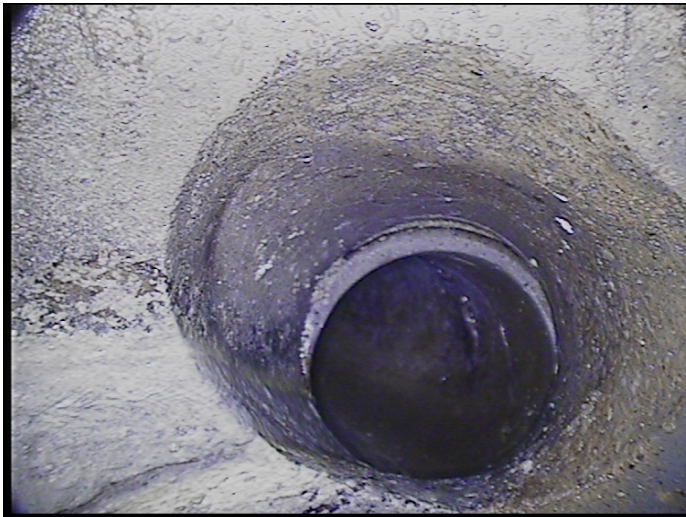
Code:	<b>TF</b>
Description:	<b>Tap Factory</b>
Distance (ft):	<b>101.5</b>
Structural Grade:	<b>0</b>
O&M Grade:	<b>0</b>
Clock Start/From:	<b>10</b>
Clock To:	
1st Value:	<b>4.000</b>
2nd Value:	
Value Percent:	
Continuous Index:	
Within 8" of Joint:	<b>NO</b>
Remarks:

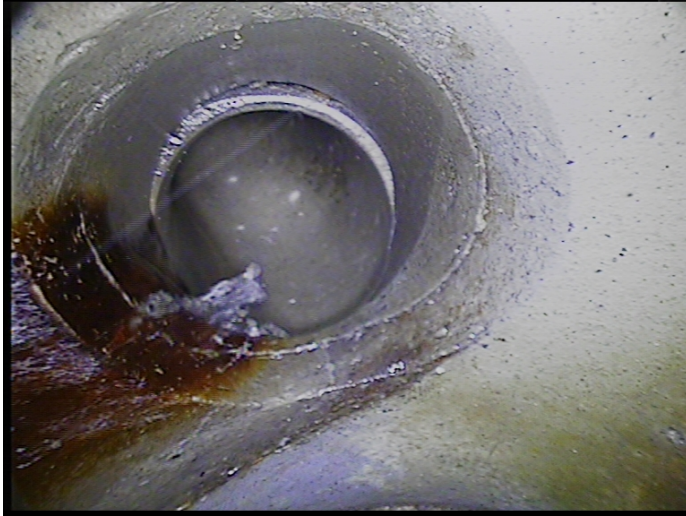
Code: **TFA**  
Description: **Tap Factory Active**

Distance (ft): **131.2**  
Structural Grade: **0**  
O&M Grade: **0**  
Clock Start/From: **10**  
Clock To:  
1st Value: **4.000**  
2nd Value:  
Value Percent:  
Continuous Index:  
Within 8" of Joint: **NO**  
Remarks:

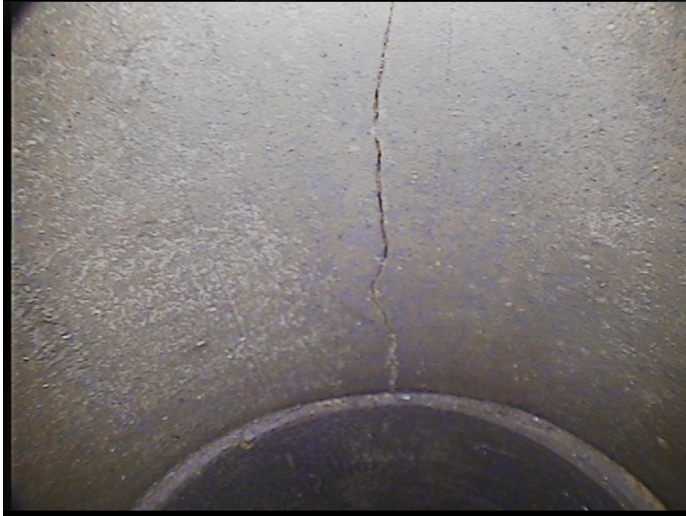
Code: **FL**  
Description: **Fracture Longitudinal**

Distance (ft): **182.0**  
Structural Grade: **3**  
O&M Grade: **0**  
Clock Start/From: **12**  
Clock To:  
1st Value:  
2nd Value:  
Value Percent:  
Continuous Index:  
Within 8" of Joint: **YES**  
Remarks:

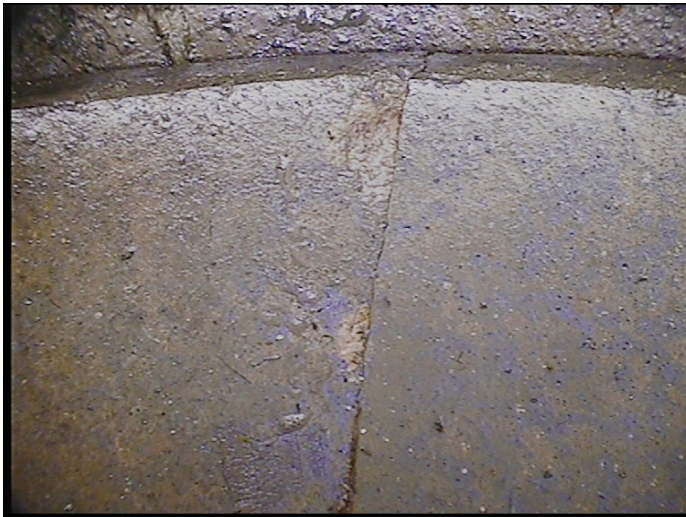
Code: **CL**  
Description: **Crack Longitudinal**

Distance (ft): **186.8**  
Structural Grade: **2**  
O&M Grade: **0**  
Clock Start/From: **9**  
Clock To:  
1st Value:  
2nd Value:  
Value Percent:  
Continuous Index:  
Within 8" of Joint: **YES**  
Remarks:

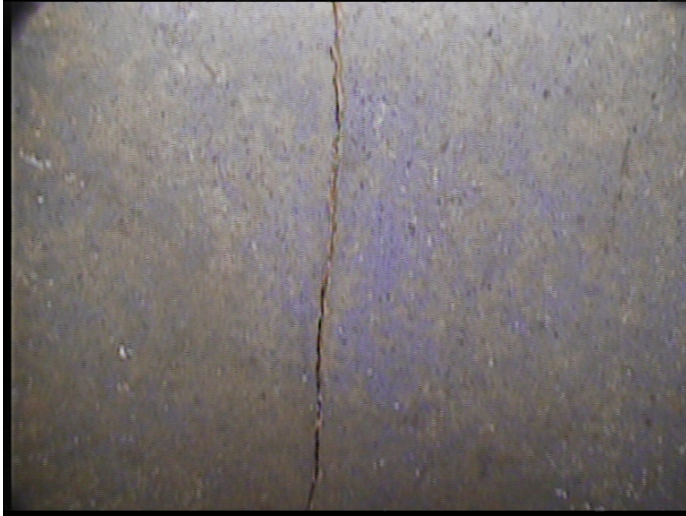
Code: **FL**  
Description: **Fracture Longitudinal**

Distance (ft): **186.8**  
Structural Grade: **3**  
O&M Grade: **0**  
Clock Start/From: **12**  
Clock To:  
1st Value:  
2nd Value:  
Value Percent:  
Continuous Index: **S03**  
Within 8" of Joint: **YES**  
Remarks:

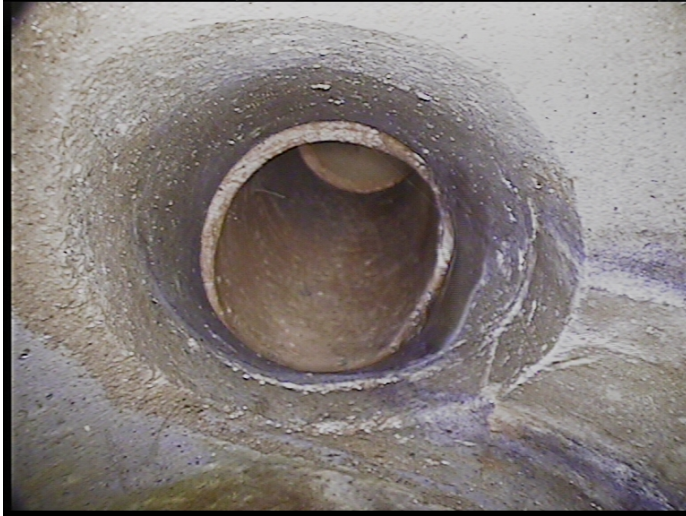
Code: **TF**  
Description: **Tap Factory**

Distance (ft): **227.1**  
Structural Grade: **0**  
O&M Grade: **0**  
Clock Start/From: **2**  
Clock To:  
1st Value: **4.000**  
2nd Value:  
Value Percent:  
Continuous Index:  
Within 8" of Joint: **NO**  
Remarks:

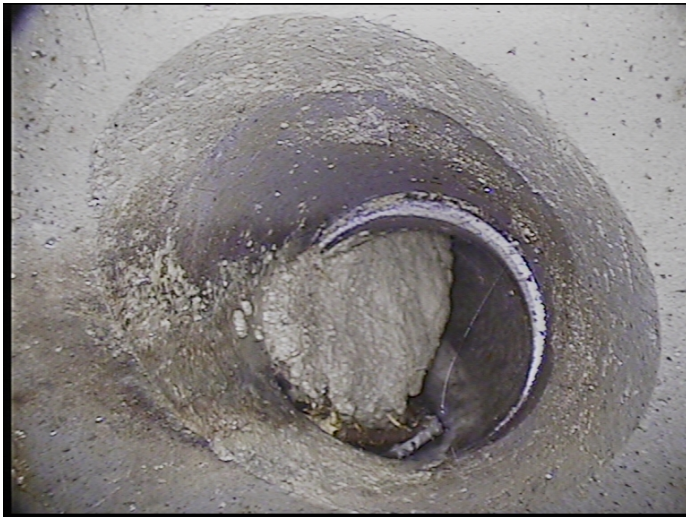
Code: **TF**  
Description: **Tap Factory**

Distance (ft): **257.3**  
Structural Grade: **0**  
O&M Grade: **0**  
Clock Start/From: **10**  
Clock To:  
1st Value: **4.000**  
2nd Value:  
Value Percent:  
Continuous Index:  
Within 8" of Joint: **NO**  
Remarks:

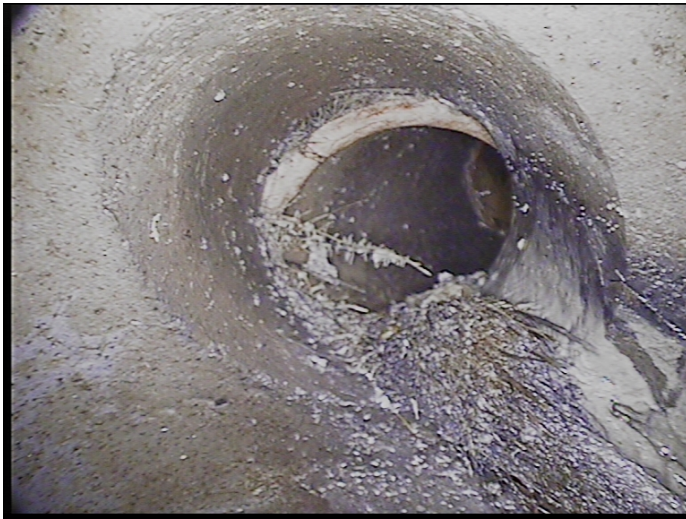
Code: **TFD**  
Description: **Tap Factory Defective**

Distance (ft): **269.3**  
Structural Grade: **0**  
O&M Grade: **2**  
Clock Start/From: **2**  
Clock To:  
1st Value: **4.000**  
2nd Value:  
Value Percent:  
Continuous Index:  
Within 8" of Joint: **NO**  
Remarks: **Defective**

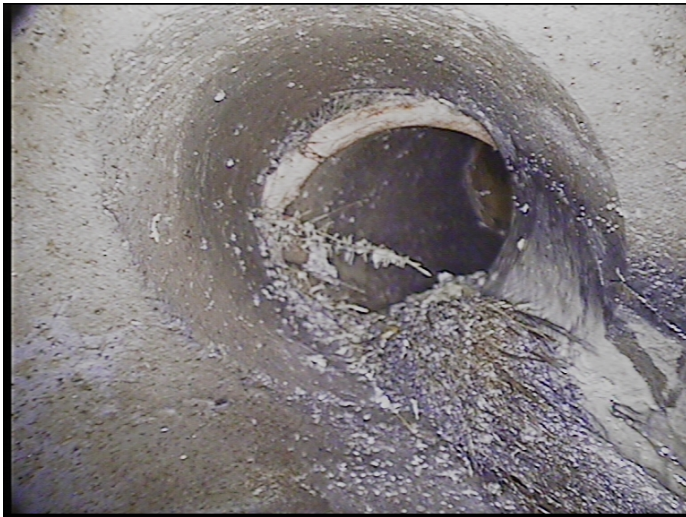
Code: **RFJ**  
Description: **Roots Fine Joint**

Distance (ft): **269.3**  
Structural Grade: **0**  
O&M Grade: **1**  
Clock Start/From: **1**  
Clock To:  
1st Value:  
2nd Value:  
Value Percent:  
Continuous Index:  
Within 8" of Joint: **YES**  
Remarks:

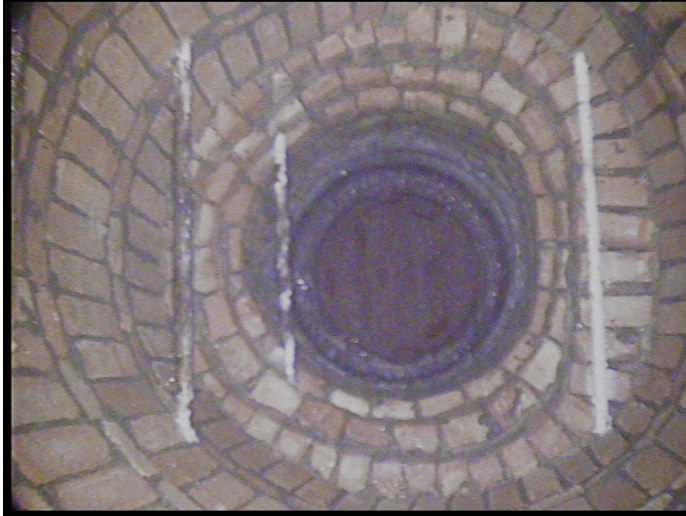
Code: **FL**  
Description: **Fracture Longitudinal**

Distance (ft): **276.7**  
Structural Grade: **3**  
O&M Grade: **0**  
Clock Start/From: **12**  
Clock To:  
1st Value:  
2nd Value:  
Value Percent:  
Continuous Index: **F03**  
Within 8" of Joint: **NO**  
Remarks:

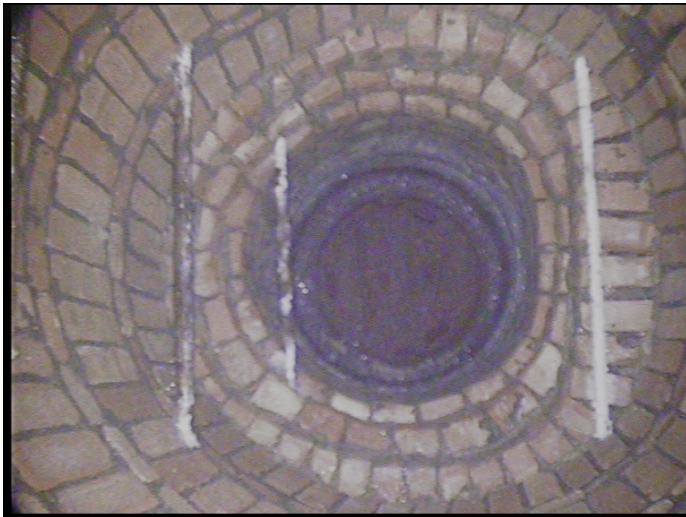
Code: **AMH**  
Description: **Manhole**

Distance (ft): **276.7**  
Structural Grade: **0**  
O&M Grade: **0**  
Clock Start/From:  
Clock To:  
1st Value:  
2nd Value:  
Value Percent:  
Continuous Index:  
Within 8" of Joint: **NO**  
Remarks: **M-605-031**
