Profile/Photo Observation Report

Street:	Connecticut Street	Flow Control:	Not Controlled
City:	Hobart, IN	Year Renewed:	
Location:	Light Highway	Tape/Media #:	DEP 60
Purpose:	Routine Assessment	Dia/Height:	18"
Use:	Sanitary	Material:	VCP
Drain Area:		Lining:	
Category:	NA		
Comment:			
Location Details:		Direction of Survey:	Upstream
US MH:	M-605-032	DS MH:	M-605-033
		Total Length Surveyed (ft):	238.1

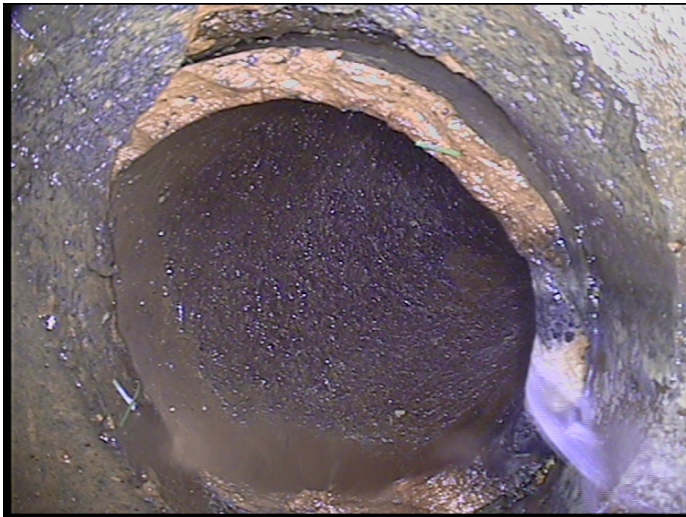
Code: **TBA**
Description: **Tap Break-in Active**

Distance (ft): **33.5**
Structural Grade: **0**
O&M Grade: **0**
Clock Start/From: **2**
Clock To:
1st Value: **4.000**
2nd Value:
Value Percent:
Continuous Index:
Within 8" of Joint: **NO**
Remarks:

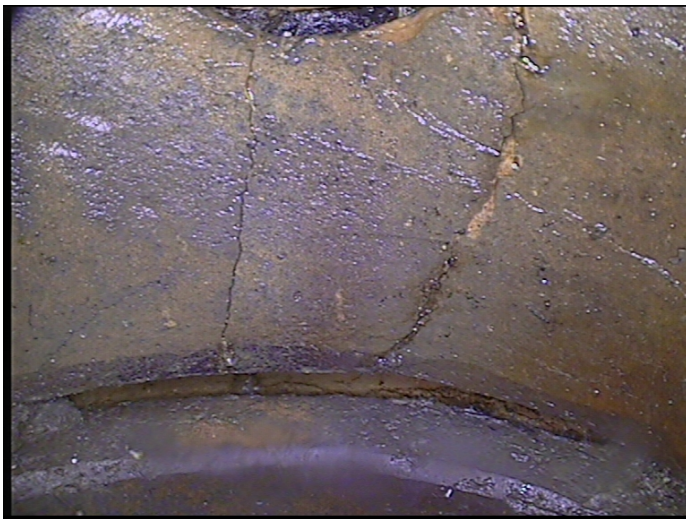
Code: **FL**
Description: **Fracture Longitudinal**

Distance (ft): **33.9**
Structural Grade: **3**
O&M Grade: **0**
Clock Start/From: **2**
Clock To:
1st Value:
2nd Value:
Value Percent:
Continuous Index:
Within 8" of Joint: **YES**
Remarks:

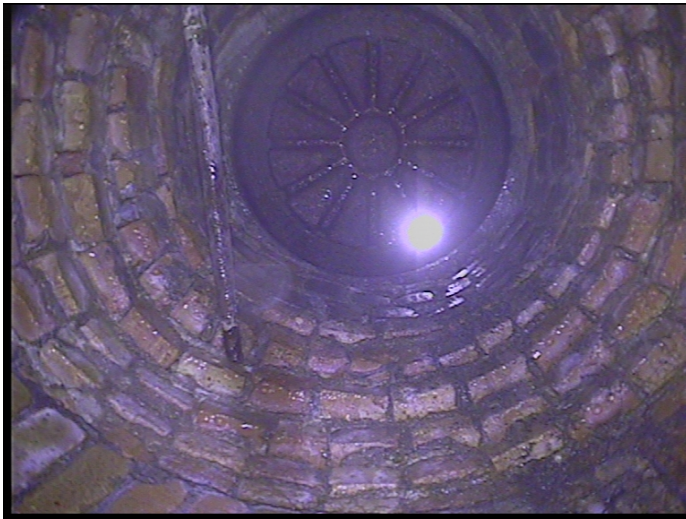
Code:	AMH
Description:	Manhole
Distance (ft):	238.1
Structural Grade:	0
O&M Grade:	0
Clock Start/From:	
Clock To:	
1st Value:	
2nd Value:	
Value Percent:	
Continuous Index:	
Within 8" of Joint:	NO
Remarks:	M-605-032
