Profile/Photo Observation Report

Street:	Connecticut Street	Flow Control:	Not Controlled
City:	Hobart, IN	Year Renewed:	
Location:	Light Highway	Tape/Media #:	DEP 61
Purpose:	Routine Assessment	Dia/Height:	18"
Use:	Sanitary	Material:	PVC
Drain Area:		Lining:	
Category:	NA		
Comment:			
Location Details:		Direction of Survey:	Upstream
US MH:	M-605-034	DS MH:	M-604-061
		Total Length Surveyed (ft):	169.3

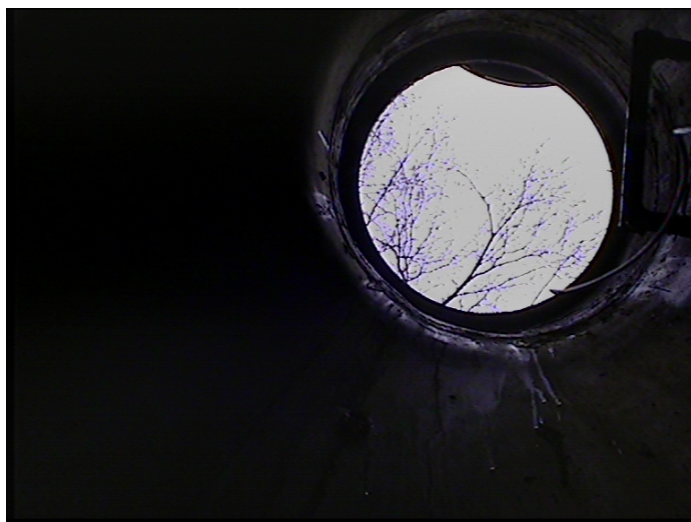
Code: **AMH**
Description: **Manhole**

Distance (ft): **.0**
Structural Grade: **0**
O&M Grade: **0**
Clock Start/From:
Clock To:
1st Value:
2nd Value:
Value Percent:
Continuous Index:
Within 8" of Joint: **NO**
Remarks: **M-604-061**

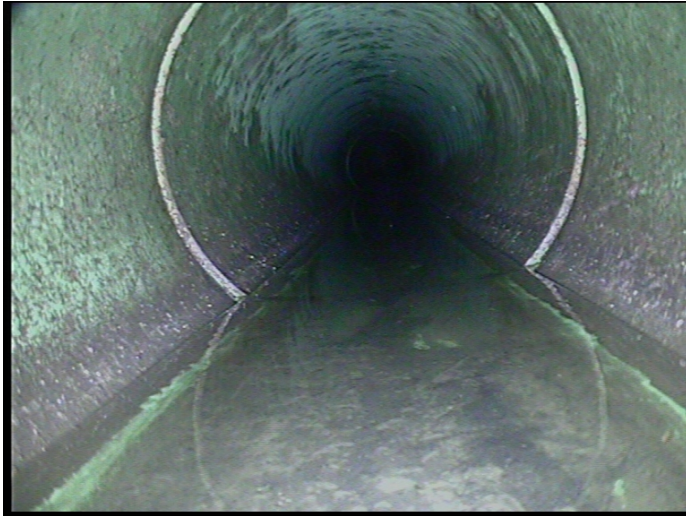
Code:	MWL
Description:	Water Level
Distance (ft):	.0
Structural Grade:	0
O&M Grade:	0
Clock Start/From:	
Clock To:	
1st Value:	
2nd Value:	
Value Percent:	10.000
Continuous Index:	
Within 8" of Joint:	NO
Remarks:

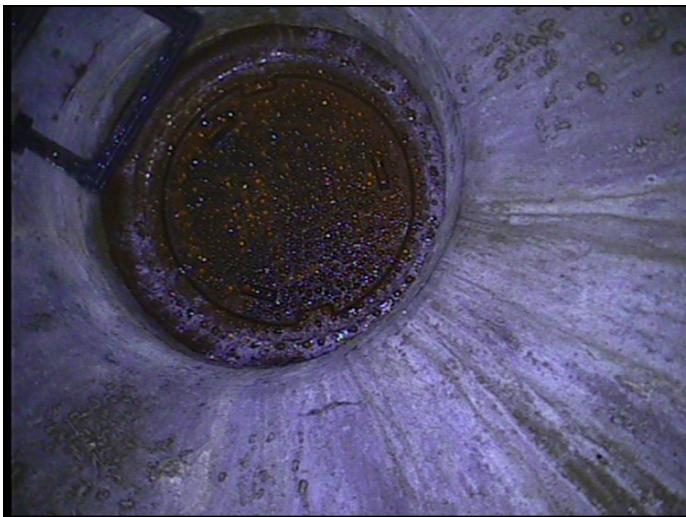
Code:	AMH
Description:	Manhole
Distance (ft):	169.3
Structural Grade:	0
O&M Grade:	0
Clock Start/From:	
Clock To:	
1st Value:	
2nd Value:	
Value Percent:	
Continuous Index:	
Within 8" of Joint:	NO
Remarks:	M-605-034
