Profile/Photo Observation Report

| Street: | Connecticut Street | Flow Control: | Not Controlled |
| Purpose: | Routine Assessment | Dia/Height: | 18" |

| US MH: | M-605-034 | DS MH: | M-604-061 |

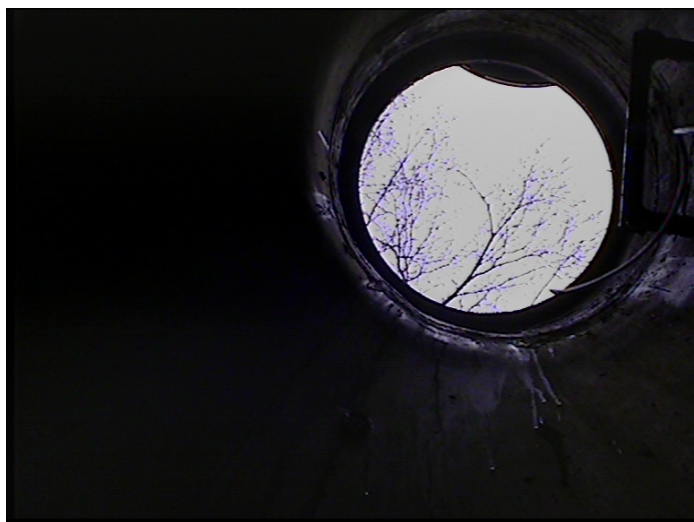
Code: **AMH**
 Description: **Manhole**

Distance (ft): **.0**
 Structural Grade: **0**
 O&M Grade: **0**
 Clock Start/From:
 Clock To:
 1st Value:
 2nd Value:
 Value Percent:
 Continuous Index:
 Within 8" of Joint: **NO**
 Remarks: **M-604-061**
