## Profile/Photo Observation Report

Date:	<b>04/26/2018</b>	Weather:		Coding:	<b>PACP 6.0</b>
Pipe Length (ft):	<b>157.7</b>	Owner:	<b>NA</b>	Pre Clean:	<b>Not Known</b>
P.O.#:		Surveyor:	<b>Mark Ruby</b>	PSR:	<b>P-605-037-036</b>
Customer:		Clean Date:	<b>01/01/1900</b>	Shape:	<b>C</b>

Street:	<b>S PENNSYLVANIA ST</b>	Flow Control:	<b>Not Controlled</b>
City:	<b>Hobart, IN</b>	Year Renewed:	
Location:	<b>Other</b>	Tape/Media #:	
Purpose:	<b>Not Known</b>	Dia/Height:	<b>12"</b>
Use:	<b>Sanitary</b>	Material:	<b>VCP</b>
Drain Area:	<b>NA</b>	Lining:	
Category:	<b>NA</b>		
Comment:	<b>Flow direction wrong. Manhole found.</b>		
Location Details:		Direction of Survey:	<b>Upstream</b>
US MH:	<b>M-605-036</b>	DS MH:	<b>M-605-037</b>
		Total Length Surveyed (ft):	<b>217.9</b>

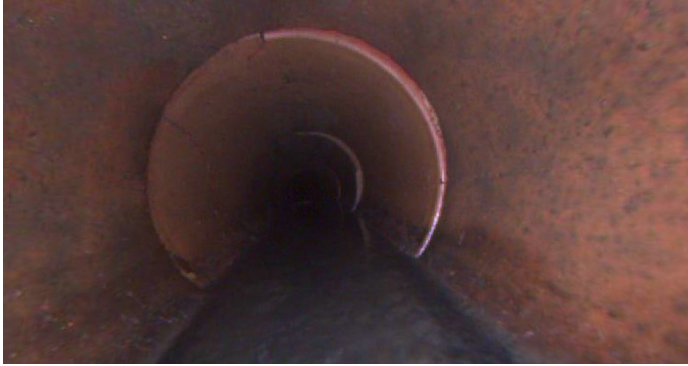
Code: **AMH**  
Description: **Manhole**

Distance (ft): **.0**  
Structural Grade: **0**  
O&M Grade: **0**  
Clock Start/From:  
Clock To:  
1st Value:  
2nd Value:  
Value Percent:  
Continuous Index:  
Within 8" of Joint: **NO**  
Remarks: **M-605-037**

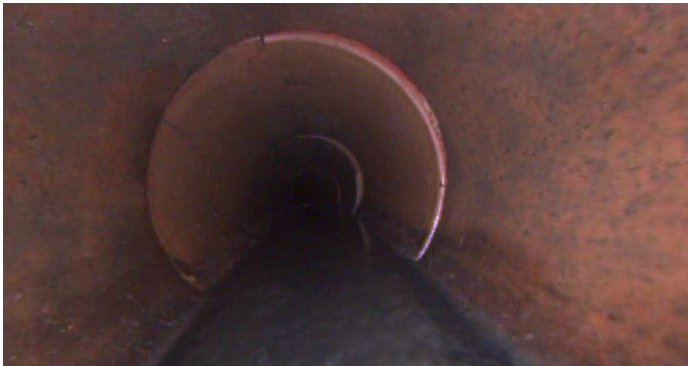
Code: **MWL**  
Description: **Water Level**

Distance (ft): **.0**  
Structural Grade: **0**  
O&M Grade: **0**  
Clock Start/From:  
Clock To:  
1st Value:  
2nd Value:  
Value Percent: **10.000**  
Continuous Index:  
Within 8" of Joint: **NO**  
Remarks:

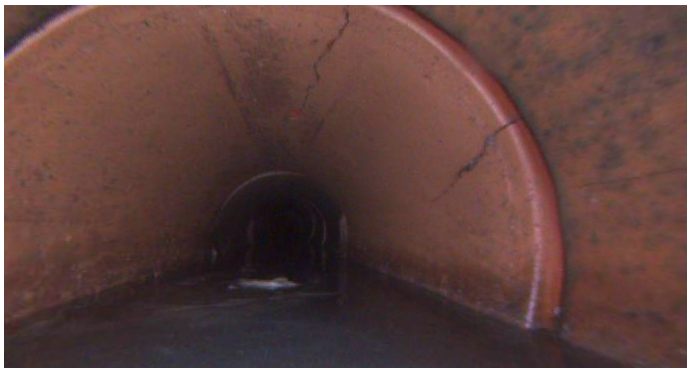
Code: **FM**  
Description: **Fracture Multiple**

Distance (ft): **5.7**  
Structural Grade: **4**  
O&M Grade: **0**  
Clock Start/From: **7**  
Clock To: **5**  
1st Value:  
2nd Value:  
Value Percent:  
Continuous Index: **S01**  
Within 8" of Joint: **YES**  
Remarks:

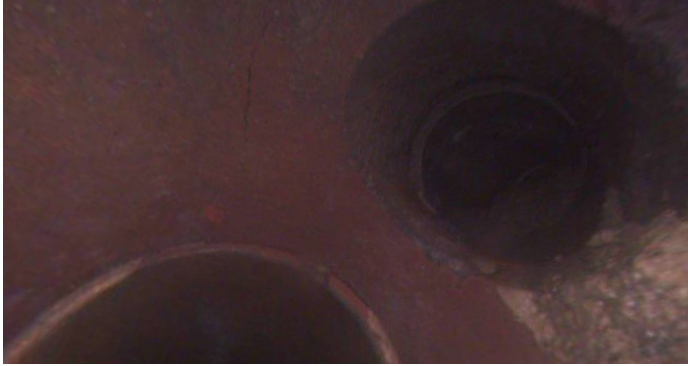
Code: **TF**  
Description: **Tap Factory**

Distance (ft): **23.7**  
Structural Grade: **0**  
O&M Grade: **0**  
Clock Start/From: **10**  
Clock To:  
1st Value: **4.000**  
2nd Value:  
Value Percent:  
Continuous Index:  
Within 8" of Joint:  
Remarks:

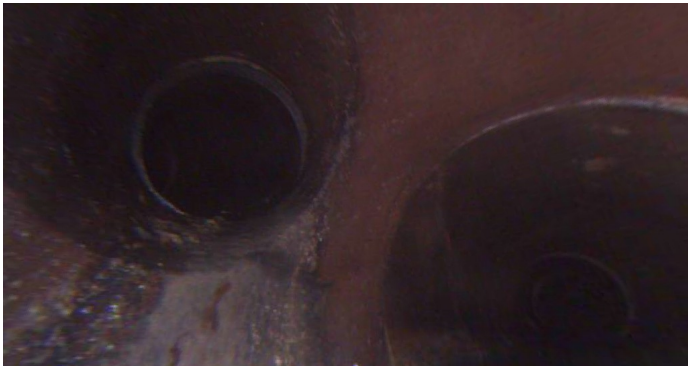
Code: **TF**  
Description: **Tap Factory**

Distance (ft): **31.8**  
Structural Grade: **0**  
O&M Grade: **0**  
Clock Start/From: **2**  
Clock To:  
1st Value: **4.000**  
2nd Value:  
Value Percent:  
Continuous Index:  
Within 8" of Joint:  
Remarks:

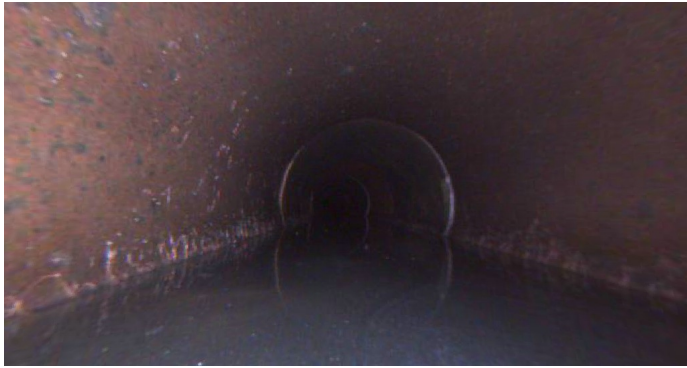
Code: **FM**  
Description: **Fracture Multiple**

Distance (ft): **47.6**  
Structural Grade: **4**  
O&M Grade: **0**  
Clock Start/From: **7**  
Clock To: **5**  
1st Value:  
2nd Value:  
Value Percent:  
Continuous Index: **F01**  
Within 8" of Joint: **YES**  
Remarks:

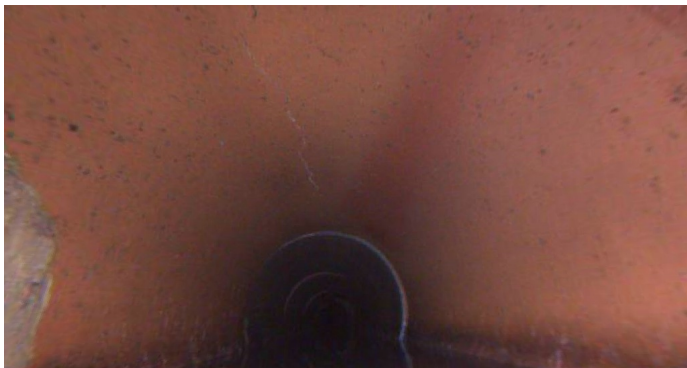
Code: **CL**  
Description: **Crack Longitudinal**

Distance (ft): **51.4**  
Structural Grade: **2**  
O&M Grade: **0**  
Clock Start/From: **12**  
Clock To:  
1st Value:  
2nd Value:  
Value Percent:  
Continuous Index:  
Within 8" of Joint: **YES**  
Remarks:

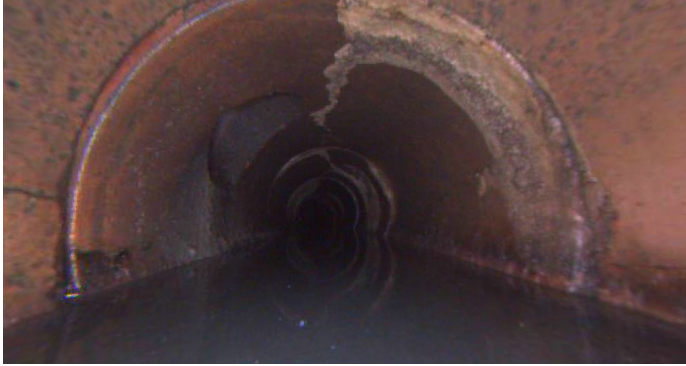
Code: **FM**  
Description: **Fracture Multiple**

Distance (ft): **57.1**  
Structural Grade: **4**  
O&M Grade: **0**  
Clock Start/From: **7**  
Clock To: **5**  
1st Value:  
2nd Value:  
Value Percent:  
Continuous Index: **S02**  
Within 8" of Joint:  
Remarks:

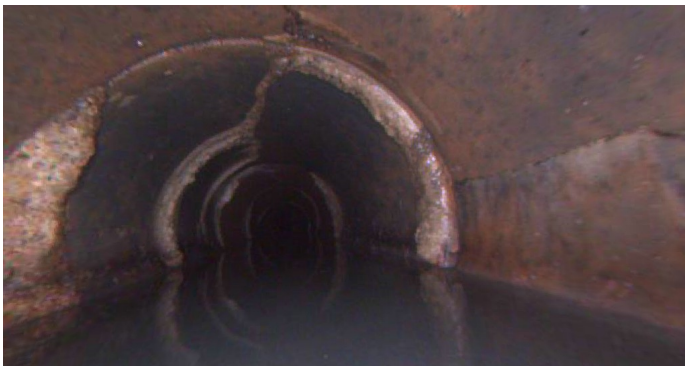
Code: **DAZ**  
Description: **Deposits Attached Other**

Distance (ft): **71.4**  
Structural Grade: **0**  
O&M Grade: **2**  
Clock Start/From: **7**  
Clock To: **5**  
1st Value:  
2nd Value:  
Value Percent: **5.000**  
Continuous Index:  
Within 8" of Joint: **YES**  
Remarks:

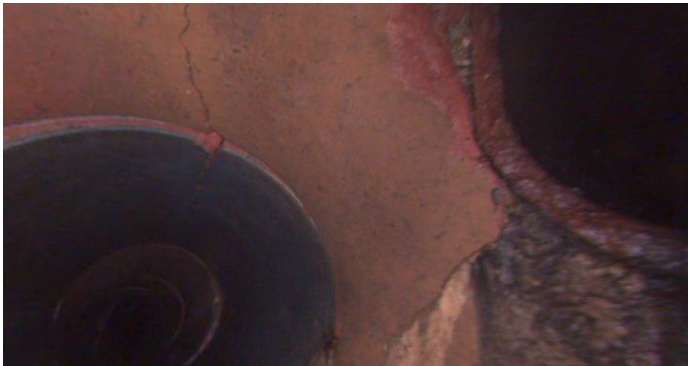
Code: **TB**  
Description: **Tap Break-in**

Distance (ft): **91.8**  
Structural Grade: **0**  
O&M Grade: **0**  
Clock Start/From: **2**  
Clock To:  
1st Value: **4.000**  
2nd Value:  
Value Percent:  
Continuous Index:  
Within 8" of Joint:  
Remarks:

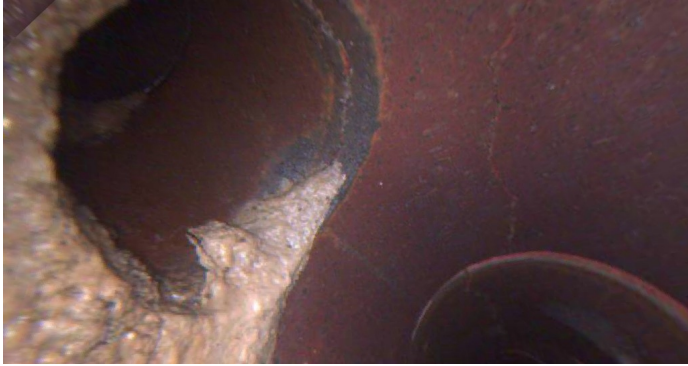
Code: **TF**  
Description: **Tap Factory**

Distance (ft): **101.7**  
Structural Grade: **0**  
O&M Grade: **0**  
Clock Start/From: **10**  
Clock To:  
1st Value: **4.000**  
2nd Value:  
Value Percent:  
Continuous Index:  
Within 8" of Joint:  
Remarks:

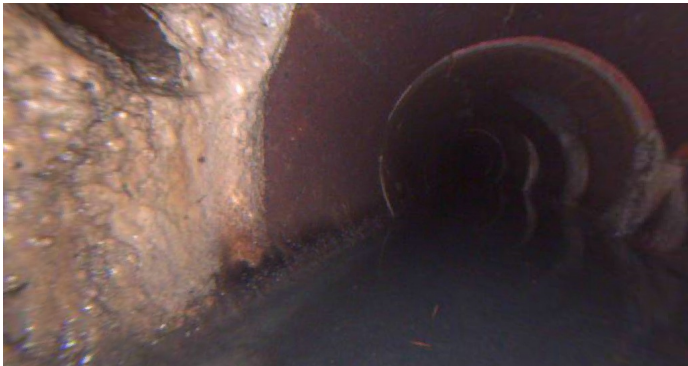
Code: **DAZ**  
Description: **Deposits Attached Other**

Distance (ft): **101.7**  
Structural Grade: **0**  
O&M Grade: **2**  
Clock Start/From: **7**  
Clock To: **11**  
1st Value:  
2nd Value:  
Value Percent: **5.000**  
Continuous Index:  
Within 8" of Joint: **NO**  
Remarks:

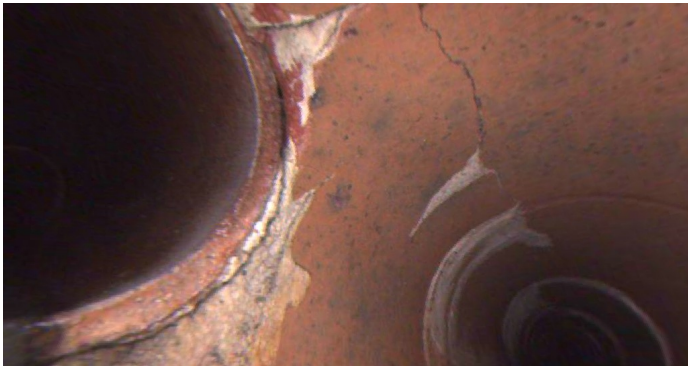
Code: **TB**  
Description: **Tap Break-in**

Distance (ft): **122.8**  
Structural Grade: **0**  
O&M Grade: **0**  
Clock Start/From: **9**  
Clock To:  
1st Value: **4.000**  
2nd Value:  
Value Percent:  
Continuous Index:  
Within 8" of Joint:  
Remarks:

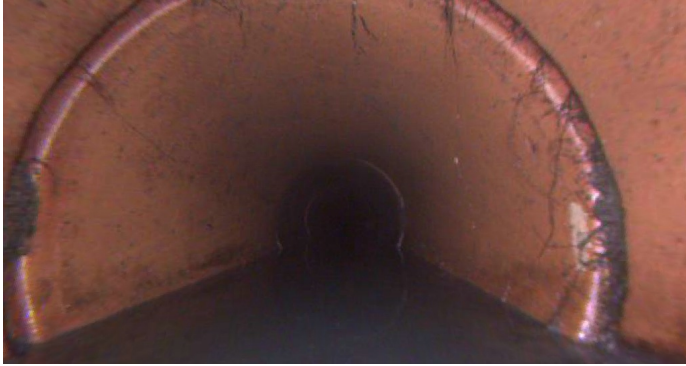
Code: **FM**  
Description: **Fracture Multiple**

Distance (ft): **173.5**  
Structural Grade: **4**  
O&M Grade: **0**  
Clock Start/From: **7**  
Clock To: **5**  
1st Value:  
2nd Value:  
Value Percent:  
Continuous Index: **F02**  
Within 8" of Joint:  
Remarks:

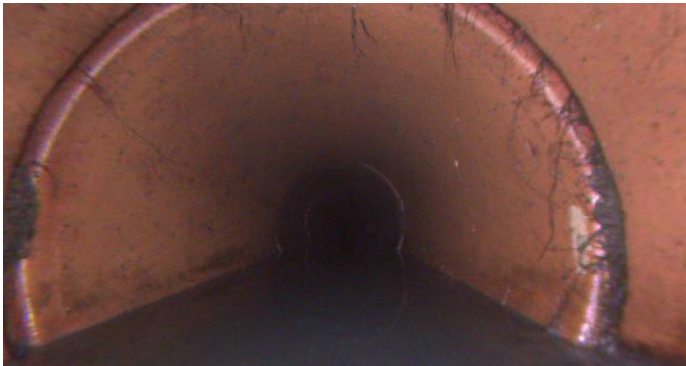
Code: **RFJ**  
Description: **Roots Fine Joint**

Distance (ft): **173.5**  
Structural Grade: **0**  
O&M Grade: **1**  
Clock Start/From: **7**  
Clock To: **5**  
1st Value:  
2nd Value:  
Value Percent:  
Continuous Index:  
Within 8" of Joint: **YES**  
Remarks:

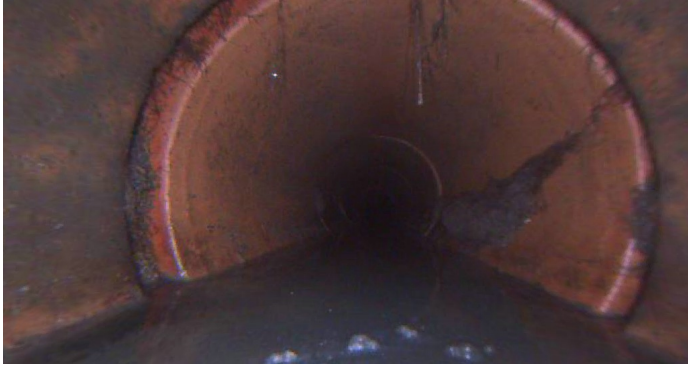
Code: **RFJ**  
Description: **Roots Fine Joint**

Distance (ft): **177.6**  
Structural Grade: **0**  
O&M Grade: **1**  
Clock Start/From: **7**  
Clock To: **5**  
1st Value:  
2nd Value:  
Value Percent:  
Continuous Index: **S03**  
Within 8" of Joint: **YES**  
Remarks:

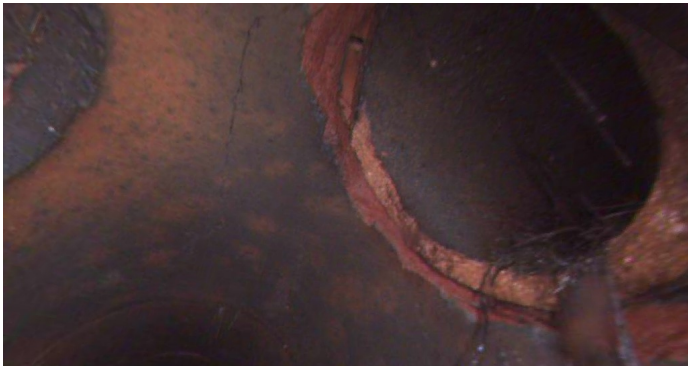
Code: **TB**  
Description: **Tap Break-in**

Distance (ft): **187.1**  
Structural Grade: **0**  
O&M Grade: **0**  
Clock Start/From: **2**  
Clock To:  
1st Value: **4.000**  
2nd Value:  
Value Percent:  
Continuous Index:  
Within 8" of Joint:  
Remarks:

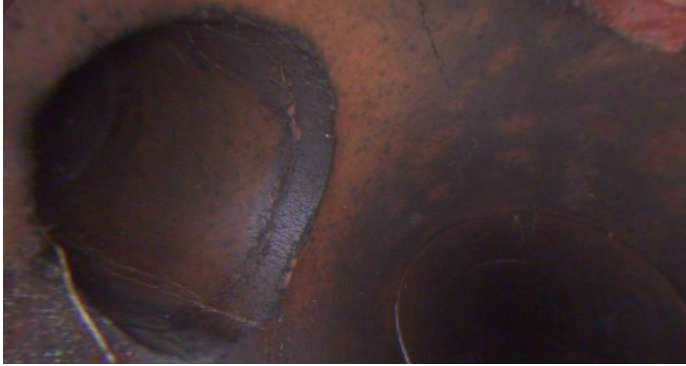
Code: **TF**  
Description: **Tap Factory**

Distance (ft): **187.1**  
Structural Grade: **0**  
O&M Grade: **0**  
Clock Start/From: **10**  
Clock To:  
1st Value: **4.000**  
2nd Value:  
Value Percent:  
Continuous Index:  
Within 8" of Joint:  
Remarks:

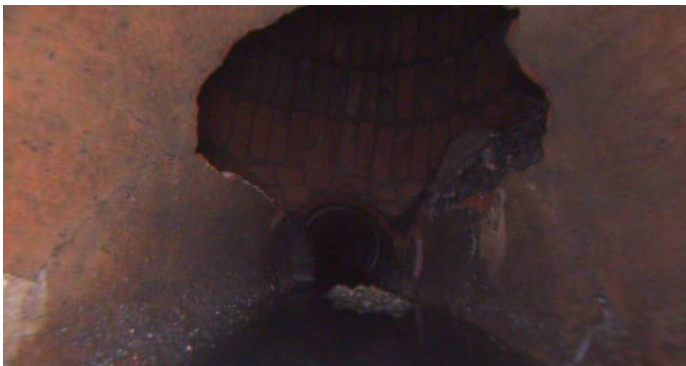
Code: **RFJ**  
Description: **Roots Fine Joint**

Distance (ft): **215.6**  
Structural Grade: **0**  
O&M Grade: **1**  
Clock Start/From: **7**  
Clock To: **5**  
1st Value:  
2nd Value:  
Value Percent:  
Continuous Index: **F03**  
Within 8" of Joint: **YES**  
Remarks:

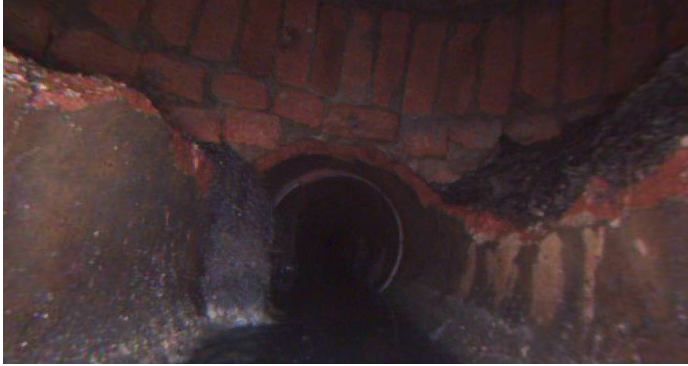
Code:	AMH
Description:	Manhole
Distance (ft):	217.9
Structural Grade:	0
O&M Grade:	0
Clock Start/From:	
Clock To:	
1st Value:	
2nd Value:	
Value Percent:	
Continuous Index:	
Within 8" of Joint:	NO
Remarks:	M-605-036
