Profile/Photo Observation Report

Date:	04/24/2018	Weather:		Coding:	PACP 6.0
Pipe Length (ft):	214.3	Owner:	NA	Pre Clean:	Not Known
P.O.#:		Surveyor:	Jen Costello	PSR:	P-605-040-039
Customer:		Clean Date:	01/01/1900	Shape:	C

Street:	S PENNSYLVANIA ST	Flow Control:	Not Controlled
City:	Hobart, IN	Year Renewed:	
Location:	Other	Tape/Media #:	
Purpose:	Not Known	Dia/Height:	12"
Use:	Sanitary	Material:	VCP
Drain Area:	NA	Lining:	
Category:	NA		
Comment:

Location Details:		Direction of Survey:	Upstream
US MH:	M-605-039	DS MH:	M-605-040
		Total Length Surveyed (ft):	5.0

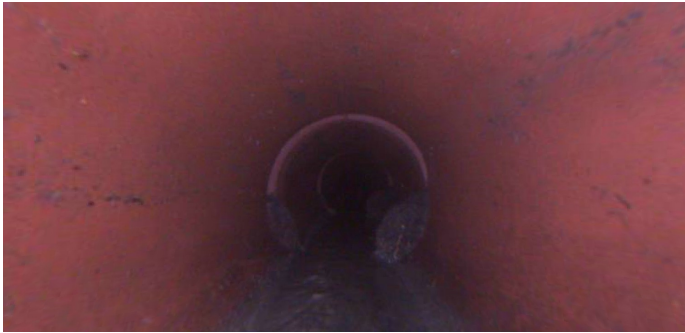
Code:	MWL
Description:	Water Level

Distance (ft):	.0
Structural Grade:	0
O&M Grade:	0
Clock Start/From:	
Clock To:	
1st Value:	
2nd Value:	
Value Percent:	5.000
Continuous Index:	
Within 8" of Joint:	NO
Remarks:

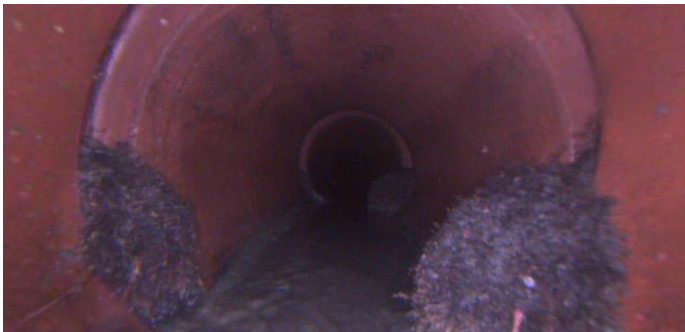
Code:	RMJ
Description:	Roots Medium Joint

Distance (ft):	.2
Structural Grade:	0
O&M Grade:	3
Clock Start/From:	8
Clock To:	4
1st Value:	
2nd Value:	
Value Percent:	10.000
Continuous Index:	
Within 8" of Joint:	YES
Remarks:

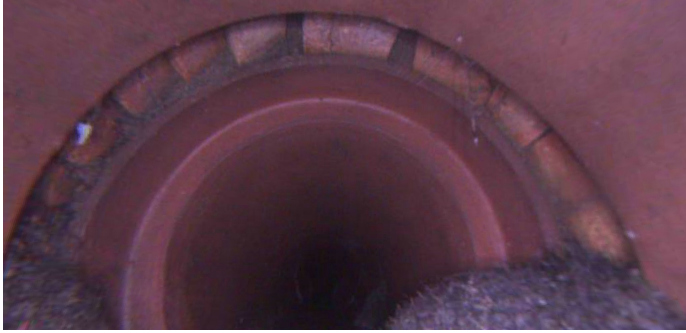
Code: **B**
Description: **Broken**

Distance (ft): **3.4**
Structural Grade: **5**
O&M Grade: **0**
Clock Start/From: **8**
Clock To: **4**
1st Value:
2nd Value:
Value Percent:
Continuous Index:
Within 8" of Joint: **YES**
Remarks:

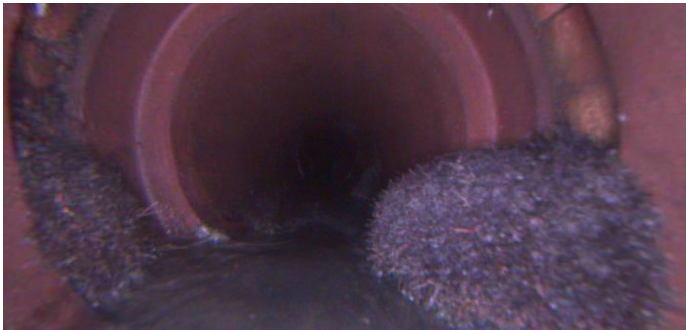
Code: **RMJ**
Description: **Roots Medium Joint**

Distance (ft): **3.4**
Structural Grade: **0**
O&M Grade: **3**
Clock Start/From: **8**
Clock To: **4**
1st Value:
2nd Value:
Value Percent: **20.000**
Continuous Index:
Within 8" of Joint: **YES**
Remarks:

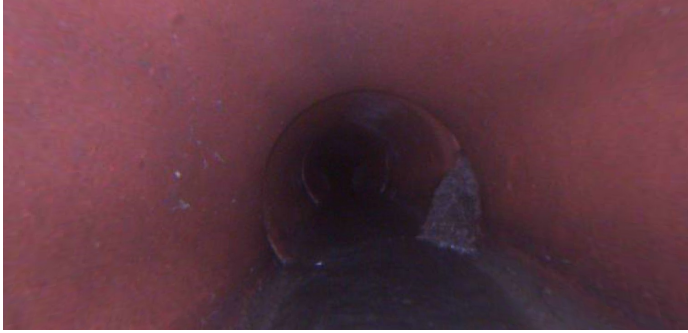
Code:	MSA
Description:	Abandoned Survey
Distance (ft):	5.0
Structural Grade:	0
O&M Grade:	0
Clock Start/From:	
Clock To:	
1st Value:	
2nd Value:	
Value Percent:	
Continuous Index:	
Within 8" of Joint:	NO
Remarks:	rmj
