Profile/Photo Observation Report

Date:	04/24/2018	Weather:		Coding:	PACP 6.0
Pipe Length (ft):	214.3	Owner:	NA	Pre Clean:	Not Known
P.O.#:		Surveyor:	Jen Costello	PSR:	P-605-040-039
Customer:		Clean Date:	01/01/1900	Shape:	C

Street:	S Pennsylvania St.	Flow Control:	Not Controlled
City:	Hobart, IN	Year Renewed:	
Location:	Other	Tape/Media #:	
Purpose:	Not Known	Dia/Height:	12"
Use:	Sanitary	Material:	VCP
Drain Area:	NA	Lining:	
Category:	NA		
Comment:

Location Details:		Direction of Survey:	Upstream
US MH:	M-605-039	DS MH:	M-605-040
		Total Length Surveyed (ft):	5.0

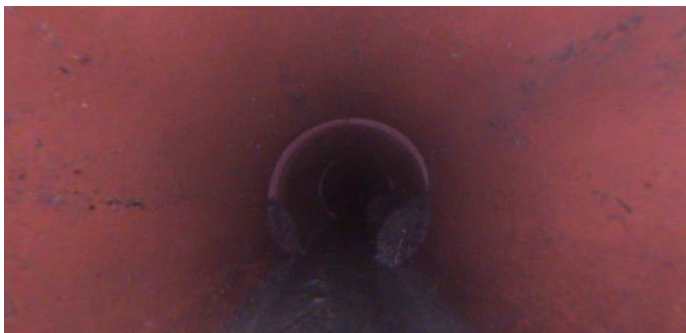
Code: **AMH**
Description: **Manhole**

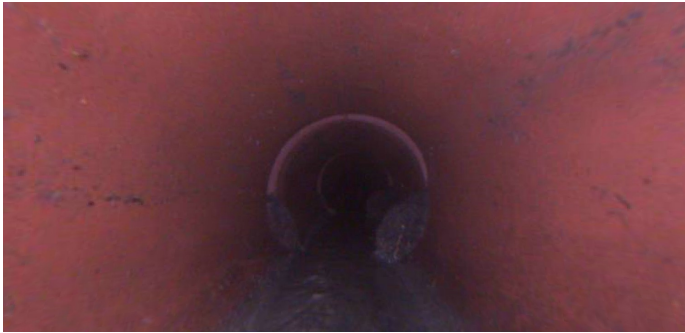
Code:	MWL
Description:	Water Level

Distance (ft):	.0
Structural Grade:	0
O&M Grade:	0
Clock Start/From:	
Clock To:	
1st Value:	
2nd Value:	
Value Percent:	5.000
Continuous Index:	
Within 8" of Joint:	NO
Remarks:

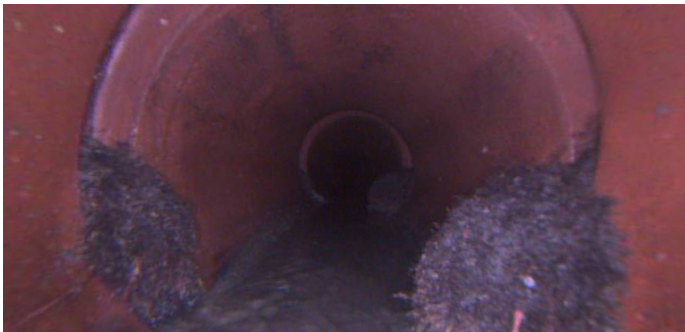
Code:	RMJ
Description:	Roots Medium Joint

Distance (ft):	.2
Structural Grade:	0
O&M Grade:	3
Clock Start/From:	8
Clock To:	4
1st Value:	
2nd Value:	
Value Percent:	10.000
Continuous Index:	
Within 8" of Joint:	YES
Remarks:

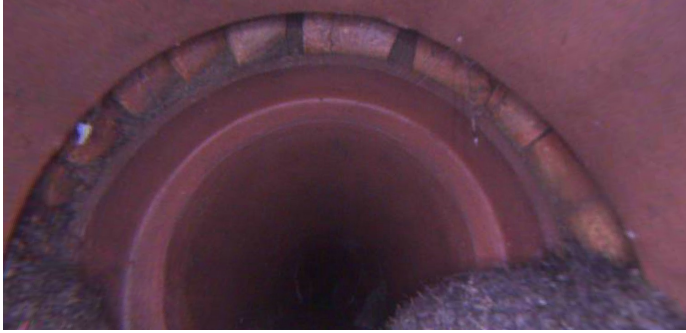
Code: **B**
Description: **Broken**

Distance (ft): **3.4**
Structural Grade: **5**
O&M Grade: **0**
Clock Start/From: **8**
Clock To: **4**
1st Value:
2nd Value:
Value Percent:
Continuous Index:
Within 8" of Joint: **YES**
Remarks:

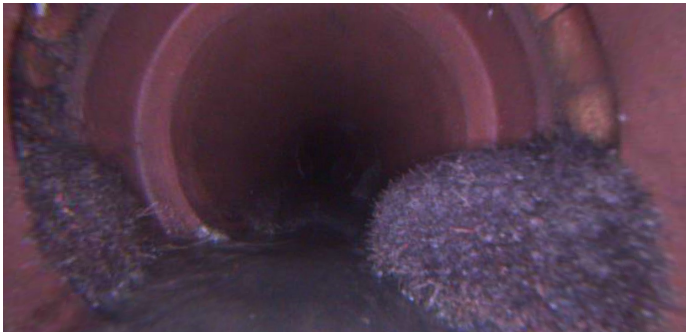
Code: **RMJ**
Description: **Roots Medium Joint**

Distance (ft): **3.4**
Structural Grade: **0**
O&M Grade: **3**
Clock Start/From: **8**
Clock To: **4**
1st Value:
2nd Value:
Value Percent: **20.000**
Continuous Index:
Within 8" of Joint: **YES**
Remarks:

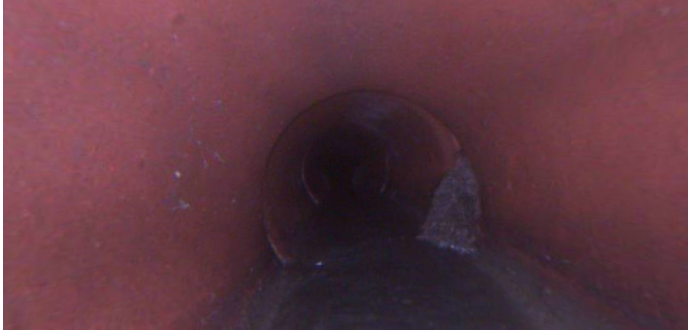
Code:	MSA
Description:	Abandoned Survey
Distance (ft):	5.0
Structural Grade:	0
O&M Grade:	0
Clock Start/From:	
Clock To:	
1st Value:	
2nd Value:	
Value Percent:	
Continuous Index:	
Within 8" of Joint:	NO
Remarks:	rmj
