Profile/Photo Observation Report

Street:	S WASHINGTON ST	Flow Control:	Not Controlled
City:	Hobart, IN	Year Renewed:	
Location:	Other	Tape/Media #:	
Purpose:	Not Known	Dia/Height:	12"
Use:	Sanitary	Material:	VCP
Drain Area:	NA	Lining:	
Category:	NA		
Comment:	Flow direction wrong.

Location Details:		Direction of Survey:	Downstream
US MH:	M-605-042	DS MH:	M-605-043
		Total Length Surveyed (ft):	215.6

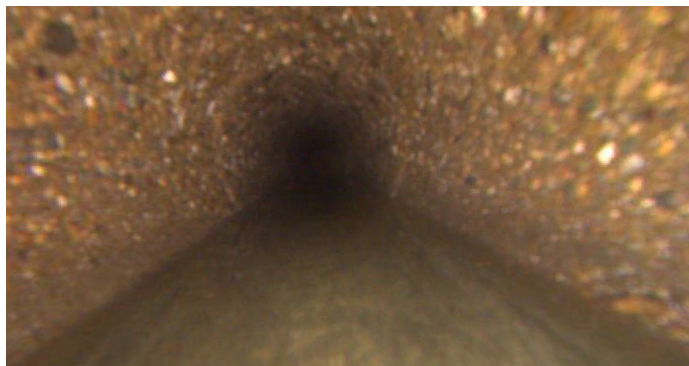
Code: **AMH**
Description: **Manhole**

Distance (ft): **.0**
Structural Grade: **0**
O&M Grade: **0**
Clock Start/From:
Clock To:
1st Value:
2nd Value:
Value Percent:
Continuous Index:
Within 8" of Joint: **NO**
Remarks: **M-605-042**

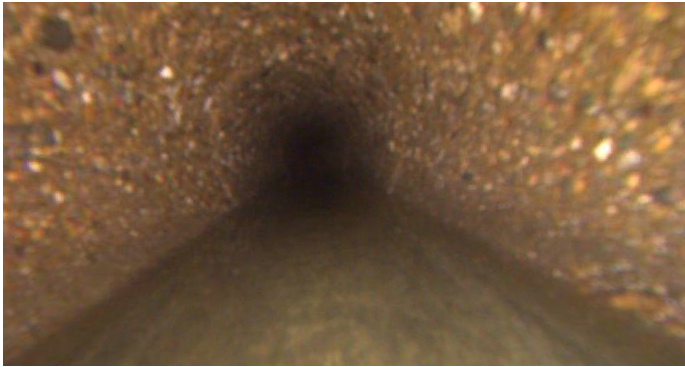
Code:	MWL
Description:	Water Level

Distance (ft):	.0
Structural Grade:	0
O&M Grade:	0
Clock Start/From:	
Clock To:	
1st Value:	
2nd Value:	
Value Percent:	10.000
Continuous Index:	
Within 8" of Joint:	NO
Remarks:

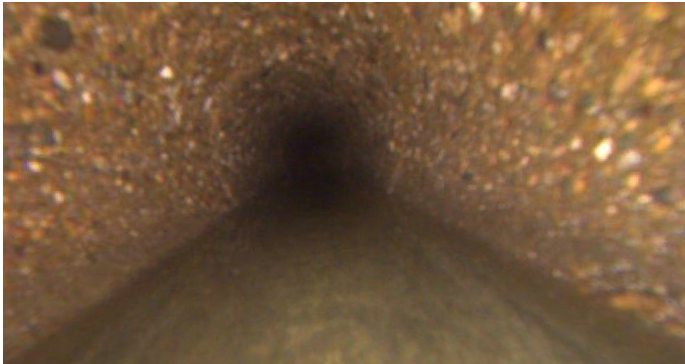
Code:	SAV
Description:	Surface Aggregate Visible

Distance (ft):	.0
Structural Grade:	3
O&M Grade:	0
Clock Start/From:	7
Clock To:	5
1st Value:	
2nd Value:	
Value Percent:	
Continuous Index:	
Within 8" of Joint:	NO
Remarks:

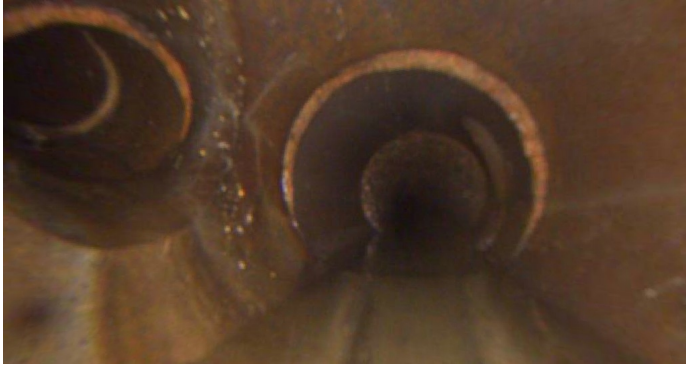
Code: **TF**
Description: **Tap Factory**

Distance (ft): **14.4**
Structural Grade: **0**
O&M Grade: **0**
Clock Start/From: **9**
Clock To:
1st Value: **4.000**
2nd Value:
Value Percent:
Continuous Index:
Within 8" of Joint:
Remarks:

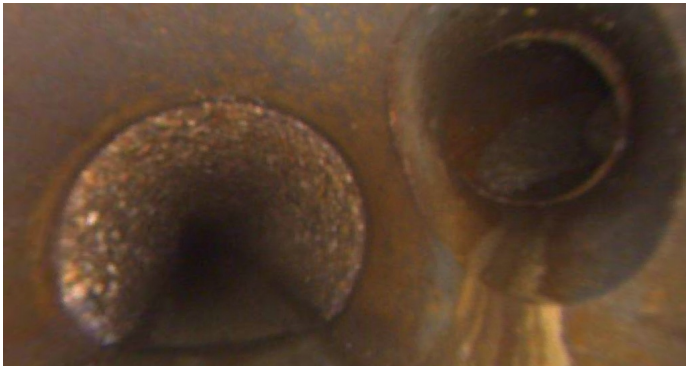
Code: **TF**
Description: **Tap Factory**

Distance (ft): **15.9**
Structural Grade: **0**
O&M Grade: **0**
Clock Start/From: **3**
Clock To:
1st Value: **4.000**
2nd Value:
Value Percent:
Continuous Index:
Within 8" of Joint:
Remarks:

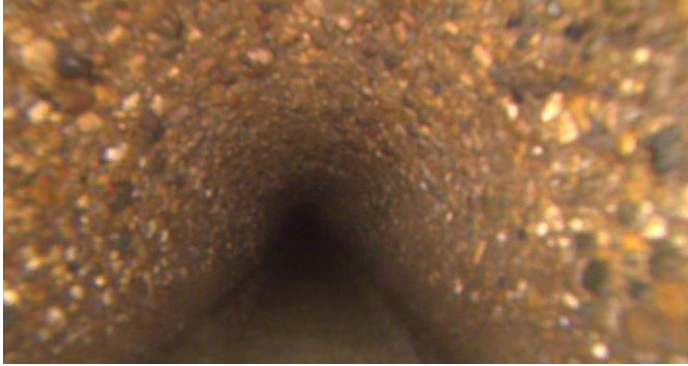
Code: **SAV**
Description: **Surface Aggregate Visible**

Distance (ft): **17.5**
Structural Grade: **3**
O&M Grade: **0**
Clock Start/From: **7**
Clock To: **5**
1st Value:
2nd Value:
Value Percent:
Continuous Index: **S01**
Within 8" of Joint: **NO**
Remarks:

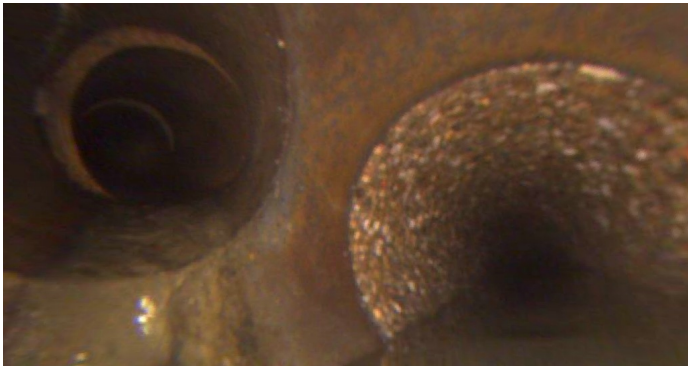
Code: **TF**
Description: **Tap Factory**

Distance (ft): **52.9**
Structural Grade: **0**
O&M Grade: **0**
Clock Start/From: **10**
Clock To:
1st Value: **4.000**
2nd Value:
Value Percent:
Continuous Index:
Within 8" of Joint:
Remarks:

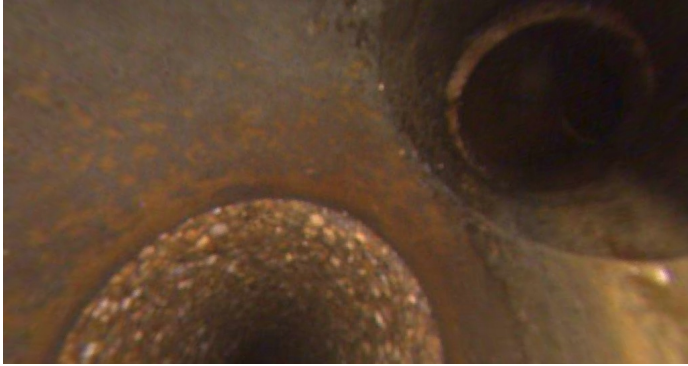
Code: **TF**
Description: **Tap Factory**

Distance (ft): **76.1**
Structural Grade: **0**
O&M Grade: **0**
Clock Start/From: **2**
Clock To:
1st Value: **4.000**
2nd Value:
Value Percent:
Continuous Index:
Within 8" of Joint:
Remarks:

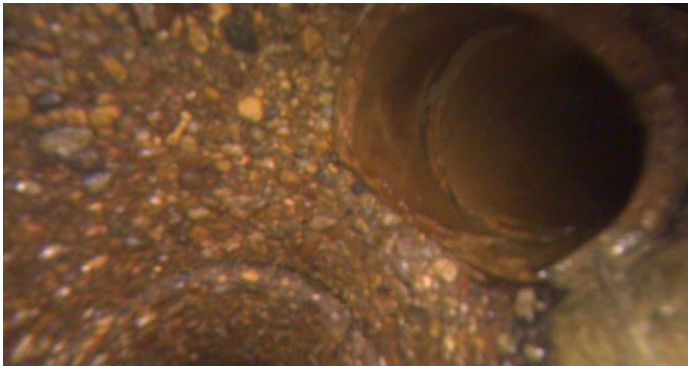
Code: **TB**
Description: **Tap Break-in**

Distance (ft): **108.8**
Structural Grade: **0**
O&M Grade: **0**
Clock Start/From: **2**
Clock To:
1st Value: **4.000**
2nd Value:
Value Percent:
Continuous Index:
Within 8" of Joint:
Remarks:

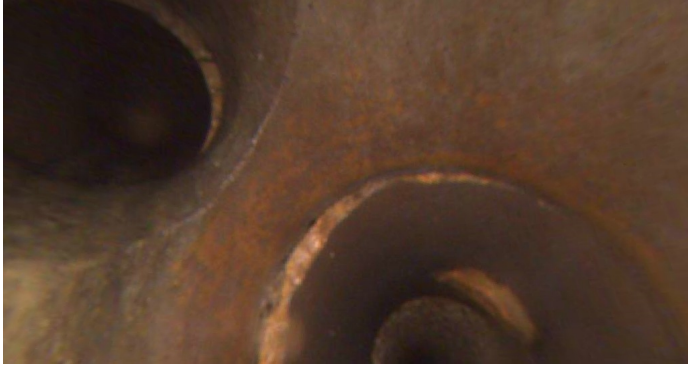
Code: **TF**
Description: **Tap Factory**

Distance (ft): **167.9**
Structural Grade: **0**
O&M Grade: **0**
Clock Start/From: **10**
Clock To:
1st Value: **4.000**
2nd Value:
Value Percent:
Continuous Index:
Within 8" of Joint:
Remarks:

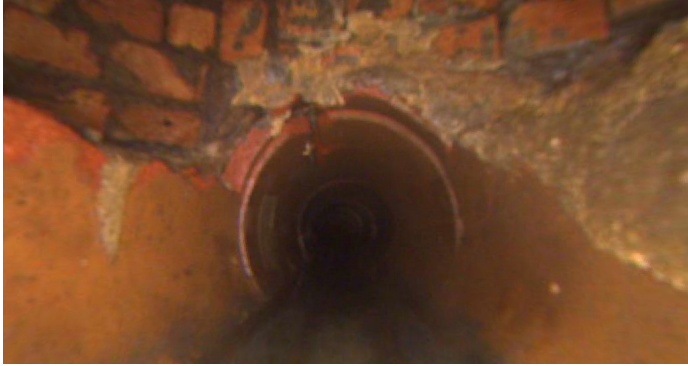
Code:	AMH
Description:	Manhole
Distance (ft):	215.6
Structural Grade:	0
O&M Grade:	0
Clock Start/From:	
Clock To:	
1st Value:	
2nd Value:	
Value Percent:	
Continuous Index:	
Within 8" of Joint:	NO
Remarks:	M-605-043
