## Profile/Photo Observation Report

Date:	<b>04/26/2018</b>	Weather:		Coding:	<b>PACP 6.0</b>
Pipe Length (ft):	<b>213.2</b>	Owner:	<b>NA</b>	Pre Clean:	<b>Not Known</b>
P.O.#:		Surveyor:	<b>Mark Ruby</b>	PSR:	<b>P-605-043-042</b>
Customer:		Clean Date:	<b>01/01/1900</b>	Shape:	<b>C</b>

Street:	<b>Washington</b>	Flow Control:	<b>Not Controlled</b>
City:	<b>Hobart, IN</b>	Year Renewed:	
Location:	<b>Other</b>	Tape/Media #:	
Purpose:	<b>Not Known</b>	Dia/Height:	<b>12"</b>
Use:	<b>Sanitary</b>	Material:	<b>VCP</b>
Drain Area:	<b>NA</b>	Lining:	
Category:	<b>NA</b>		
Comment:	<b>Flow direction wrong.</b>

Location Details:		Direction of Survey:	<b>Downstream</b>
US MH:	<b>M-605-042</b>	DS MH:	<b>M-605-043</b>
		Total Length Surveyed (ft):	<b>215.6</b>

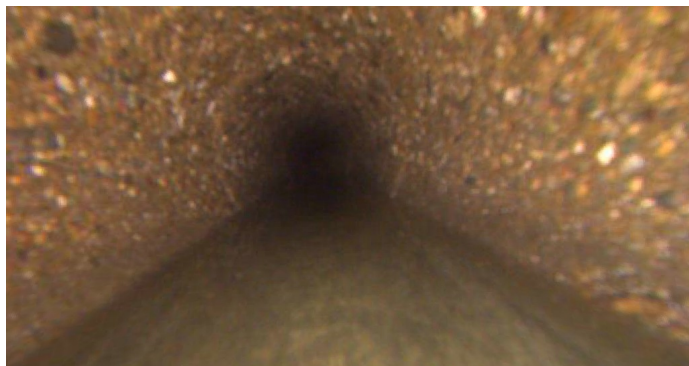
Code: **AMH**  
 Description: **Manhole**

Distance (ft): **.0**  
 Structural Grade: **0**  
 O&M Grade: **0**  
 Clock Start/From:  
 Clock To:  
 1st Value:  
 2nd Value:  
 Value Percent:  
 Continuous Index:  
 Within 8" of Joint: **NO**  
 Remarks: **M-605-042**

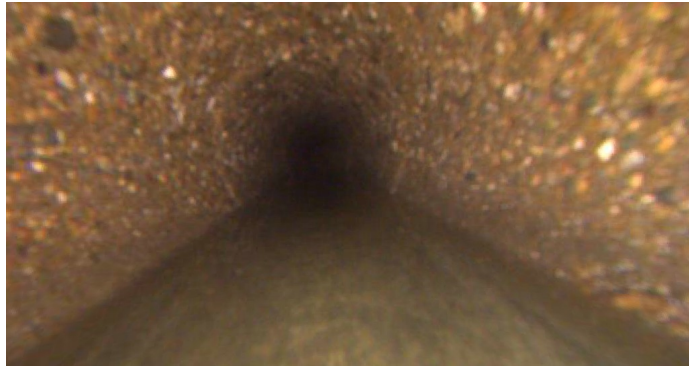
Code: **MWL**  
Description: **Water Level**

Distance (ft): **.0**  
Structural Grade: **0**  
O&M Grade: **0**  
Clock Start/From:  
Clock To:  
1st Value:  
2nd Value:  
Value Percent: **10.000**  
Continuous Index:  
Within 8" of Joint: **NO**  
Remarks:

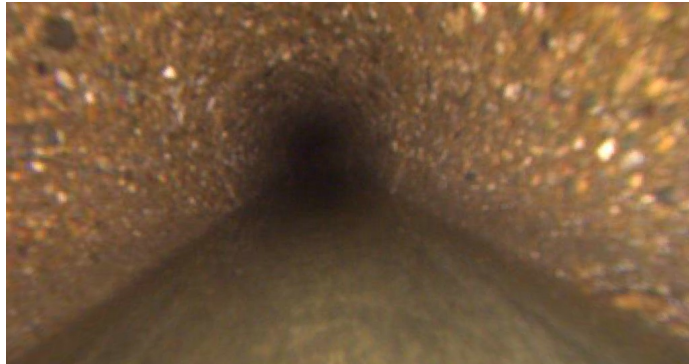
Code: **SAV**  
Description: **Surface Aggregate Visible**

Distance (ft): **.0**  
Structural Grade: **3**  
O&M Grade: **0**  
Clock Start/From: **7**  
Clock To: **5**  
1st Value:  
2nd Value:  
Value Percent:  
Continuous Index:  
Within 8" of Joint: **NO**  
Remarks:

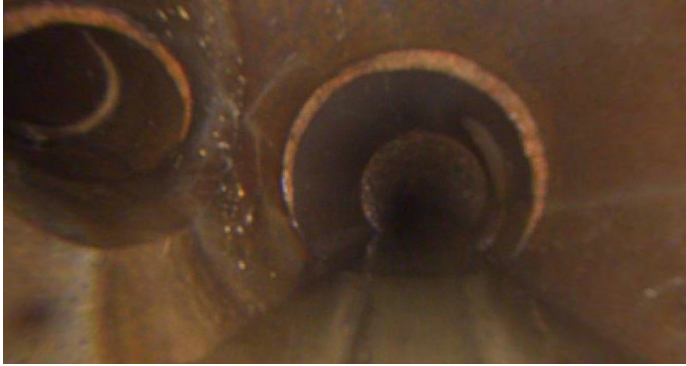
Code: **TF**  
Description: **Tap Factory**

Distance (ft): **14.4**  
Structural Grade: **0**  
O&M Grade: **0**  
Clock Start/From: **9**  
Clock To:  
1st Value: **4.000**  
2nd Value:  
Value Percent:  
Continuous Index:  
Within 8" of Joint:  
Remarks:

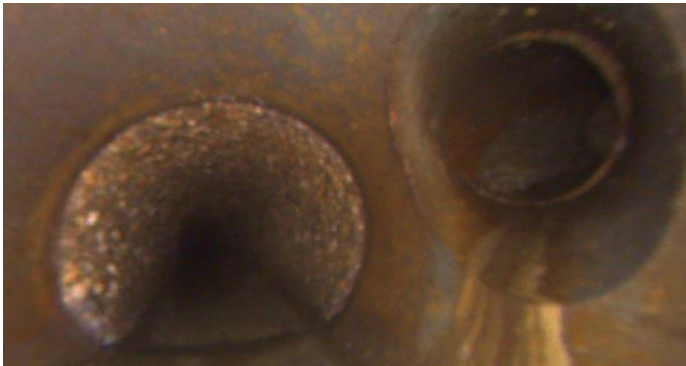
Code: **TF**  
Description: **Tap Factory**

Distance (ft): **15.9**  
Structural Grade: **0**  
O&M Grade: **0**  
Clock Start/From: **3**  
Clock To:  
1st Value: **4.000**  
2nd Value:  
Value Percent:  
Continuous Index:  
Within 8" of Joint:  
Remarks:

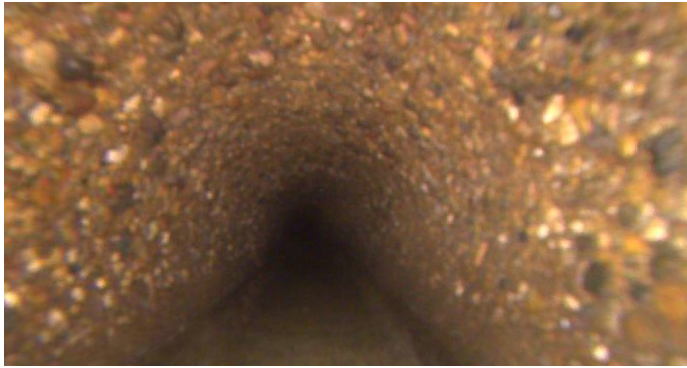
Code:	<b>SAV</b>
Description:	<b>Surface Aggregate Visible</b>
Distance (ft):	<b>17.5</b>
Structural Grade:	<b>3</b>
O&M Grade:	<b>0</b>
Clock Start/From:	<b>7</b>
Clock To:	<b>5</b>
1st Value:	
2nd Value:	
Value Percent:	
Continuous Index:	<b>S01</b>
Within 8" of Joint:	<b>NO</b>
Remarks:

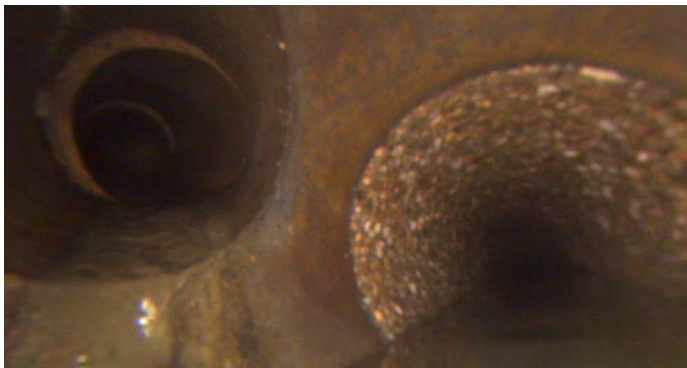
Code:	<b>TF</b>
Description:	<b>Tap Factory</b>
Distance (ft):	<b>52.9</b>
Structural Grade:	<b>0</b>
O&M Grade:	<b>0</b>
Clock Start/From:	<b>10</b>
Clock To:	
1st Value:	<b>4.000</b>
2nd Value:	
Value Percent:	
Continuous Index:	
Within 8" of Joint:	
Remarks:

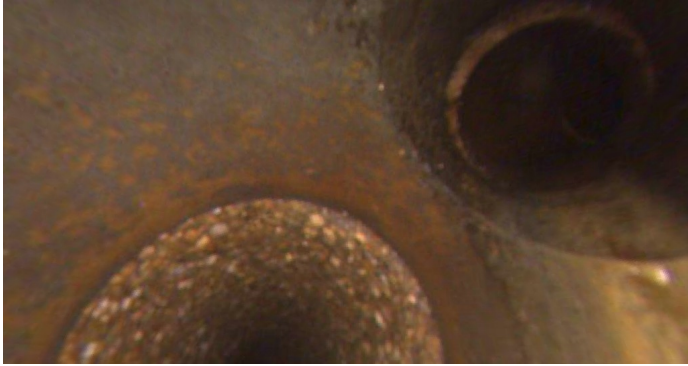
Code: **TF**  
Description: **Tap Factory**

Distance (ft): **76.1**  
Structural Grade: **0**  
O&M Grade: **0**  
Clock Start/From: **2**  
Clock To:  
1st Value: **4.000**  
2nd Value:  
Value Percent:  
Continuous Index:  
Within 8" of Joint:  
Remarks:

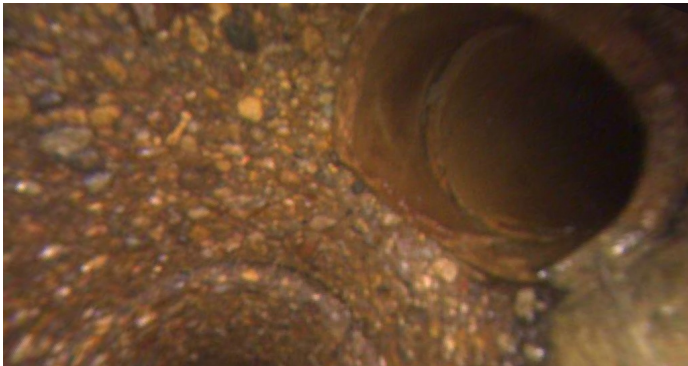
Code: **TB**  
Description: **Tap Break-in**

Distance (ft): **108.8**  
Structural Grade: **0**  
O&M Grade: **0**  
Clock Start/From: **2**  
Clock To:  
1st Value: **4.000**  
2nd Value:  
Value Percent:  
Continuous Index:  
Within 8" of Joint:  
Remarks:

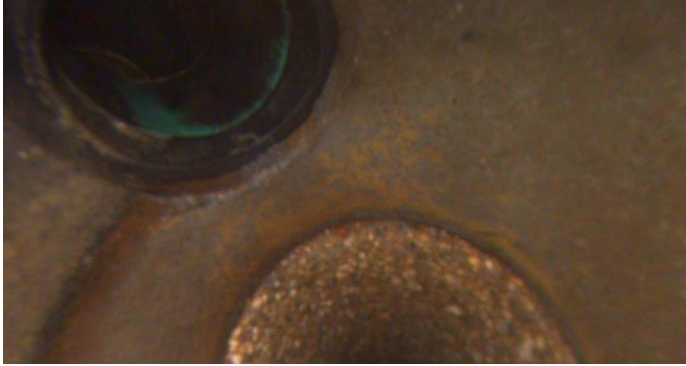
Code: **TS**  
Description: **Tap Saddle**

Distance (ft): **128.9**  
Structural Grade: **0**  
O&M Grade: **0**  
Clock Start/From: **10**  
Clock To:  
1st Value: **4.000**  
2nd Value:  
Value Percent:  
Continuous Index:  
Within 8" of Joint:  
Remarks:

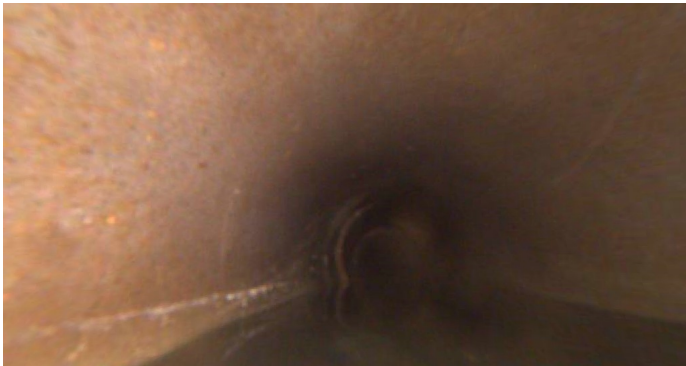
Code: **SAV**  
Description: **Surface Aggregate Visible**

Distance (ft): **165.8**  
Structural Grade: **3**  
O&M Grade: **0**  
Clock Start/From: **7**  
Clock To: **5**  
1st Value:  
2nd Value:  
Value Percent:  
Continuous Index: **F01**  
Within 8" of Joint: **NO**  
Remarks:

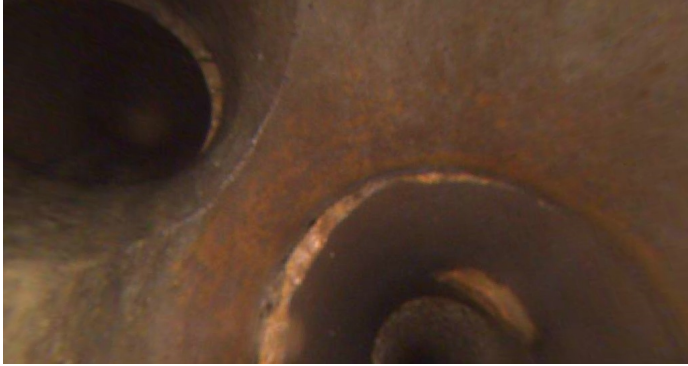
Code: **TF**  
Description: **Tap Factory**

Distance (ft): **167.9**  
Structural Grade: **0**  
O&M Grade: **0**  
Clock Start/From: **10**  
Clock To:  
1st Value: **4.000**  
2nd Value:  
Value Percent:  
Continuous Index:  
Within 8" of Joint:  
Remarks:

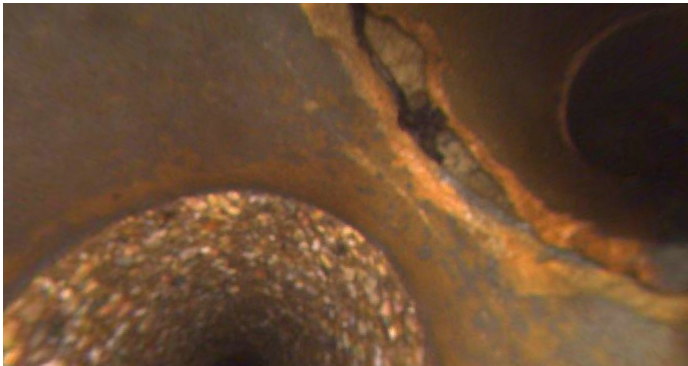
Code: **TB**  
Description: **Tap Break-in**

Distance (ft): **169.8**  
Structural Grade: **0**  
O&M Grade: **0**  
Clock Start/From: **2**  
Clock To:  
1st Value: **4.000**  
2nd Value:  
Value Percent:  
Continuous Index:  
Within 8" of Joint:  
Remarks:

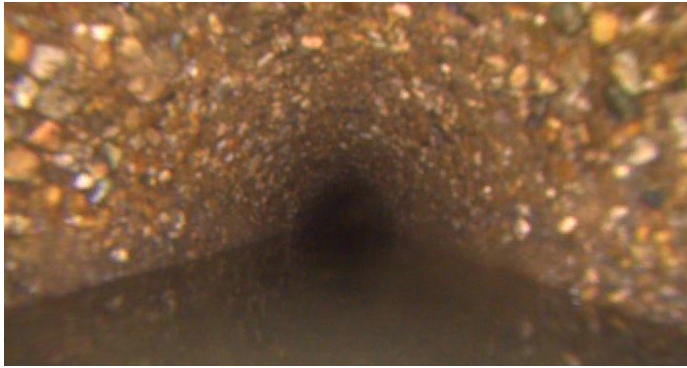
Code: **SAV**  
Description: **Surface Aggregate Visible**

Distance (ft): **170.8**  
Structural Grade: **3**  
O&M Grade: **0**  
Clock Start/From: **7**  
Clock To: **5**  
1st Value:  
2nd Value:  
Value Percent:  
Continuous Index: **S02**  
Within 8" of Joint:  
Remarks:

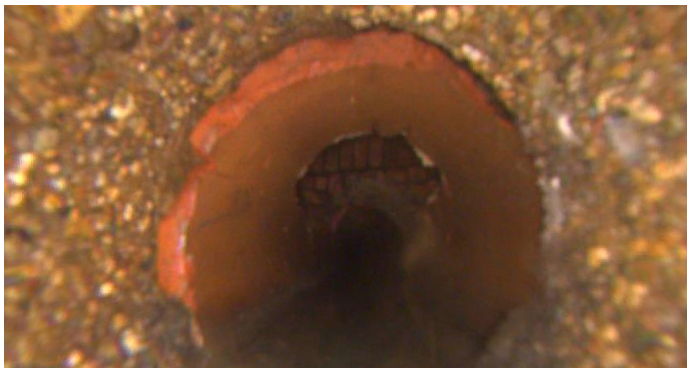
Code: **SAV**  
Description: **Surface Aggregate Visible**

Distance (ft): **212.2**  
Structural Grade: **3**  
O&M Grade: **0**  
Clock Start/From: **7**  
Clock To: **5**  
1st Value:  
2nd Value:  
Value Percent:  
Continuous Index: **F02**  
Within 8" of Joint:  
Remarks:

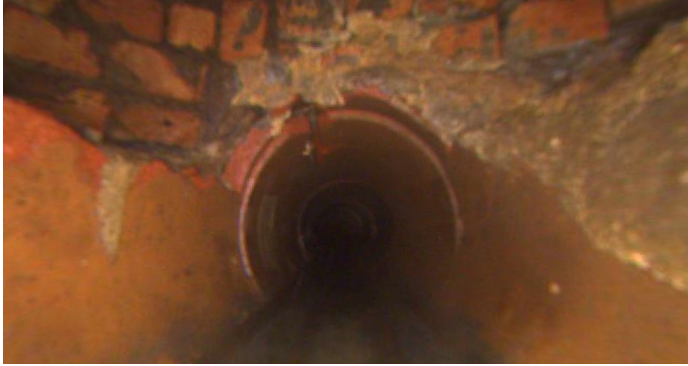
Code:	<b>AMH</b>
Description:	<b>Manhole</b>
Distance (ft):	<b>215.6</b>
Structural Grade:	<b>0</b>
O&M Grade:	<b>0</b>
Clock Start/From:	
Clock To:	
1st Value:	
2nd Value:	
Value Percent:	
Continuous Index:	
Within 8" of Joint:	<b>NO</b>
Remarks:	<b>M-605-043</b>
