Profile/Photo Observation Report

Street:	S WASHINGTON ST	Flow Control:	Not Controlled
City:	Hobart, IN	Year Renewed:	
Location:	Light Highway	Tape/Media #:	
Purpose:	Not Known	Dia/Height:	12"
Use:	Sanitary	Material:	VCP
Drain Area:	NA	Lining:	
Category:	NA		
Comment:

Location Details:		Direction of Survey:	Downstream
US MH:	M-605-043	DS MH:	M-605-044
		Total Length Surveyed (ft):	245.5

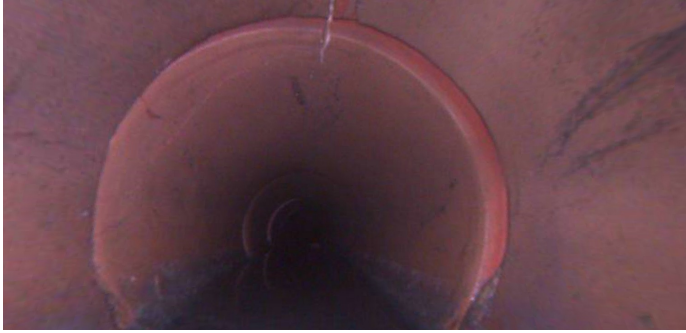
Code: **AMH**
Description: **Manhole**

Distance (ft): **.0**
Structural Grade: **0**
O&M Grade: **0**
Clock Start/From:
Clock To:
1st Value:
2nd Value:
Value Percent:
Continuous Index:
Within 8" of Joint: **NO**
Remarks: **M-605-043**

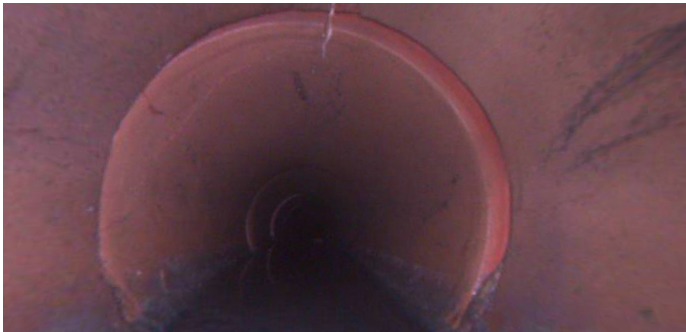
Code: **MWL**
Description: **Water Level**

Distance (ft): **.0**
Structural Grade: **0**
O&M Grade: **0**
Clock Start/From:
Clock To:
1st Value:
2nd Value:
Value Percent: **10.000**
Continuous Index:
Within 8" of Joint: **NO**
Remarks:

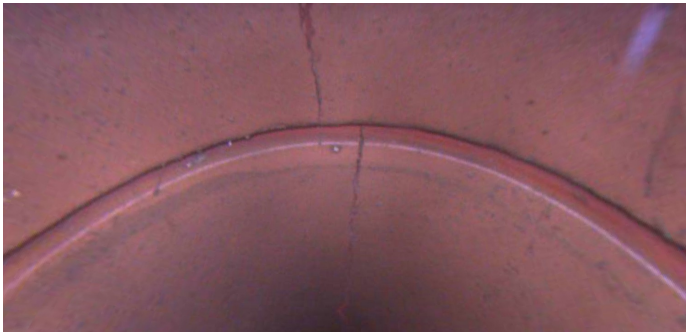
Code: **FL**
Description: **Fracture Longitudinal**

Distance (ft): **12.5**
Structural Grade: **3**
O&M Grade: **0**
Clock Start/From: **12**
Clock To:
1st Value:
2nd Value:
Value Percent:
Continuous Index:
Within 8" of Joint: **YES**
Remarks:

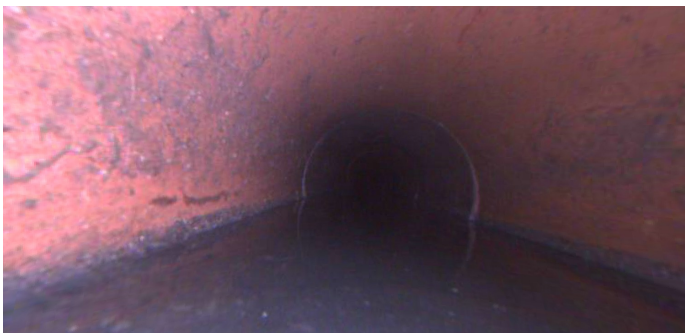
Code: **MWL**
Description: **Water Level**

Distance (ft): **44.6**
Structural Grade: **0**
O&M Grade: **0**
Clock Start/From:
Clock To:
1st Value:
2nd Value:
Value Percent: **30.000**
Continuous Index:
Within 8" of Joint: **NO**
Remarks:

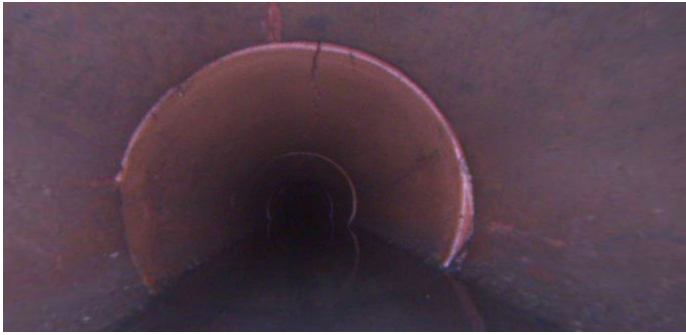
Code: **RFJ**
Description: **Roots Fine Joint**

Distance (ft): **51.2**
Structural Grade: **0**
O&M Grade: **1**
Clock Start/From: **8**
Clock To: **4**
1st Value:
2nd Value:
Value Percent:
Continuous Index: **S02**
Within 8" of Joint: **YES**
Remarks:

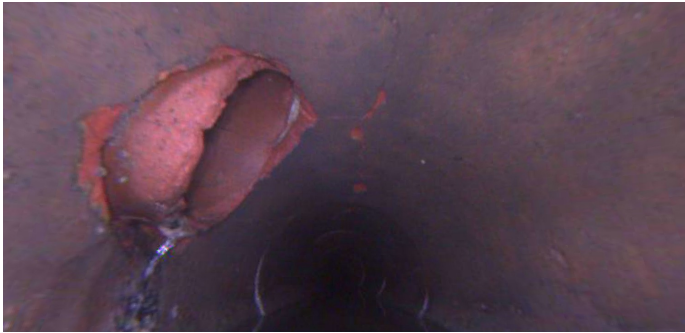
Code: **TBI**
Description: **Tap Break-in Intruding**

Distance (ft): **64.0**
Structural Grade: **0**
O&M Grade: **2**
Clock Start/From: **10**
Clock To:
1st Value: **4.000**
2nd Value: **1.000**
Value Percent:
Continuous Index:
Within 8" of Joint:
Remarks:

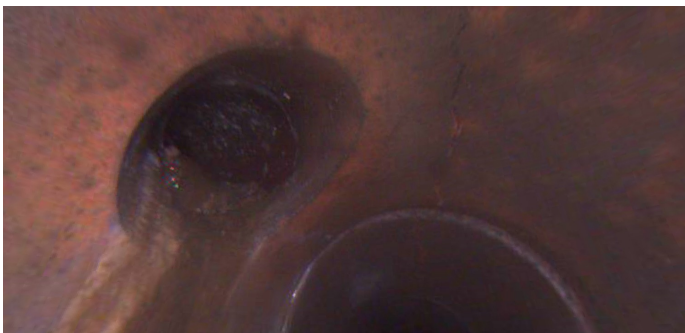
Code: **TFA**
Description: **Tap Factory Active**

Distance (ft): **75.2**
Structural Grade: **0**
O&M Grade: **0**
Clock Start/From: **2**
Clock To:
1st Value: **4.000**
2nd Value:
Value Percent:
Continuous Index:
Within 8" of Joint:
Remarks:

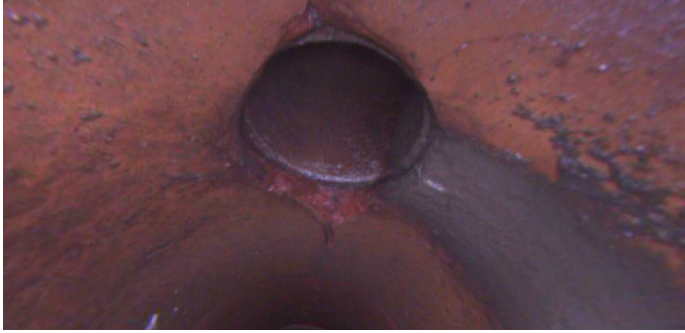
Code: **TB**
Description: **Tap Break-in**

Distance (ft): **80.3**
Structural Grade: **0**
O&M Grade: **0**
Clock Start/From: **12**
Clock To:
1st Value: **4.000**
2nd Value:
Value Percent:
Continuous Index:
Within 8" of Joint:
Remarks:

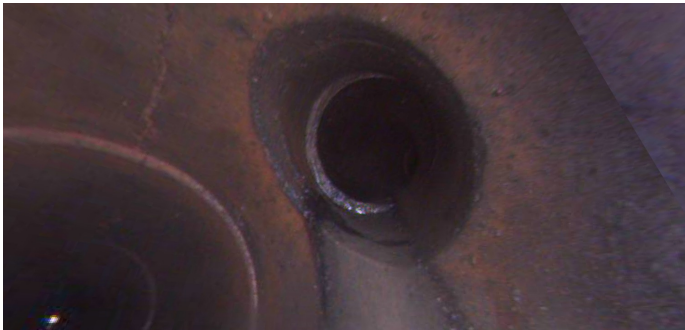
Code: **TF**
Description: **Tap Factory**

Distance (ft): **96.9**
Structural Grade: **0**
O&M Grade: **0**
Clock Start/From: **10**
Clock To:
1st Value: **4.000**
2nd Value:
Value Percent:
Continuous Index:
Within 8" of Joint:
Remarks:

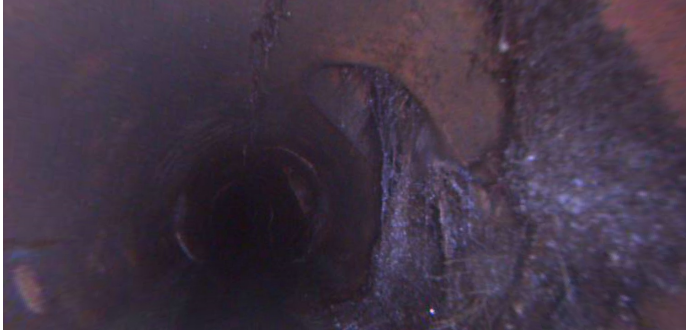
Code: **RMJ**
Description: **Roots Medium Joint**

Distance (ft): **174.6**
Structural Grade: **0**
O&M Grade: **3**
Clock Start/From: **1**
Clock To: **4**
1st Value:
2nd Value:
Value Percent: **10.000**
Continuous Index:
Within 8" of Joint: **YES**
Remarks:

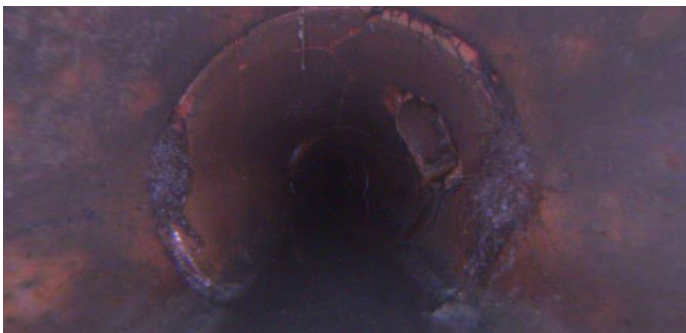
Code: **RMJ**
Description: **Roots Medium Joint**

Distance (ft): **176.0**
Structural Grade: **0**
O&M Grade: **3**
Clock Start/From: **8**
Clock To: **4**
1st Value:
2nd Value:
Value Percent: **5.000**
Continuous Index:
Within 8" of Joint: **YES**
Remarks:

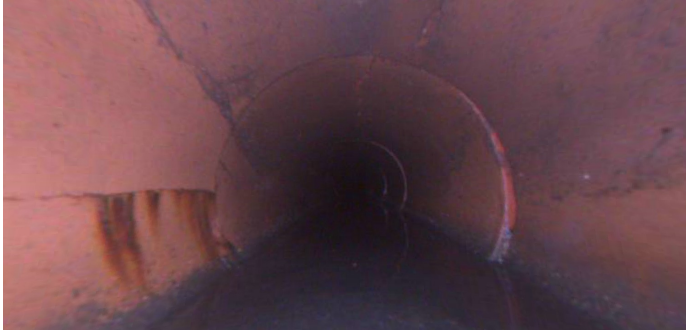
Code: **IW**
Description: **Infil Weeper**

Distance (ft): **179.6**
Structural Grade: **0**
O&M Grade: **2**
Clock Start/From: **9**
Clock To:
1st Value:
2nd Value:
Value Percent:
Continuous Index:
Within 8" of Joint: **YES**
Remarks:

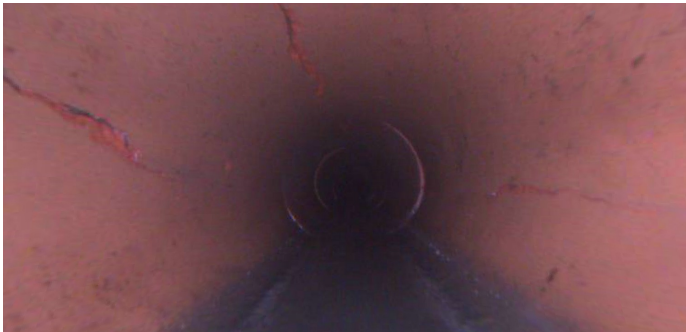
Code: **RFJ**
Description: **Roots Fine Joint**

Distance (ft): **192.3**
Structural Grade: **0**
O&M Grade: **1**
Clock Start/From: **8**
Clock To: **4**
1st Value:
2nd Value:
Value Percent:
Continuous Index: **F02**
Within 8" of Joint: **YES**
Remarks:

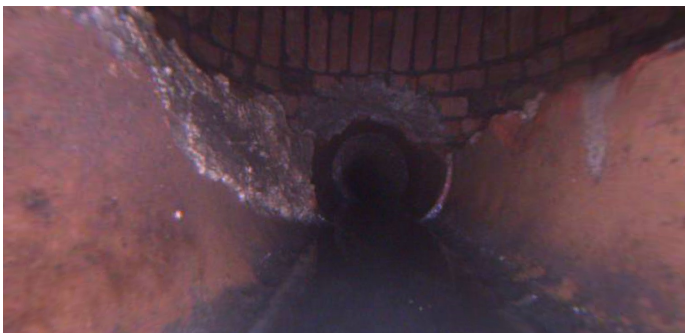
Code: **FM**
Description: **Fracture Multiple**

Distance (ft): **243.5**
Structural Grade: **4**
O&M Grade: **0**
Clock Start/From: **8**
Clock To: **4**
1st Value:
2nd Value:
Value Percent:
Continuous Index: **F01**
Within 8" of Joint: **YES**
Remarks:
