## Profile/Photo Observation Report

Street:	<b>Summerlin</b>	Flow Control:	<b>Not Controlled</b>
City:	<b>Hobart, IN</b>	Year Renewed:	
Location:	<b>Light Highway</b>	Tape/Media #:	
Purpose:	<b>Not Known</b>	Dia/Height:	<b>12"</b>
Use:	<b>Sanitary</b>	Material:	<b>VCP</b>
Drain Area:	<b>NA</b>	Lining:	
Category:	<b>NA</b>		
Comment:

Location Details:		Direction of Survey:	<b>Downstream</b>
US MH:	<b>M-605-043</b>	DS MH:	<b>M-605-044</b>
		Total Length Surveyed (ft):	<b>245.5</b>

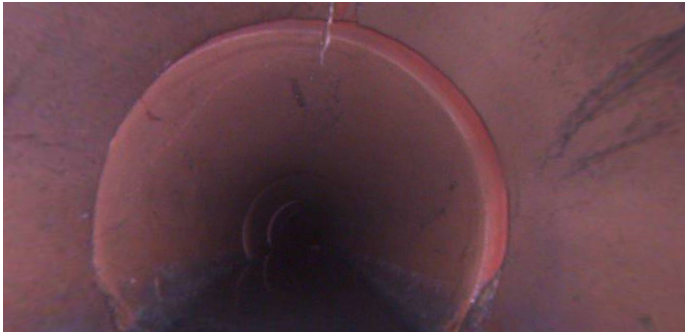
Code: **AMH**  
Description: **Manhole**

Distance (ft): **.0**  
Structural Grade: **0**  
O&M Grade: **0**  
Clock Start/From:  
Clock To:  
1st Value:  
2nd Value:  
Value Percent:  
Continuous Index:  
Within 8" of Joint: **NO**  
Remarks: **M-605-043**

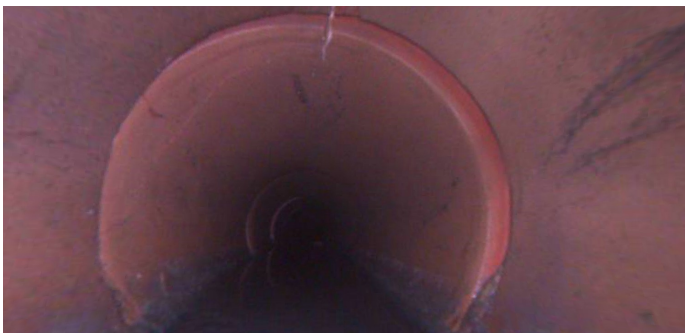
Code: **MWL**  
Description: **Water Level**

Distance (ft): **.0**  
Structural Grade: **0**  
O&M Grade: **0**  
Clock Start/From:  
Clock To:  
1st Value:  
2nd Value:  
Value Percent: **10.000**  
Continuous Index:  
Within 8" of Joint: **NO**  
Remarks:

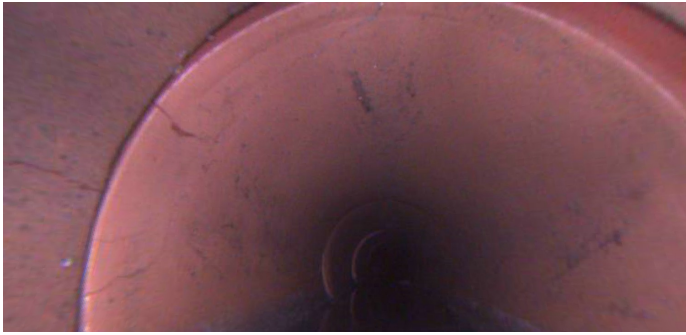
Code: **FM**  
Description: **Fracture Multiple**

Distance (ft): **.5**  
Structural Grade: **4**  
O&M Grade: **0**  
Clock Start/From: **9**  
Clock To: **12**  
1st Value:  
2nd Value:  
Value Percent:  
Continuous Index:  
Within 8" of Joint: **YES**  
Remarks:

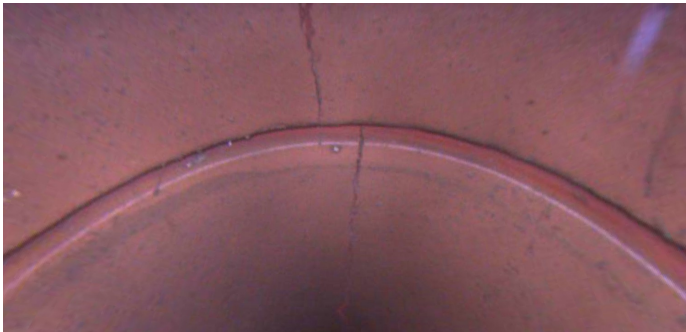
Code: **FL**  
Description: **Fracture Longitudinal**

Distance (ft): **12.5**  
Structural Grade: **3**  
O&M Grade: **0**  
Clock Start/From: **12**  
Clock To:  
1st Value:  
2nd Value:  
Value Percent:  
Continuous Index:  
Within 8" of Joint: **YES**  
Remarks:

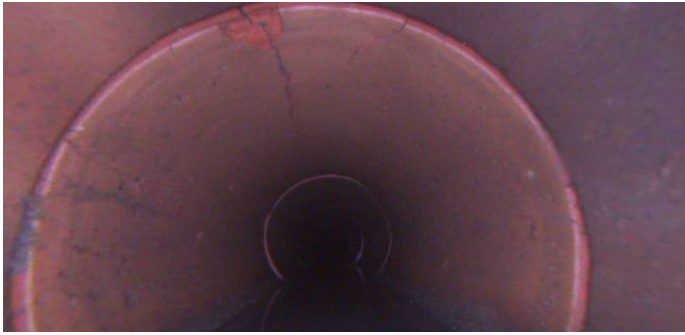
Code: **FM**  
Description: **Fracture Multiple**

Distance (ft): **18.2**  
Structural Grade: **4**  
O&M Grade: **0**  
Clock Start/From: **8**  
Clock To: **4**  
1st Value:  
2nd Value:  
Value Percent:  
Continuous Index: **S01**  
Within 8" of Joint: **YES**  
Remarks:

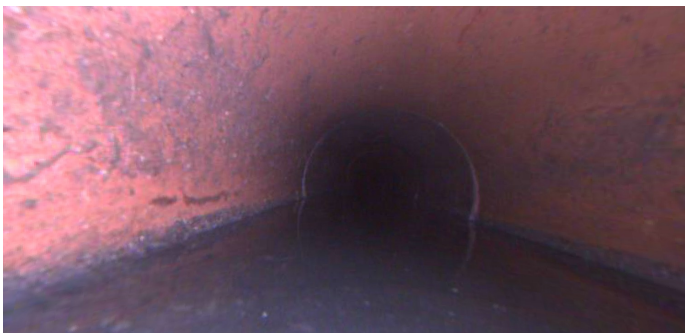
Code: **MWL**  
Description: **Water Level**

Distance (ft): **44.6**  
Structural Grade: **0**  
O&M Grade: **0**  
Clock Start/From:  
Clock To:  
1st Value:  
2nd Value:  
Value Percent: **30.000**  
Continuous Index:  
Within 8" of Joint: **NO**  
Remarks:

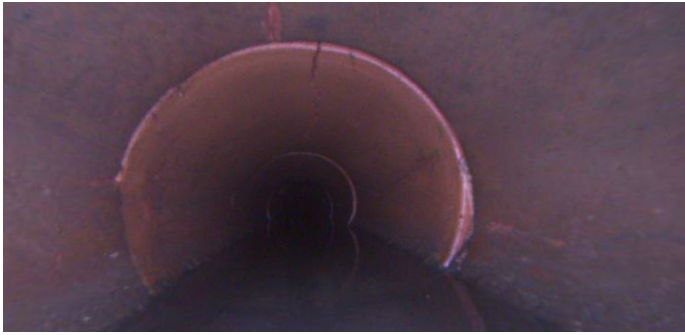
Code: **RFJ**  
Description: **Roots Fine Joint**

Distance (ft): **51.2**  
Structural Grade: **0**  
O&M Grade: **1**  
Clock Start/From: **8**  
Clock To: **4**  
1st Value:  
2nd Value:  
Value Percent:  
Continuous Index: **S02**  
Within 8" of Joint: **YES**  
Remarks:

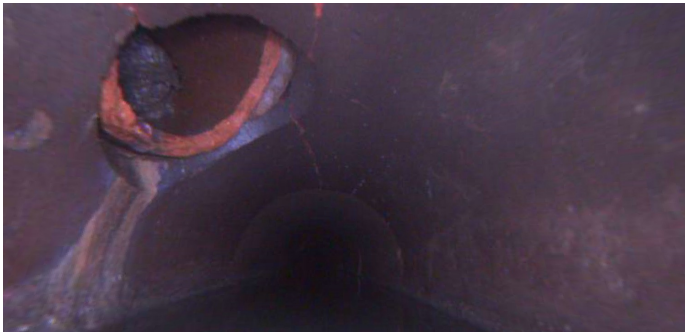
Code: **TB**  
Description: **Tap Break-in**

Distance (ft): **56.2**  
Structural Grade: **0**  
O&M Grade: **0**  
Clock Start/From: **11**  
Clock To:  
1st Value: **4.000**  
2nd Value:  
Value Percent:  
Continuous Index:  
Within 8" of Joint:  
Remarks:

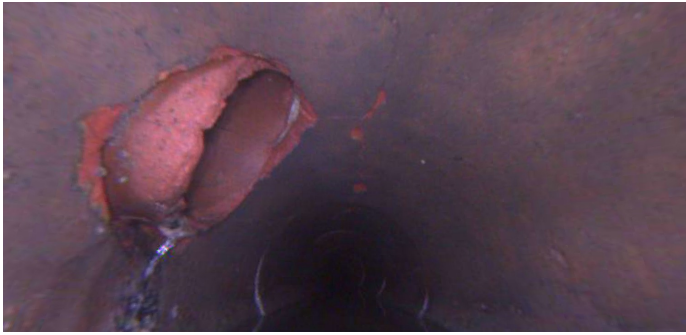
Code: **TBI**  
Description: **Tap Break-in Intruding**

Distance (ft): **64.0**  
Structural Grade: **0**  
O&M Grade: **2**  
Clock Start/From: **10**  
Clock To:  
1st Value: **4.000**  
2nd Value: **1.000**  
Value Percent:  
Continuous Index:  
Within 8" of Joint:  
Remarks:

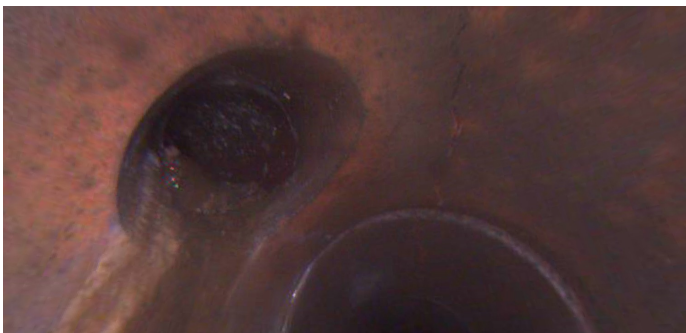
Code: **TFA**  
Description: **Tap Factory Active**

Distance (ft): **75.2**  
Structural Grade: **0**  
O&M Grade: **0**  
Clock Start/From: **2**  
Clock To:  
1st Value: **4.000**  
2nd Value:  
Value Percent:  
Continuous Index:  
Within 8" of Joint:  
Remarks:

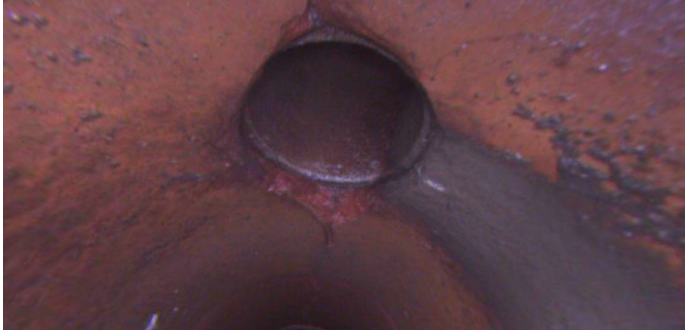
Code: **TB**  
Description: **Tap Break-in**

Distance (ft): **80.3**  
Structural Grade: **0**  
O&M Grade: **0**  
Clock Start/From: **12**  
Clock To:  
1st Value: **4.000**  
2nd Value:  
Value Percent:  
Continuous Index:  
Within 8" of Joint:  
Remarks:

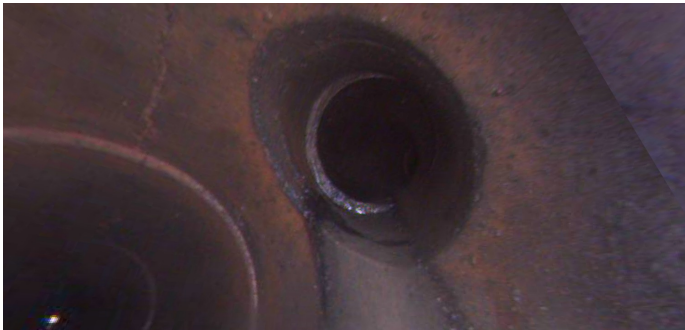
Code: **TF**  
Description: **Tap Factory**

Distance (ft): **96.9**  
Structural Grade: **0**  
O&M Grade: **0**  
Clock Start/From: **10**  
Clock To:  
1st Value: **4.000**  
2nd Value:  
Value Percent:  
Continuous Index:  
Within 8" of Joint:  
Remarks:

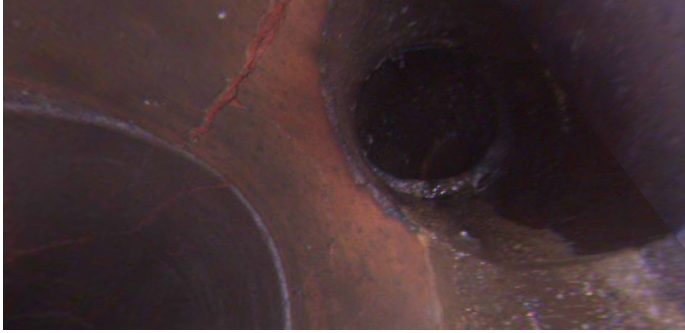
Code: **TF**  
Description: **Tap Factory**

Distance (ft): **138.0**  
Structural Grade: **0**  
O&M Grade: **0**  
Clock Start/From: **10**  
Clock To:  
1st Value: **4.000**  
2nd Value:  
Value Percent:  
Continuous Index:  
Within 8" of Joint:  
Remarks:

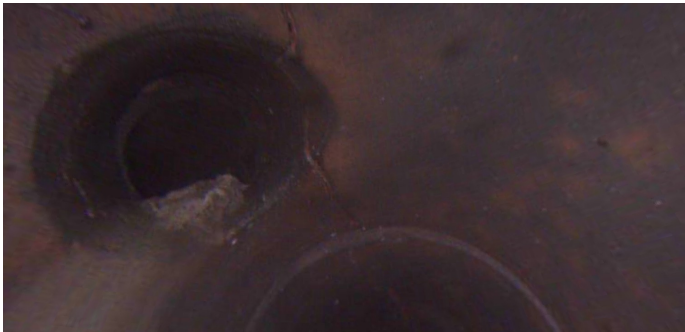
Code: **TFD**  
Description: **Tap Factory Defective**

Distance (ft): **140.3**  
Structural Grade: **0**  
O&M Grade: **2**  
Clock Start/From: **1**  
Clock To:  
1st Value: **4.000**  
2nd Value:  
Value Percent:  
Continuous Index:  
Within 8" of Joint:  
Remarks: **FRACTURED**

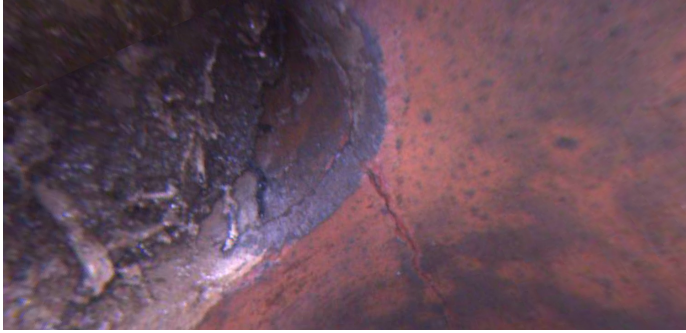
Code: **TFD**  
Description: **Tap Factory Defective**

Distance (ft): **173.4**  
Structural Grade: **0**  
O&M Grade: **2**  
Clock Start/From: **11**  
Clock To:  
1st Value: **4.000**  
2nd Value:  
Value Percent:  
Continuous Index:  
Within 8" of Joint:  
Remarks: **ROOTS**

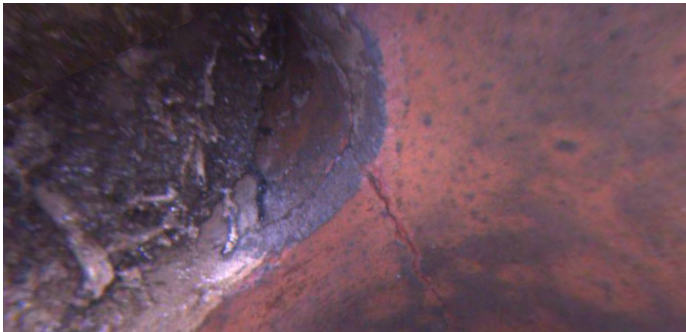
Code: **RFL**  
Description: **Roots Fine Lateral**

Distance (ft): **173.4**  
Structural Grade: **0**  
O&M Grade: **1**  
Clock Start/From: **11**  
Clock To:  
1st Value:  
2nd Value:  
Value Percent:  
Continuous Index:  
Within 8" of Joint: **NO**  
Remarks:

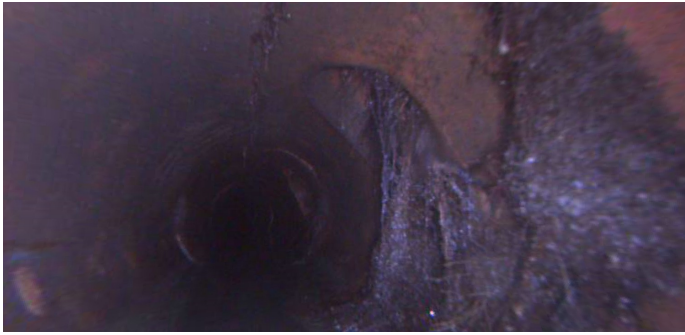
Code: **RMJ**  
Description: **Roots Medium Joint**

Distance (ft): **174.6**  
Structural Grade: **0**  
O&M Grade: **3**  
Clock Start/From: **1**  
Clock To: **4**  
1st Value:  
2nd Value:  
Value Percent: **10.000**  
Continuous Index:  
Within 8" of Joint: **YES**  
Remarks:

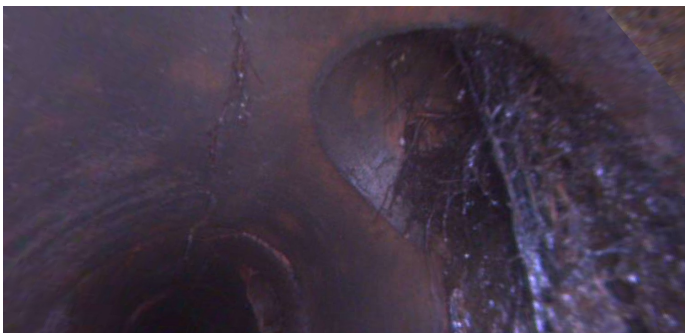
Code: **TFD**  
Description: **Tap Factory Defective**

Distance (ft): **175.1**  
Structural Grade: **0**  
O&M Grade: **2**  
Clock Start/From: **1**  
Clock To:  
1st Value: **4.000**  
2nd Value:  
Value Percent:  
Continuous Index:  
Within 8" of Joint:  
Remarks: **ROOTS**

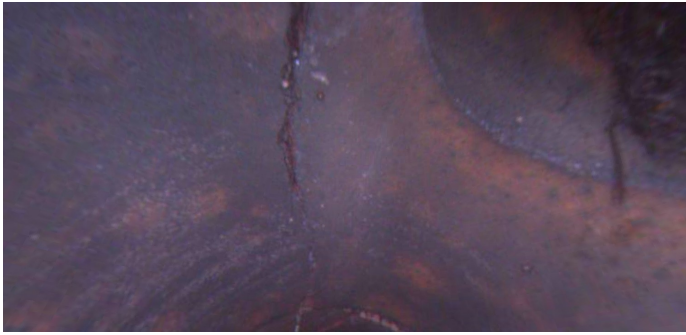
Code: **RFB**  
Description: **Roots Fine Barrel**

Distance (ft): **175.6**  
Structural Grade: **0**  
O&M Grade: **2**  
Clock Start/From: **12**  
Clock To:  
1st Value:  
2nd Value:  
Value Percent:  
Continuous Index:  
Within 8" of Joint: **NO**  
Remarks:

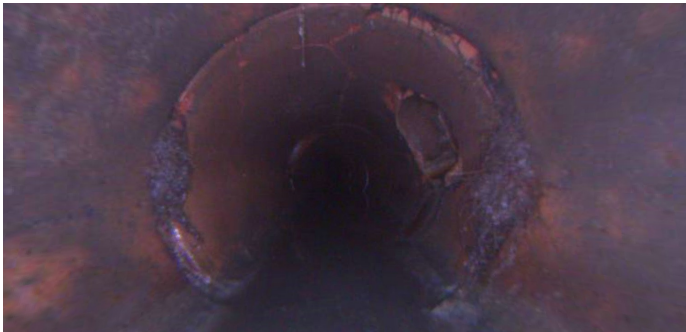
Code: **RMJ**  
Description: **Roots Medium Joint**

Distance (ft): **176.0**  
Structural Grade: **0**  
O&M Grade: **3**  
Clock Start/From: **8**  
Clock To: **4**  
1st Value:  
2nd Value:  
Value Percent: **5.000**  
Continuous Index:  
Within 8" of Joint: **YES**  
Remarks:

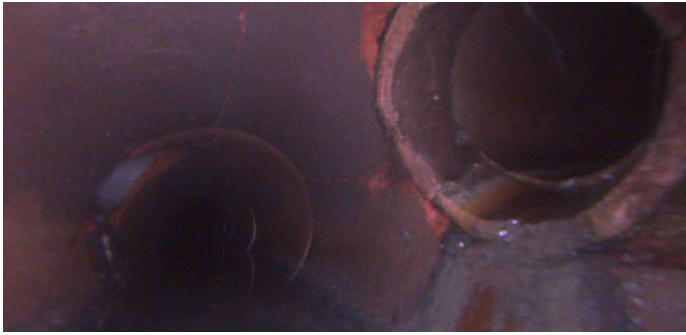
Code: **TBI**  
Description: **Tap Break-in Intruding**

Distance (ft): **177.1**  
Structural Grade: **0**  
O&M Grade: **2**  
Clock Start/From: **2**  
Clock To:  
1st Value: **4.000**  
2nd Value: **1.000**  
Value Percent:  
Continuous Index:  
Within 8" of Joint:  
Remarks:

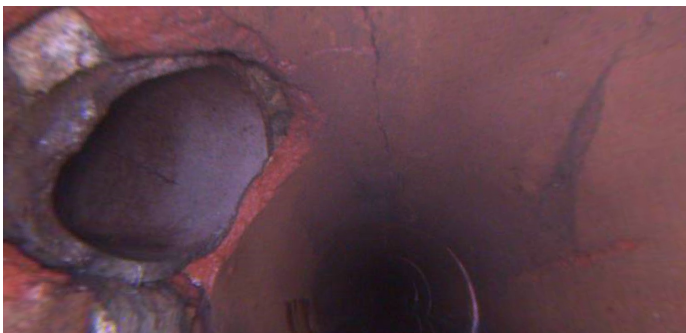
Code: **TB**  
Description: **Tap Break-in**

Distance (ft): **178.6**  
Structural Grade: **0**  
O&M Grade: **0**  
Clock Start/From: **9**  
Clock To:  
1st Value: **4.000**  
2nd Value:  
Value Percent:  
Continuous Index:  
Within 8" of Joint:  
Remarks:

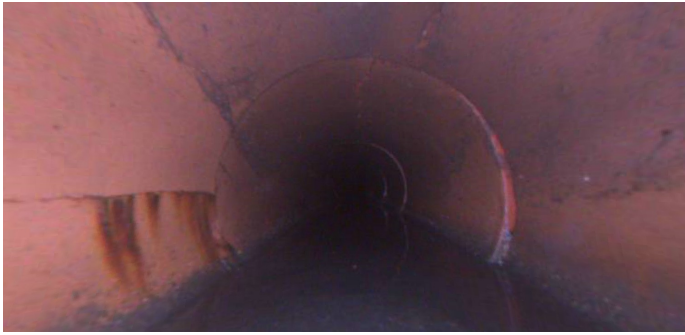
Code: **IW**  
Description: **Infil Weeper**

Distance (ft): **179.6**  
Structural Grade: **0**  
O&M Grade: **2**  
Clock Start/From: **9**  
Clock To:  
1st Value:  
2nd Value:  
Value Percent:  
Continuous Index:  
Within 8" of Joint: **YES**  
Remarks:

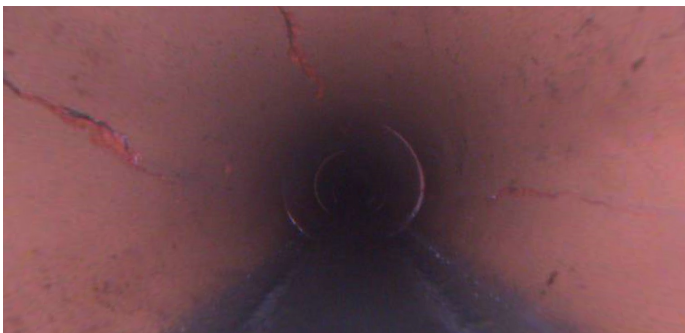
Code: **RFJ**  
Description: **Roots Fine Joint**

Distance (ft): **192.3**  
Structural Grade: **0**  
O&M Grade: **1**  
Clock Start/From: **8**  
Clock To: **4**  
1st Value:  
2nd Value:  
Value Percent:  
Continuous Index: **F02**  
Within 8" of Joint: **YES**  
Remarks:

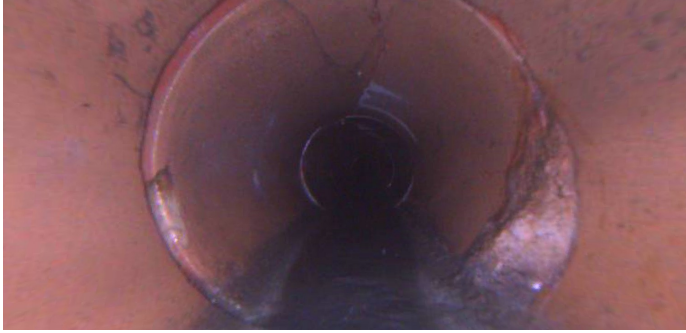
Code: **DAE**  
Description: **Deposits Attached Encrustation**

Distance (ft): **197.6**  
Structural Grade: **0**  
O&M Grade: **2**  
Clock Start/From: **3**  
Clock To: **4**  
1st Value:  
2nd Value:  
Value Percent: **5.000**  
Continuous Index:  
Within 8" of Joint: **YES**  
Remarks:

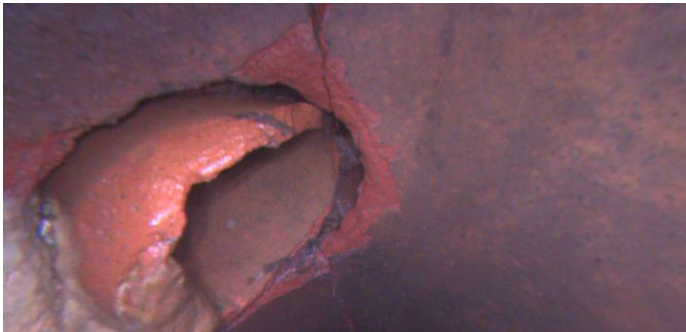
Code: **TBI**  
Description: **Tap Break-in Intruding**

Distance (ft): **208.5**  
Structural Grade: **0**  
O&M Grade: **2**  
Clock Start/From: **10**  
Clock To:  
1st Value: **4.000**  
2nd Value: **1.000**  
Value Percent:  
Continuous Index:  
Within 8" of Joint:  
Remarks:

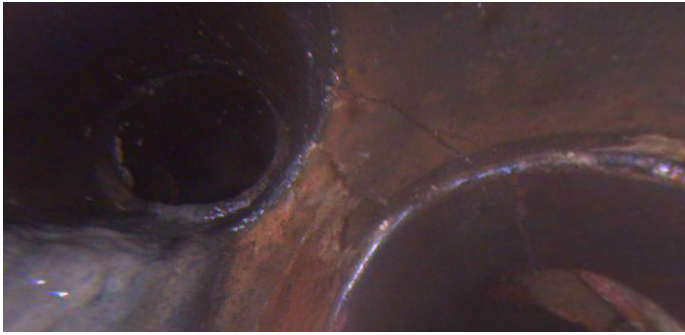
Code: **TF**  
Description: **Tap Factory**

Distance (ft): **211.0**  
Structural Grade: **0**  
O&M Grade: **0**  
Clock Start/From: **2**  
Clock To:  
1st Value: **4.000**  
2nd Value:  
Value Percent:  
Continuous Index:  
Within 8" of Joint:  
Remarks:

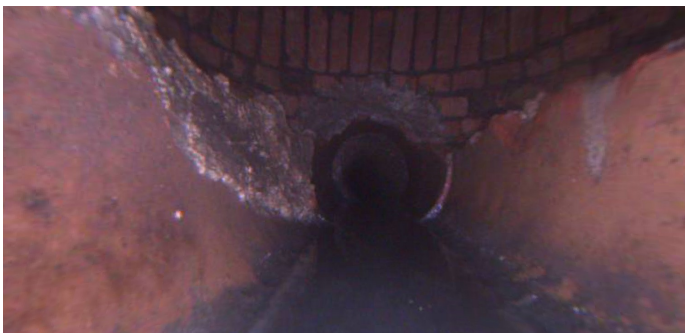
Code: **FM**  
Description: **Fracture Multiple**

Distance (ft): **243.5**  
Structural Grade: **4**  
O&M Grade: **0**  
Clock Start/From: **8**  
Clock To: **4**  
1st Value:  
2nd Value:  
Value Percent:  
Continuous Index: **F01**  
Within 8" of Joint: **YES**  
Remarks:

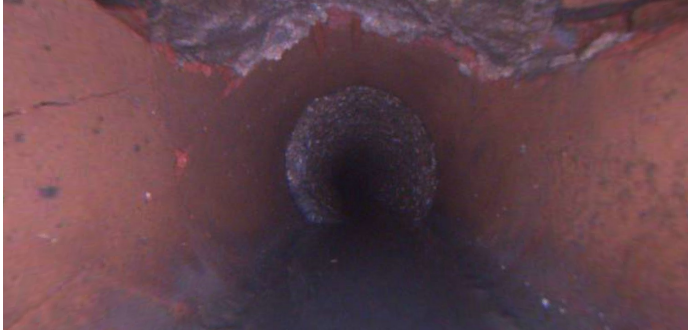
Code:	<b>AMH</b>
Description:	<b>Manhole</b>
Distance (ft):	<b>245.5</b>
Structural Grade:	<b>0</b>
O&M Grade:	<b>0</b>
Clock Start/From:	
Clock To:	
1st Value:	
2nd Value:	
Value Percent:	
Continuous Index:	
Within 8" of Joint:	<b>NO</b>
Remarks:	<b>M-605-044</b>
