Profile/Photo Observation Report

Date:	04/29/2018	Weather:		Coding:	PACP 6.0
Pipe Length (ft):		Owner:	City of Hobart	Pre Clean:	No Pre-Cleaning
P.O.#:	135	Surveyor:	M. Pielacha	PSR:	P-605-050-049
Customer:	City of Hobart	Clean Date:		Shape:	C

Street:	Wisconsin Street	Flow Control:	Not Controlled
City:	Hobart, IN	Year Renewed:	
Location:	Light Highway	Tape/Media #:	DEP 135
Purpose:	Routine Assessment	Dia/Height:	20"
Use:	Sanitary	Material:	VCP
Drain Area:		Lining:	
Category:	NA		
Comment:	5-21-2018		
Location Details:		Direction of Survey:	Upstream
US MH:	M-605-050	DS MH:	M-605-049
		Total Length Surveyed (ft):	133.2

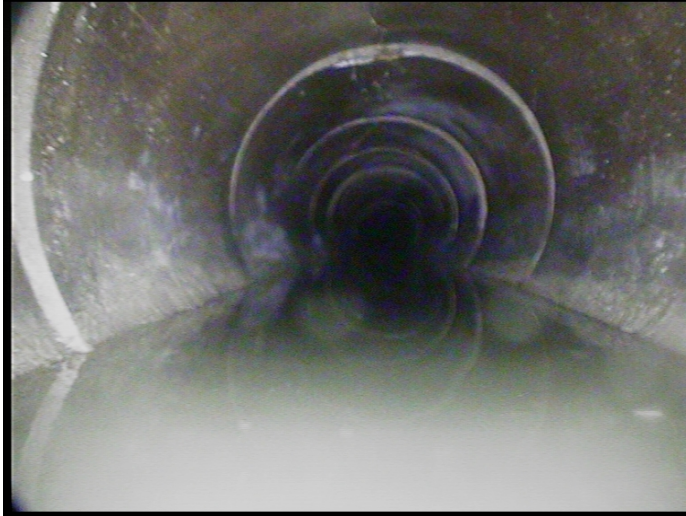
Code: **MWL**
Description: **Water Level**

Distance (ft): **.0**
Structural Grade: **0**
O&M Grade: **0**
Clock Start/From:
Clock To:
1st Value:
2nd Value:
Value Percent: **20.000**
Continuous Index:
Within 8" of Joint: **NO**
Remarks:

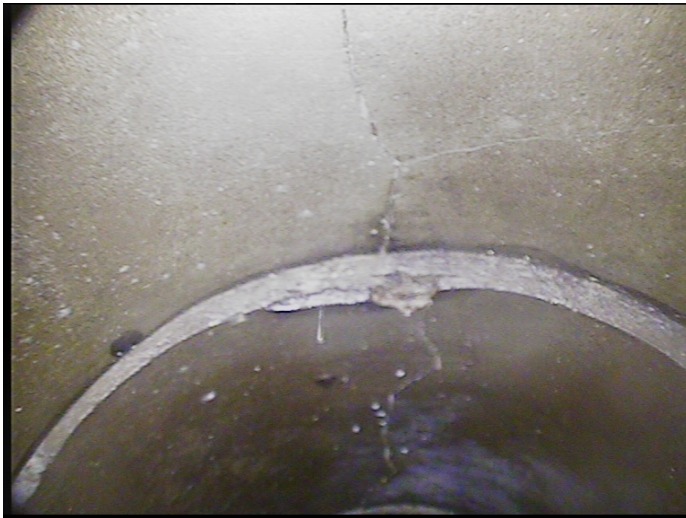
Code: **CL**
Description: **Crack Longitudinal**

Distance (ft): **4.0**
Structural Grade: **2**
O&M Grade: **0**
Clock Start/From: **12**
Clock To:
1st Value:
2nd Value:
Value Percent:
Continuous Index: **S01**
Within 8" of Joint: **YES**
Remarks:

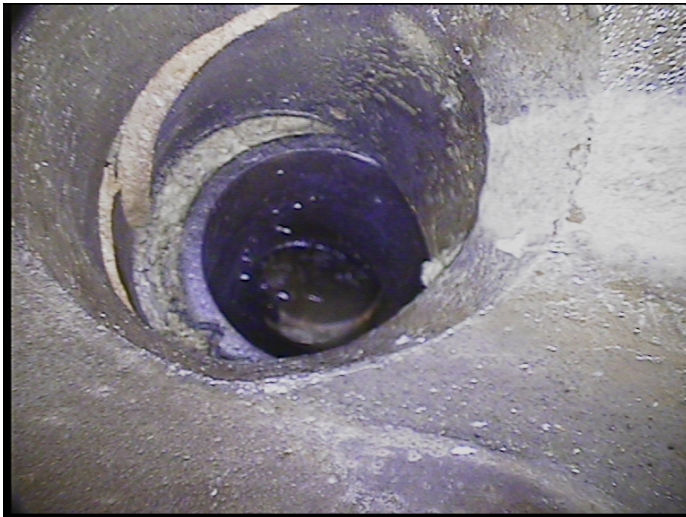
Code: **TF**
Description: **Tap Factory**

Distance (ft): **17.0**
Structural Grade: **0**
O&M Grade: **0**
Clock Start/From: **2**
Clock To:
1st Value: **4.000**
2nd Value:
Value Percent:
Continuous Index:
Within 8" of Joint: **NO**
Remarks:

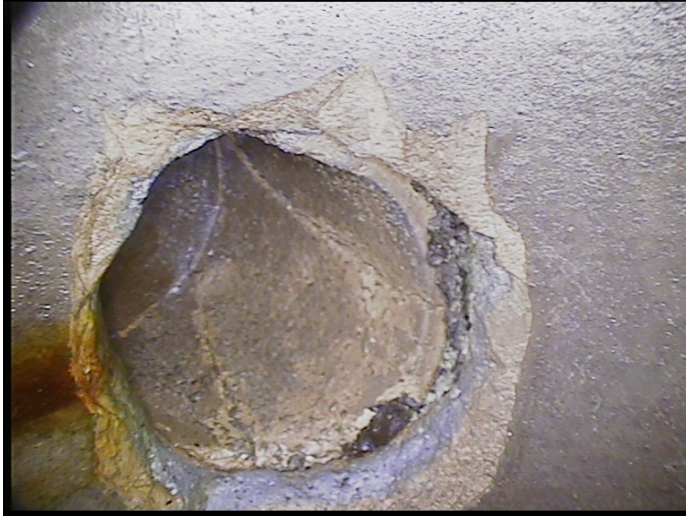
Code: **TF**
Description: **Tap Factory**

Distance (ft): **19.4**
Structural Grade: **0**
O&M Grade: **0**
Clock Start/From: **10**
Clock To:
1st Value: **4.000**
2nd Value:
Value Percent:
Continuous Index:
Within 8" of Joint: **NO**
Remarks:

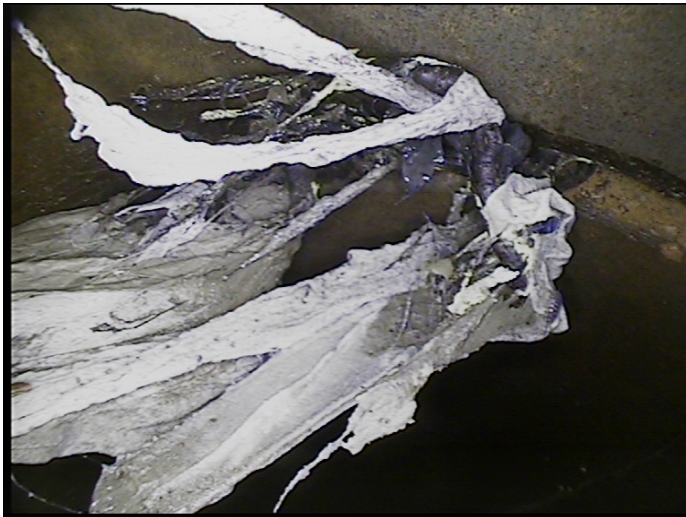
Code:	RMJ
Description:	Roots Medium Joint
Distance (ft):	64.4
Structural Grade:	0
O&M Grade:	3
Clock Start/From:	9
Clock To:	3
1st Value:	
2nd Value:	
Value Percent:	5.000
Continuous Index:	
Within 8" of Joint:	YES
Remarks:

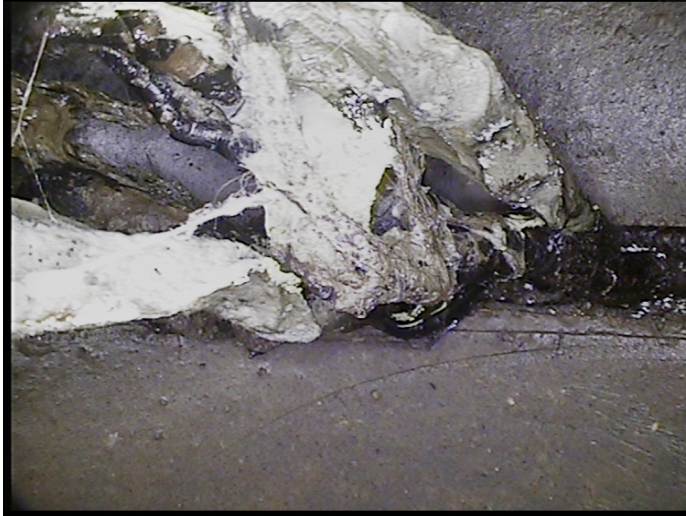
Code: **RTJ**
Description: **Roots Tap Joint**

Distance (ft): **75.4**
Structural Grade: **0**
O&M Grade: **2**
Clock Start/From: **10**
Clock To:
1st Value:
2nd Value:
Value Percent: **5.000**
Continuous Index:
Within 8" of Joint: **YES**
Remarks:

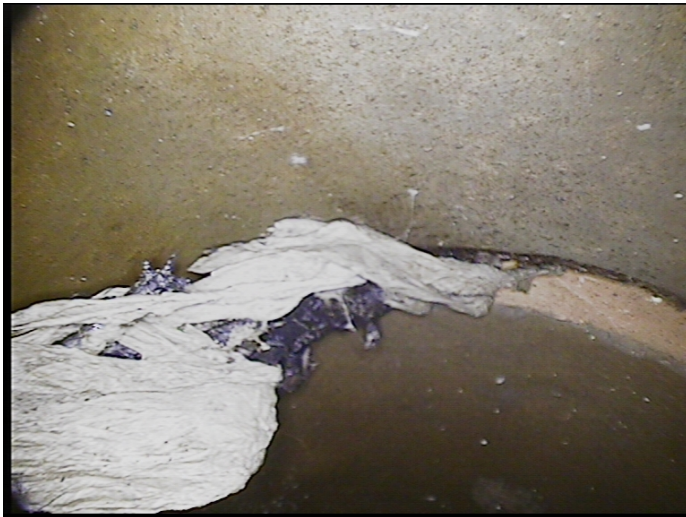
Code: **RMJ**
Description: **Roots Medium Joint**

Distance (ft): **81.9**
Structural Grade: **0**
O&M Grade: **3**
Clock Start/From: **8**
Clock To: **4**
1st Value:
2nd Value:
Value Percent: **10.000**
Continuous Index: **S02**
Within 8" of Joint: **YES**
Remarks:

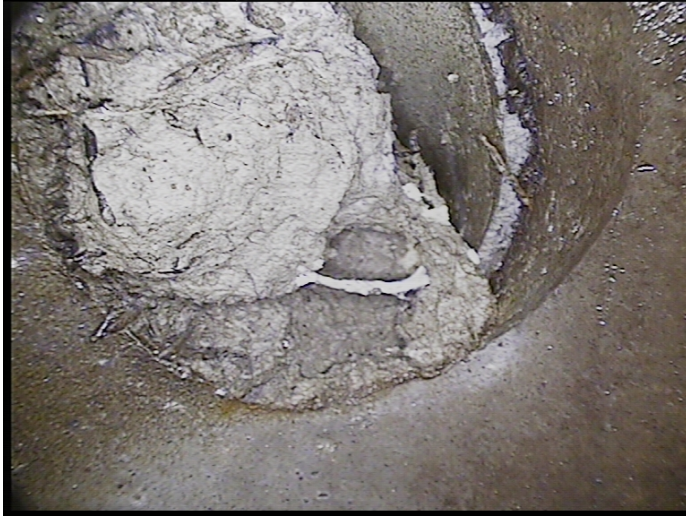
Code: **TFD**
Description: **Tap Factory Defective**

Distance (ft): **94.5**
Structural Grade: **0**
O&M Grade: **2**
Clock Start/From: **10**
Clock To:
1st Value: **4.000**
2nd Value:
Value Percent:
Continuous Index:
Within 8" of Joint: **NO**
Remarks: **Defective**

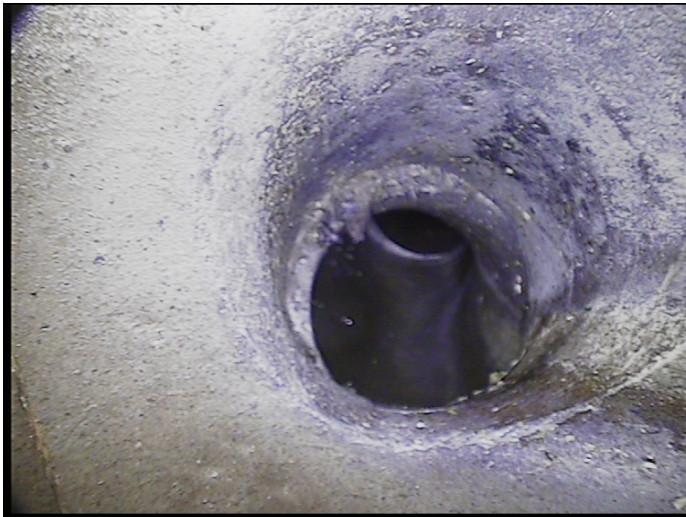
Code: **TF**
Description: **Tap Factory**

Distance (ft): **96.8**
Structural Grade: **0**
O&M Grade: **0**
Clock Start/From: **2**
Clock To:
1st Value: **4.000**
2nd Value:
Value Percent:
Continuous Index:
Within 8" of Joint: **NO**
Remarks:

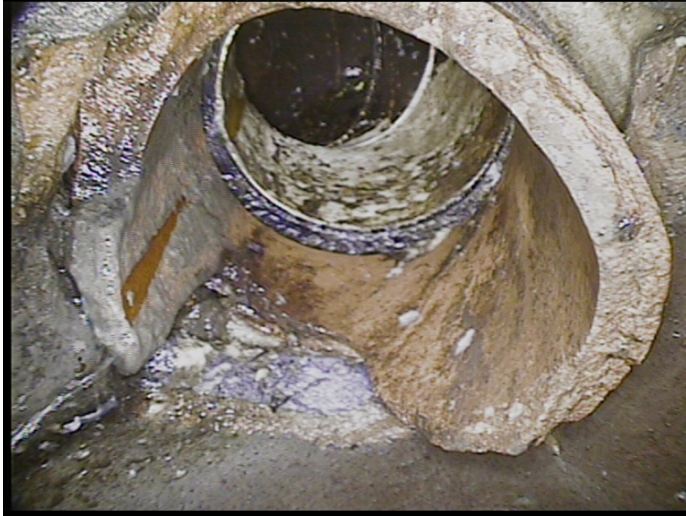
Code: **TBA**
Description: **Tap Break-in Active**

Distance (ft): **96.8**
Structural Grade: **0**
O&M Grade: **0**
Clock Start/From: **10**
Clock To:
1st Value: **4.000**
2nd Value:
Value Percent:
Continuous Index:
Within 8" of Joint: **NO**
Remarks:

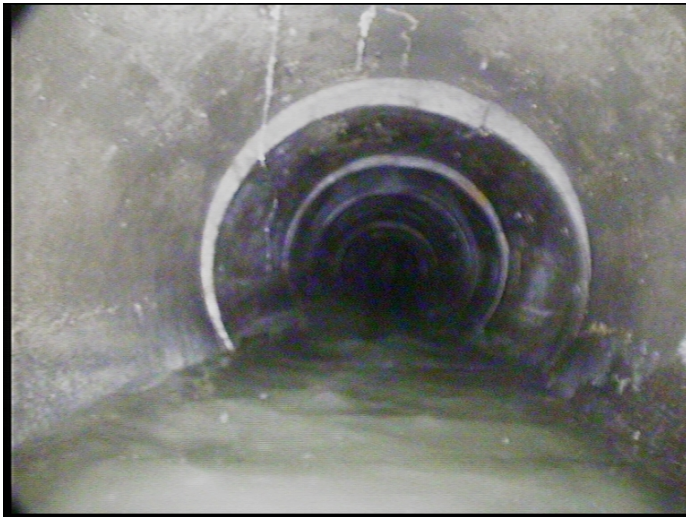
Code: **RMJ**
Description: **Roots Medium Joint**

Distance (ft): **102.4**
Structural Grade: **0**
O&M Grade: **3**
Clock Start/From: **8**
Clock To: **4**
1st Value:
2nd Value:
Value Percent: **10.000**
Continuous Index: **F02**
Within 8" of Joint: **YES**
Remarks:

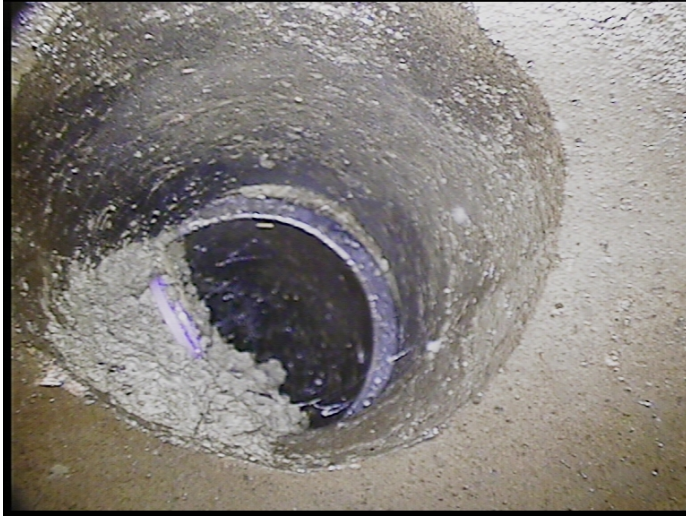
Code: **TF**
Description: **Tap Factory**

Distance (ft): **132.8**
Structural Grade: **0**
O&M Grade: **0**
Clock Start/From: **10**
Clock To:
1st Value: **4.000**
2nd Value:
Value Percent:
Continuous Index:
Within 8" of Joint: **NO**
Remarks:

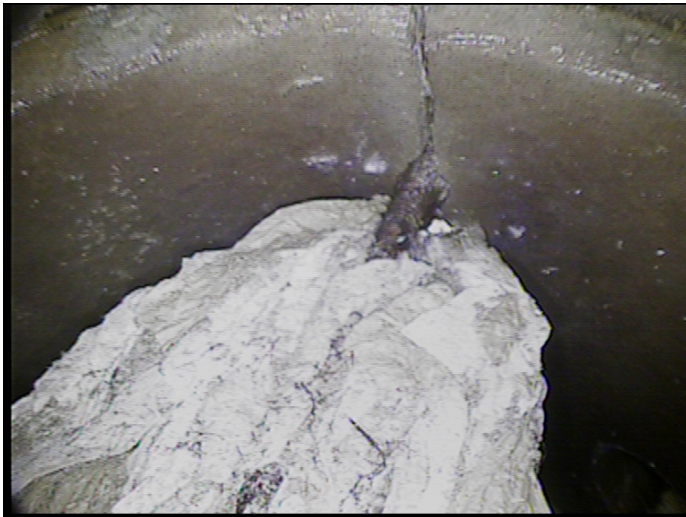
Code: **CL**
Description: **Crack Longitudinal**

Distance (ft): **133.1**
Structural Grade: **2**
O&M Grade: **0**
Clock Start/From: **12**
Clock To:
1st Value:
2nd Value:
Value Percent:
Continuous Index: **F01**
Within 8" of Joint: **NO**
Remarks:

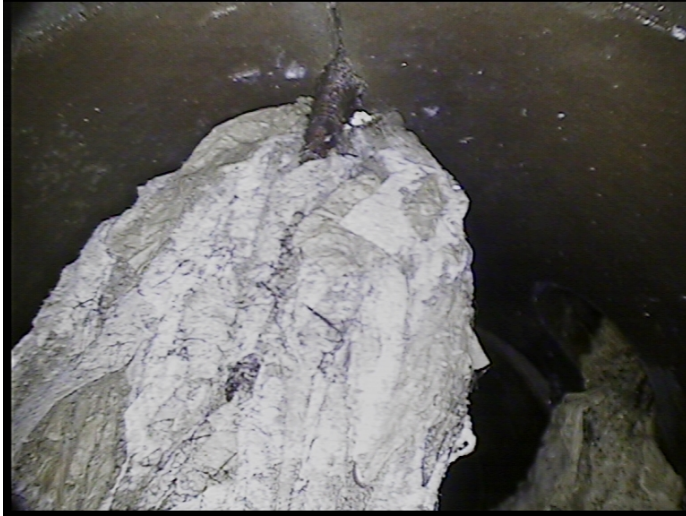
Code: **RTJ**
Description: **Roots Tap Joint**

Distance (ft): **133.2**
Structural Grade: **0**
O&M Grade: **2**
Clock Start/From: **11**
Clock To:
1st Value:
2nd Value:
Value Percent: **15.000**
Continuous Index:
Within 8" of Joint: **YES**
Remarks:

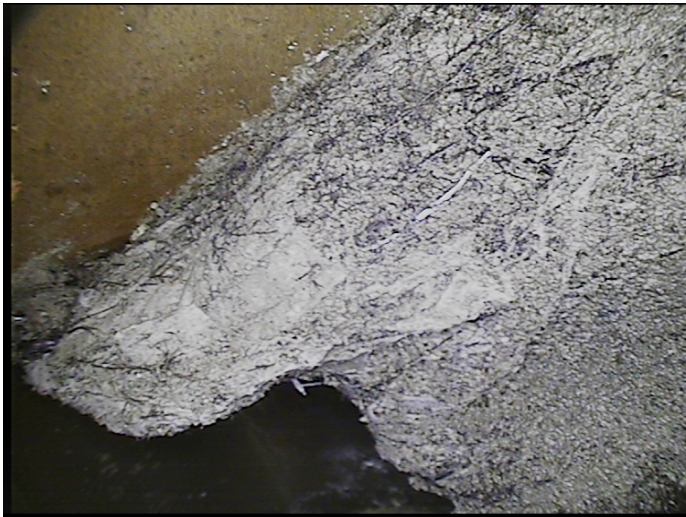
Code: **RMJ**
Description: **Roots Medium Joint**

Distance (ft): **133.2**
Structural Grade: **0**
O&M Grade: **3**
Clock Start/From: **1**
Clock To: **5**
1st Value:
2nd Value:
Value Percent: **15.000**
Continuous Index:
Within 8" of Joint: **YES**
Remarks:

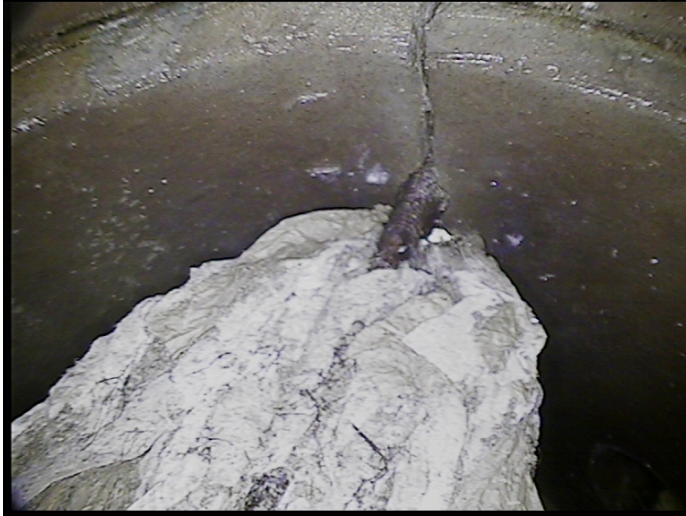
Code:	MSA
Description:	Abandoned Survey
Distance (ft):	133.2
Structural Grade:	0
O&M Grade:	0
Clock Start/From:	
Clock To:	
1st Value:	
2nd Value:	
Value Percent:	
Continuous Index:	
Within 8" of Joint:	NO
Remarks:	can not pass roots
