Profile/Photo Observation Report

Date:	04/24/2018	Weather:		Coding:	PACP 6.0
Pipe Length (ft):		Owner:	City of Hobart	Pre Clean:	No Pre-Cleaning
P.O.#:	67	Surveyor:	M. Pielacha	PSR:	P-504-001-052
Customer:	City of Hobart	Clean Date:		Shape:	C

Street:	Wisconsin Street	Flow Control:	Not Controlled
City:	Hobart, IN	Year Renewed:	
Location:	Light Highway	Tape/Media #:	DEP 67
Purpose:	Routine Assessment	Dia/Height:	18"
Use:	Sanitary	Material:	VCP
Drain Area:		Lining:	
Category:	NA		
Comment:	YES501824 Submittal 2		
Location Details:		Direction of Survey:	Downstream
US MH:	M-504-001	DS MH:	M-605-052
		Total Length Surveyed (ft):	4.2

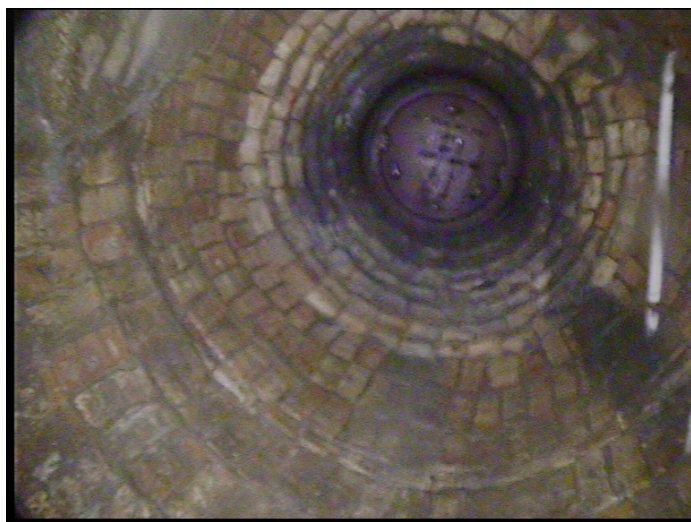
Code: **AMH**
Description: **Manhole**

Distance (ft): **.0**
Structural Grade: **0**
O&M Grade: **0**
Clock Start/From:
Clock To:
1st Value:
2nd Value:
Value Percent:
Continuous Index:
Within 8" of Joint: **NO**
Remarks: **M-504-001**

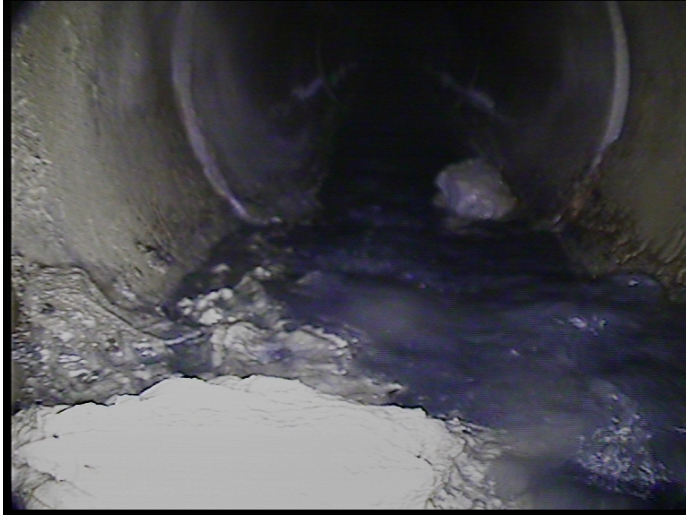
Code: **MWL**
Description: **Water Level**

Distance (ft): **.0**
Structural Grade: **0**
O&M Grade: **0**
Clock Start/From:
Clock To:
1st Value:
2nd Value:
Value Percent: **10.000**
Continuous Index:
Within 8" of Joint: **NO**
Remarks:

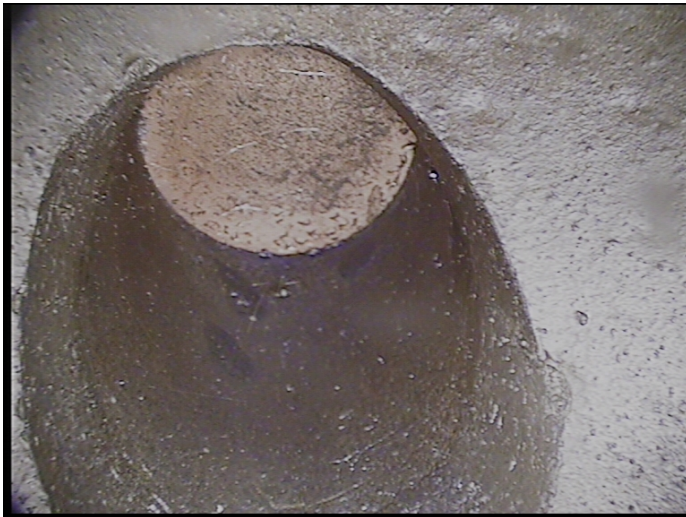
Code: **TFC**
Description: **Tap Factory Capped**

Distance (ft): **3.5**
Structural Grade: **0**
O&M Grade: **0**
Clock Start/From: **10**
Clock To:
1st Value: **4.000**
2nd Value:
Value Percent:
Continuous Index:
Within 8" of Joint: **NO**
Remarks:

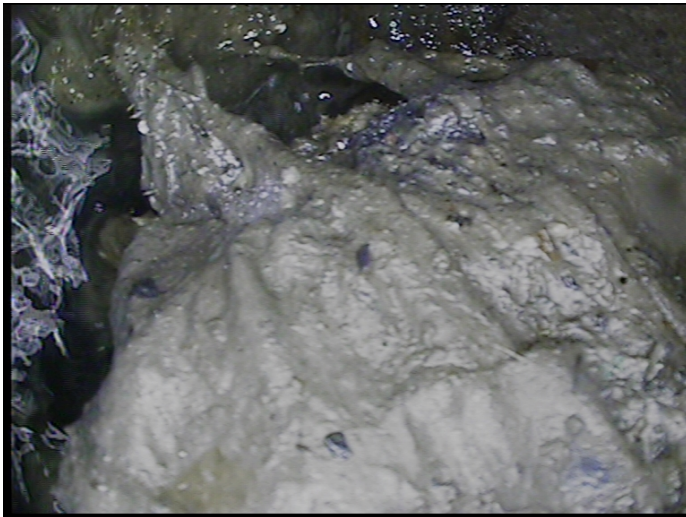
Code: **OBR**
Description: **Obstacle Rocks**

Distance (ft): **3.7**
Structural Grade: **0**
O&M Grade: **3**
Clock Start/From: **4**
Clock To:
1st Value:
2nd Value:
Value Percent: **15.000**
Continuous Index:
Within 8" of Joint: **NO**
Remarks:

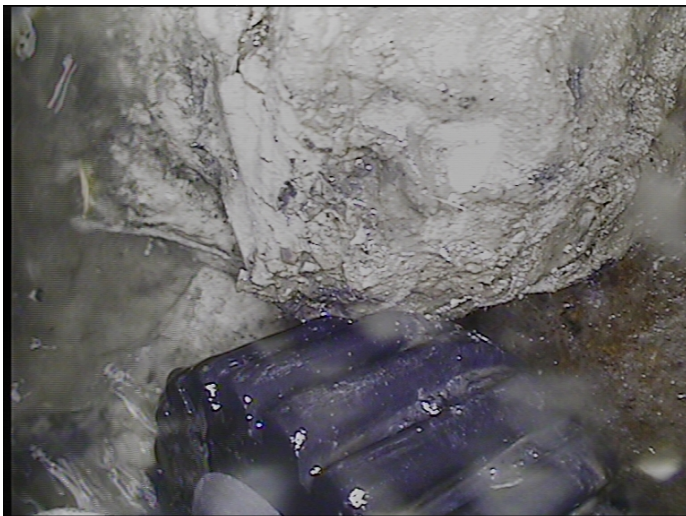
Code: **MSA**
Description: **Abandoned Survey**

Distance (ft): **4.2**
Structural Grade: **0**
O&M Grade: **0**
Clock Start/From:
Clock To:
1st Value:
2nd Value:
Value Percent:
Continuous Index:
Within 8" of Joint: **NO**
Remarks: **Will roll over if i try and pass large rock**
