Profile/Photo Observation Report

Date:	04/16/2018	Weather:		Coding:	PACP 6.0
Pipe Length (ft):		Owner:	City of Hobart	Pre Clean:	No Pre-Cleaning
P.O.#:	64-3	Surveyor:	M. Pielacha	PSR:	M-605-056-M-605-055
Customer:	City of Hobart	Clean Date:		Shape:	C

Street:	Beverly Lane	Flow Control:	Not Controlled
City:	Hobart, IN	Year Renewed:	
Location:	Light Highway	Tape/Media #:	DEP 64
Purpose:	Routine Assessment	Dia/Height:	15"
Use:	Sanitary	Material:	CP
Drain Area:		Lining:

US MH: **M-605-056** DS MH: **M-605-055** Total Length Surveyed (ft): **20.7**

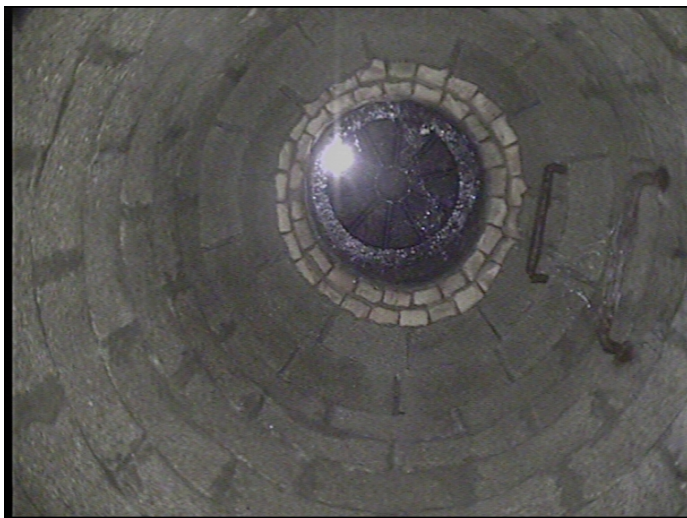
Code: **AMH**
Description: **Manhole**

Distance (ft): **.0**
Structural Grade: **0**
O&M Grade: **0**
Clock Start/From:
Clock To:
1st Value:
2nd Value:
Value Percent:
Continuous Index:
Within 8" of Joint: **NO**
Remarks: **M-605-056**

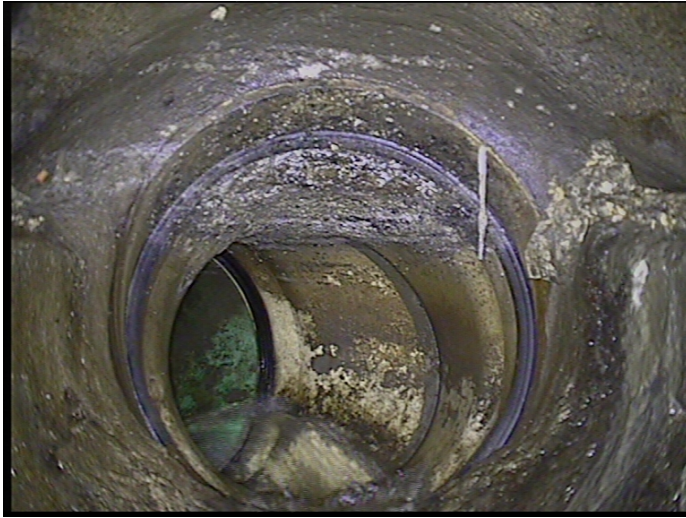
Code: **MWL**
Description: **Water Level**

Distance (ft): **.0**
Structural Grade: **0**
O&M Grade: **0**
Clock Start/From:
Clock To:
1st Value:
2nd Value:
Value Percent: **10.000**
Continuous Index:
Within 8" of Joint: **NO**
Remarks:

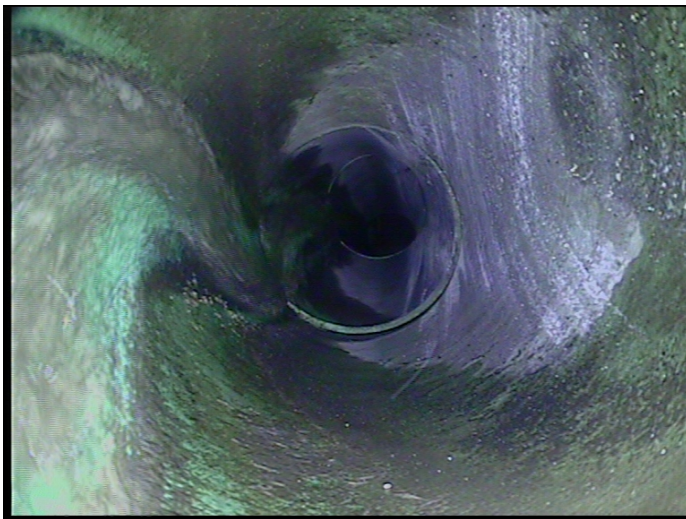
Code: **LL**
Description: **Alignment Left**

Distance (ft): **3.6**
Structural Grade: **0**
O&M Grade: **4**
Clock Start/From:
Clock To:
1st Value:
2nd Value:
Value Percent: **25.000**
Continuous Index:
Within 8" of Joint: **NO**
Remarks:

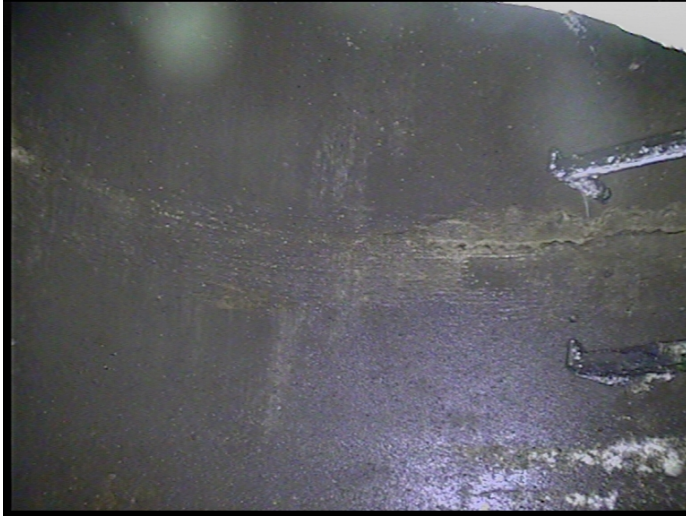
Code:	AMH
Description:	Manhole
Distance (ft):	20.7
Structural Grade:	0
O&M Grade:	0
Clock Start/From:	
Clock To:	
1st Value:	
2nd Value:	
Value Percent:	
Continuous Index:	
Within 8" of Joint:	NO
Remarks:	M-605-055
