Profile/Photo Observation Report

Date:	04/16/2018	Weather:		Coding:	PACP 6.0
Pipe Length (ft):		Owner:	City of Hobart	Pre Clean:	No Pre-Cleaning
P.O.#:	64-2	Surveyor:	M. Pielacha	PSR:	M-605-057-M-605-056
Customer:	City of Hobart	Clean Date:		Shape:	C

Street:	Beverly Lane	Flow Control:	Not Controlled
City:	Hobart, IN	Year Renewed:	
Location:	Light Highway	Tape/Media #:	DEP 64
Purpose:	Routine Assessment	Dia/Height:	15"
Use:	Sanitary	Material:	CP
Drain Area:		Lining:	
Category:	NA		
Comment:			
Location Details:		Direction of Survey:	Downstream
US MH:	M-605-057	DS MH:	M-605-056
		Total Length Surveyed (ft):	298.7

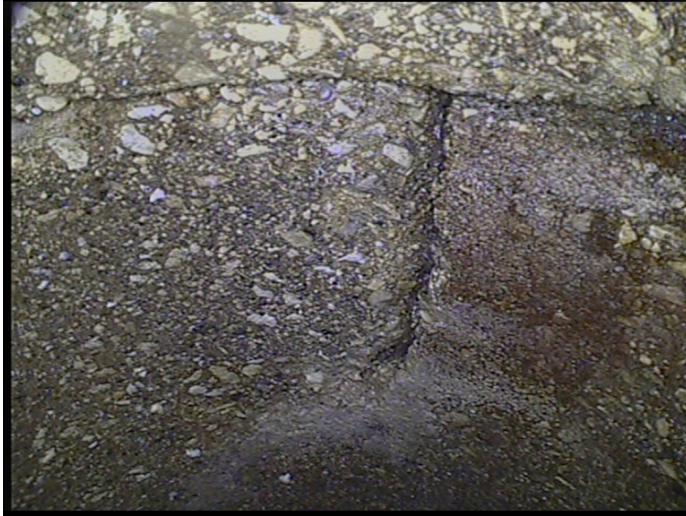
Code: **FL**
Description: **Fracture Longitudinal**

Distance (ft): **127.1**
Structural Grade: **3**
O&M Grade: **0**
Clock Start/From: **3**
Clock To:
1st Value:
2nd Value:
Value Percent:
Continuous Index:
Within 8" of Joint: **YES**
Remarks:

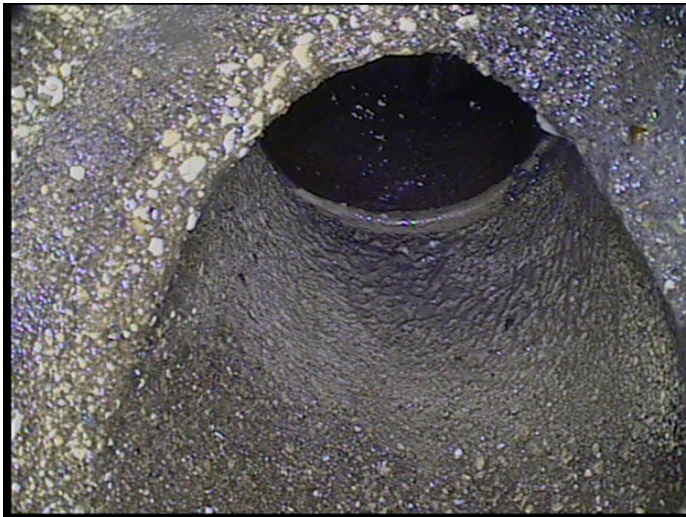
Code: **TF**
Description: **Tap Factory**

Distance (ft): **153.1**
Structural Grade: **0**
O&M Grade: **0**
Clock Start/From: **2**
Clock To:
1st Value: **4.000**
2nd Value:
Value Percent:
Continuous Index:
Within 8" of Joint: **NO**
Remarks:

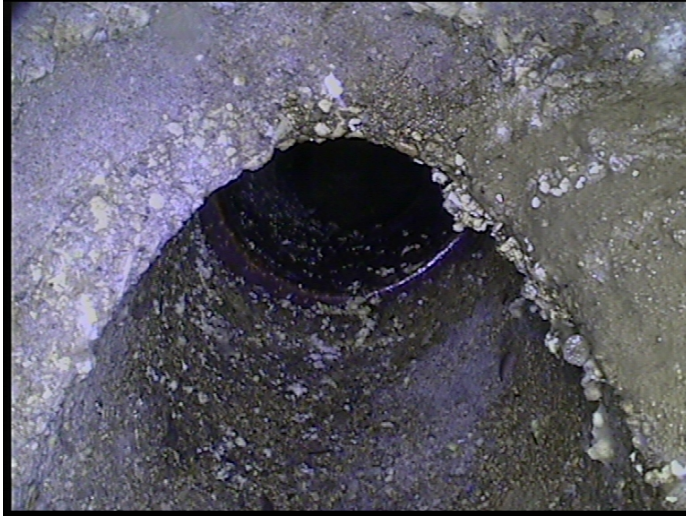
Code: **TF**
Description: **Tap Factory**

Distance (ft): **268.6**
Structural Grade: **0**
O&M Grade: **0**
Clock Start/From: **2**
Clock To:
1st Value: **4.000**
2nd Value:
Value Percent:
Continuous Index:
Within 8" of Joint: **NO**
Remarks:

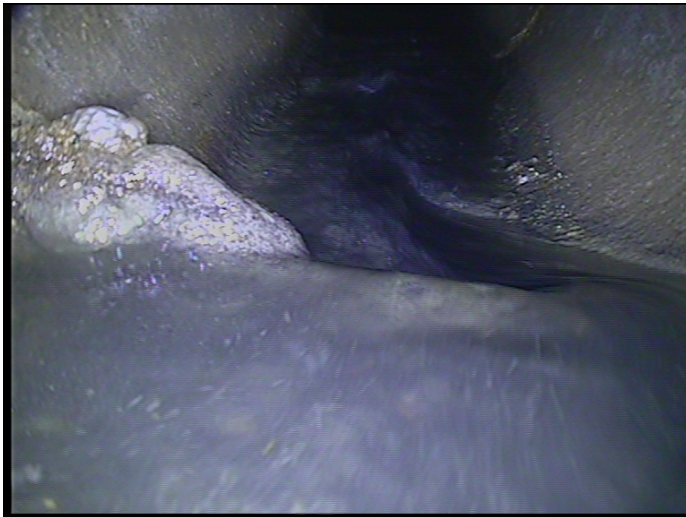
Code: **OBZ**
Description: **Obstacle Other**

Distance (ft): **276.0**
Structural Grade: **0**
O&M Grade: **3**
Clock Start/From: **5**
Clock To: **8**
1st Value:
2nd Value:
Value Percent: **15.000**
Continuous Index:
Within 8" of Joint: **NO**
Remarks: **Debris**
