## Profile/Photo Observation Report

Street:	<b>S LAKE PARK AVE &amp; W CLEVELAND A</b>	Flow Control:	<b>Not Controlled</b>
City:	<b>Hobart, IN</b>	Year Renewed:	
Location:	<b>Other</b>	Tape/Media #:	
Purpose:	<b>Not Known</b>	Dia/Height:	<b>10"</b>
Use:	<b>Sanitary</b>	Material:	<b>VCP</b>
Drain Area:	<b>NA</b>	Lining:	
Category:	<b>NA</b>		
Comment:

Location Details:		Direction of Survey:	<b>Upstream</b>
US MH:	<b>M-605-061</b>	DS MH:	<b>M-604-001</b>
		Total Length Surveyed (ft):	<b>68.4</b>

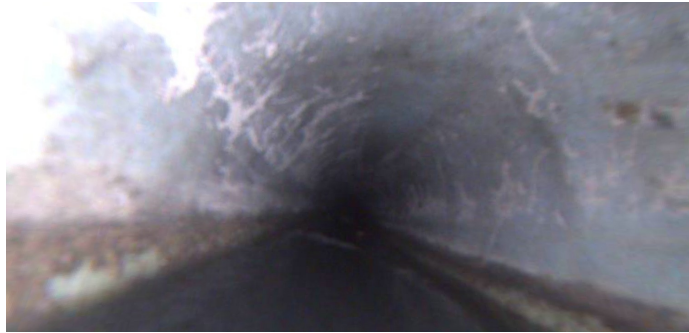
Code: **MWL**  
Description: **Water Level**

Distance (ft): **.0**  
Structural Grade: **0**  
O&M Grade: **0**  
Clock Start/From:  
Clock To:  
1st Value:  
2nd Value:  
Value Percent: **20.000**  
Continuous Index:  
Within 8" of Joint: **NO**  
Remarks:

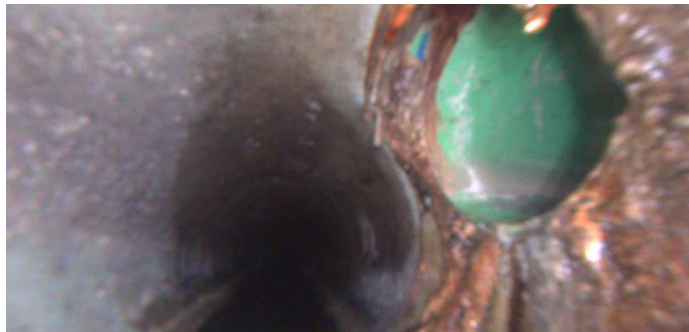
Code: **TB**  
Description: **Tap Break-in**

Distance (ft): **20.9**  
Structural Grade: **0**  
O&M Grade: **0**  
Clock Start/From: **2**  
Clock To:  
1st Value: **4.000**  
2nd Value:  
Value Percent:  
Continuous Index:  
Within 8" of Joint:  
Remarks: **dae**

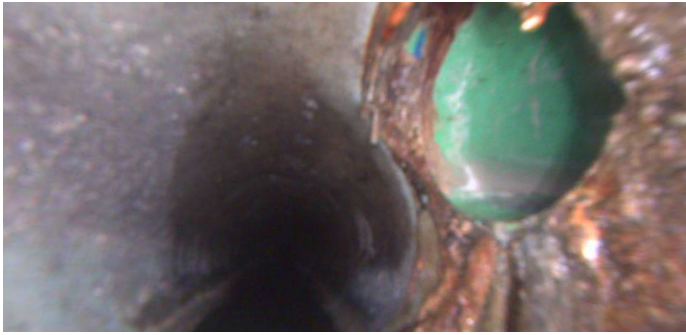
Code: **DAE**  
Description: **Deposits Attached Encrustation**

Distance (ft): **20.9**  
Structural Grade: **0**  
O&M Grade: **2**  
Clock Start/From: **1**  
Clock To: **5**  
1st Value:  
2nd Value:  
Value Percent: **5.000**  
Continuous Index:  
Within 8" of Joint: **NO**  
Remarks:

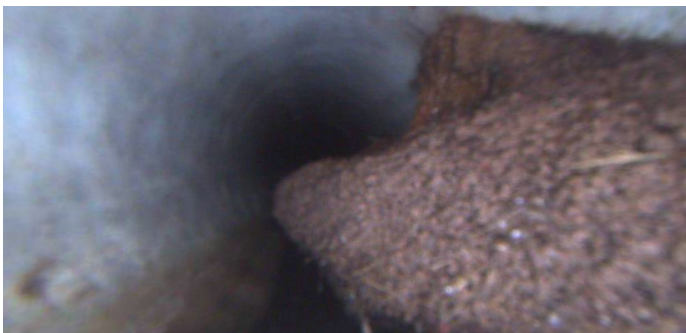
Code: **RMB**  
Description: **Roots Medium Barrel**

Distance (ft): **67.2**  
Structural Grade: **0**  
O&M Grade: **4**  
Clock Start/From: **1**  
Clock To: **6**  
1st Value:  
2nd Value:  
Value Percent: **40.000**  
Continuous Index:  
Within 8" of Joint: **NO**  
Remarks:

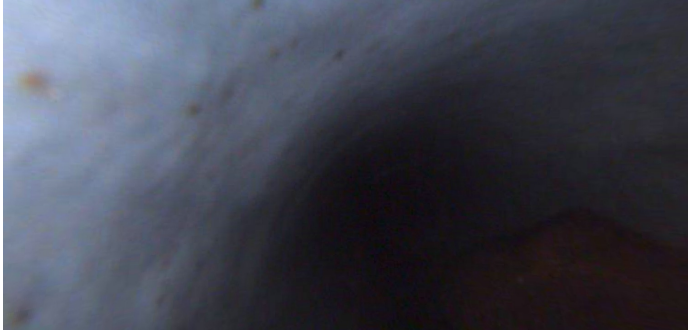
Code:	<b>MSA</b>
Description:	<b>Abandoned Survey</b>
Distance (ft):	<b>68.4</b>
Structural Grade:	<b>0</b>
O&M Grade:	<b>0</b>
Clock Start/From:	
Clock To:	
1st Value:	
2nd Value:	
Value Percent:	
Continuous Index:	
Within 8" of Joint:	<b>NO</b>
Remarks:	<b>roots</b>
