Profile/Photo Observation Report

Date:	04/23/2018	Weather:		Coding:	PACP 6.0
Pipe Length (ft):	335.0	Owner:	NA	Pre Clean:	Not Known
P.O.#:		Surveyor:	Jen Costello	PSR:	P-604-001-061
Customer:		Clean Date:	01/01/1900	Shape:	C

Street:	S Lake Park Ave	Flow Control:	Not Controlled
City:	Hobart, IN	Year Renewed:	
Location:	Other	Tape/Media #:	
Purpose:	Not Known	Dia/Height:	10"
Use:	Sanitary	Material:	VCP
Drain Area:	NA	Lining:	
Category:	NA		
Comment:

Location Details:		Direction of Survey:	Upstream
US MH:	M-605-061	DS MH:	M-604-001
		Total Length Surveyed (ft):	68.4

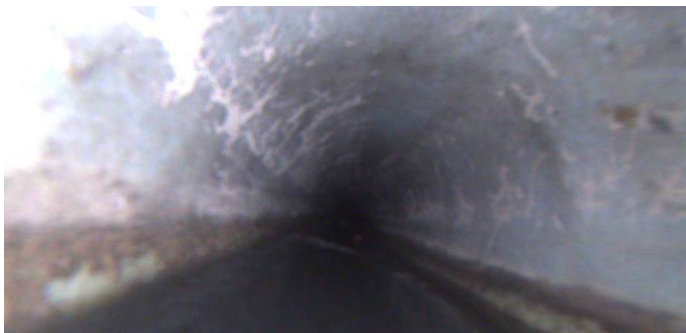
Code: **AMH**
Description: **Manhole**

Distance (ft): **.0**
Structural Grade: **0**
O&M Grade: **0**
Clock Start/From:
Clock To:
1st Value:
2nd Value:
Value Percent:
Continuous Index:
Within 8" of Joint: **NO**
Remarks: **M-604-001**

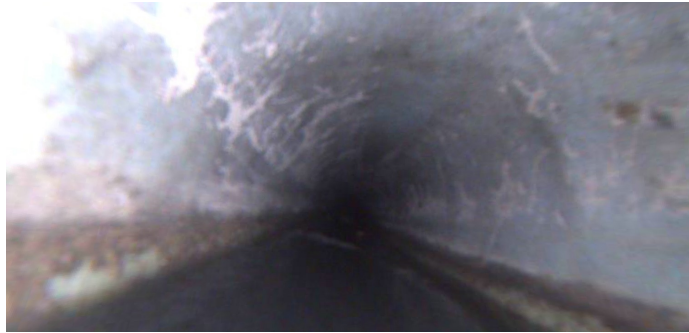
Code: **MWL**
Description: **Water Level**

Distance (ft): **.0**
Structural Grade: **0**
O&M Grade: **0**
Clock Start/From:
Clock To:
1st Value:
2nd Value:
Value Percent: **20.000**
Continuous Index:
Within 8" of Joint: **NO**
Remarks:

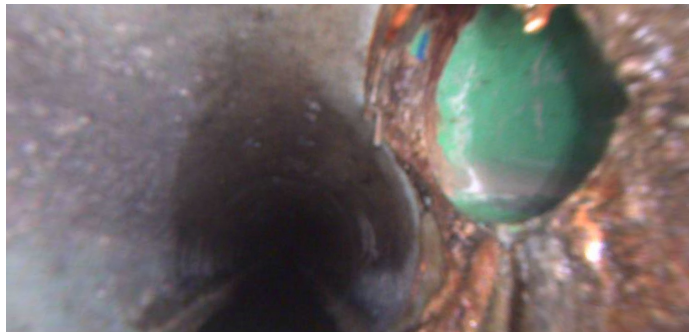
Code: **TB**
Description: **Tap Break-in**

Distance (ft): **20.9**
Structural Grade: **0**
O&M Grade: **0**
Clock Start/From: **2**
Clock To:
1st Value: **4.000**
2nd Value:
Value Percent:
Continuous Index:
Within 8" of Joint:
Remarks: **dae**

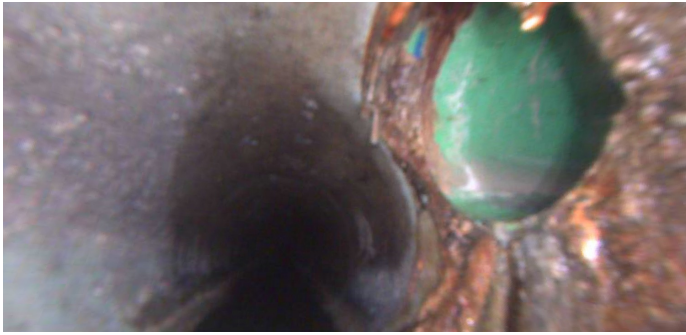
Code: **DAE**
Description: **Deposits Attached Encrustation**

Distance (ft): **20.9**
Structural Grade: **0**
O&M Grade: **2**
Clock Start/From: **1**
Clock To: **5**
1st Value:
2nd Value:
Value Percent: **5.000**
Continuous Index:
Within 8" of Joint: **NO**
Remarks:

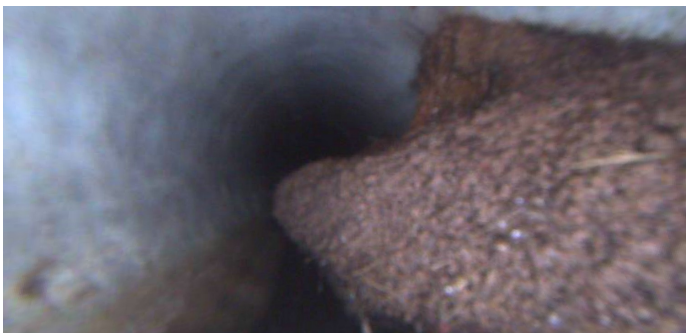
Code: **RMB**
Description: **Roots Medium Barrel**

Distance (ft): **67.2**
Structural Grade: **0**
O&M Grade: **4**
Clock Start/From: **1**
Clock To: **6**
1st Value:
2nd Value:
Value Percent: **40.000**
Continuous Index:
Within 8" of Joint: **NO**
Remarks:

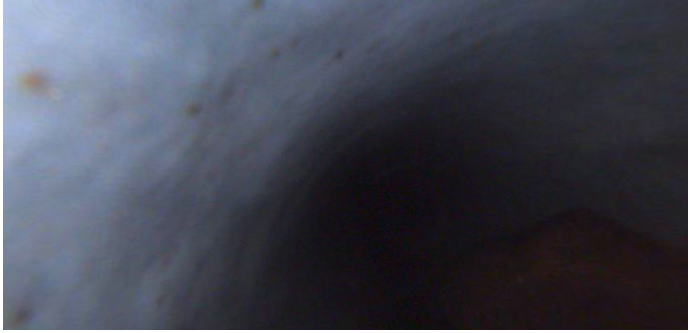
Code:	MSA
Description:	Abandoned Survey
Distance (ft):	68.4
Structural Grade:	0
O&M Grade:	0
Clock Start/From:	
Clock To:	
1st Value:	
2nd Value:	
Value Percent:	
Continuous Index:	
Within 8" of Joint:	NO
Remarks:	roots
