Profile/Photo Observation Report

Street:	Beverly Ln.	Flow Control:	Not Controlled
City:	Hobart, IN	Year Renewed:	
Location:	Other	Tape/Media #:	
Purpose:	Not Known	Dia/Height:	8"
Use:	Sanitary	Material:	CP
Drain Area:	NA	Lining:	
Category:	NA		
Comment:

Location Details:		Direction of Survey:	Downstream
US MH:	M-605-066	DS MH:	M-605-065
		Total Length Surveyed (ft):	3.4

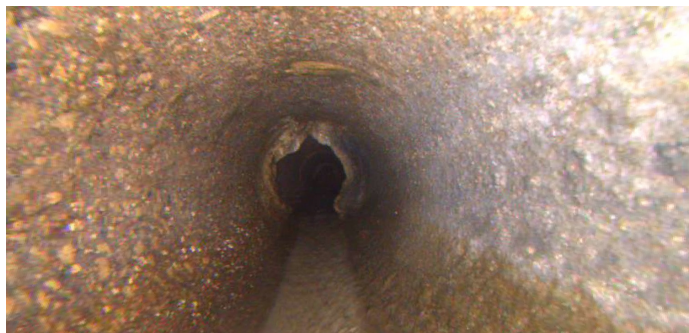
Code: **AMH**
 Description: **Manhole**

Distance (ft): **.0**
 Structural Grade: **0**
 O&M Grade: **0**
 Clock Start/From:
 Clock To:
 1st Value:
 2nd Value:
 Value Percent:
 Continuous Index:
 Within 8" of Joint: **NO**
 Remarks: **M-605-066**

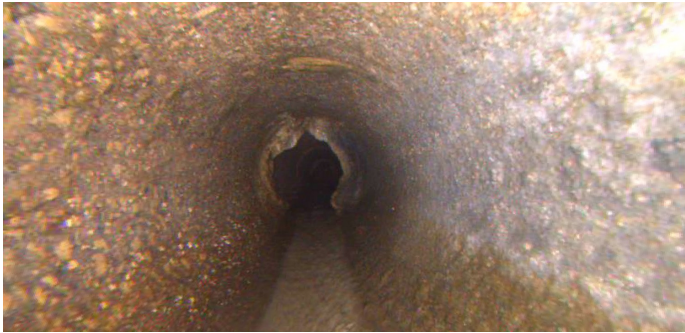
Code:	MWL
Description:	Water Level

Distance (ft):	.0
Structural Grade:	0
O&M Grade:	0
Clock Start/From:	
Clock To:	
1st Value:	
2nd Value:	
Value Percent:	5.000
Continuous Index:	
Within 8" of Joint:	NO
Remarks:

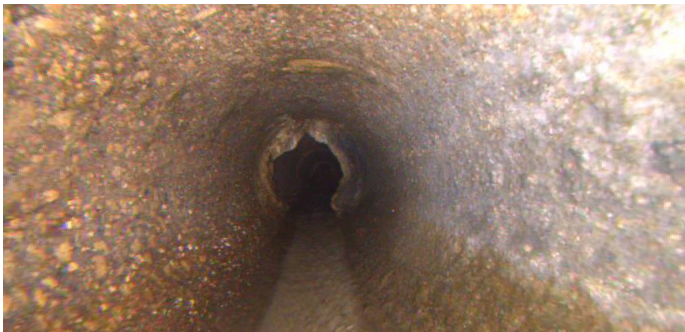
Code:	SAP
Description:	Surface Aggregate Projecting

Distance (ft):	.0
Structural Grade:	3
O&M Grade:	0
Clock Start/From:	8
Clock To:	4
1st Value:	
2nd Value:	
Value Percent:	
Continuous Index:	
Within 8" of Joint:	
Remarks:

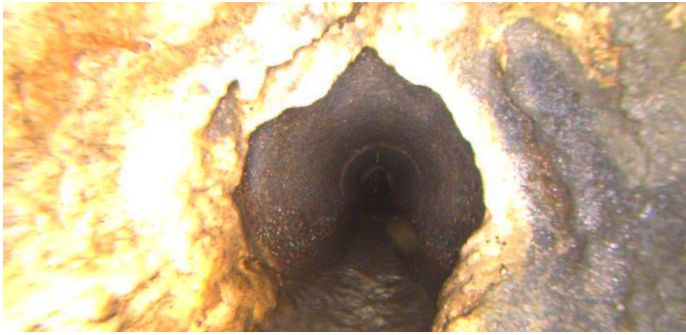
Code: **DAE**
Description: **Deposits Attached Encrustation**

Distance (ft): **2.5**
Structural Grade: **0**
O&M Grade: **4**
Clock Start/From: **7**
Clock To: **5**
1st Value:
2nd Value:
Value Percent: **30.000**
Continuous Index:
Within 8" of Joint: **YES**
Remarks:

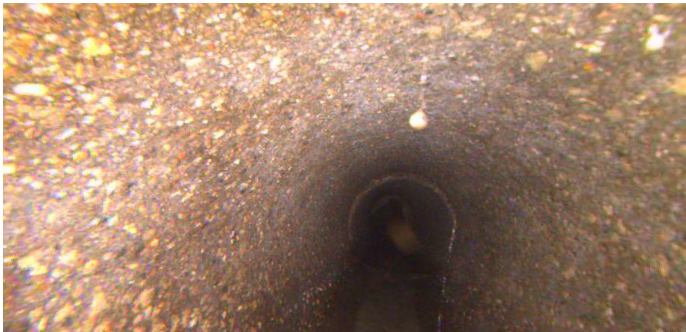
Code: **MSA**
Description: **Abandoned Survey**

Distance (ft): **3.4**
Structural Grade: **0**
O&M Grade: **0**
Clock Start/From:
Clock To:
1st Value:
2nd Value:
Value Percent:
Continuous Index:
Within 8" of Joint: **NO**
Remarks: **DAE**
