Profile/Photo Observation Report

Date:	04/23/2018	Weather:		Coding:	PACP 6.0
Pipe Length (ft):	364.4	Owner:	NA	Pre Clean:	Not Known
P.O.#:		Surveyor:	Jen Costello	PSR:	P-605-067-066
Customer:		Clean Date:	01/01/1900	Shape:	C

Street:	BEVERLY BLVD	Flow Control:	Not Controlled
City:	Hobart, IN	Year Renewed:	
Location:	Other	Tape/Media #:	
Purpose:	Not Known	Dia/Height:	12"
Use:	Sanitary	Material:	CP
Drain Area:	NA	Lining:	
Category:	NA		
Comment:			
Location Details:		Direction of Survey:	Upstream
US MH:	M-605-067	DS MH:	M-605-066
		Total Length Surveyed (ft):	359.5

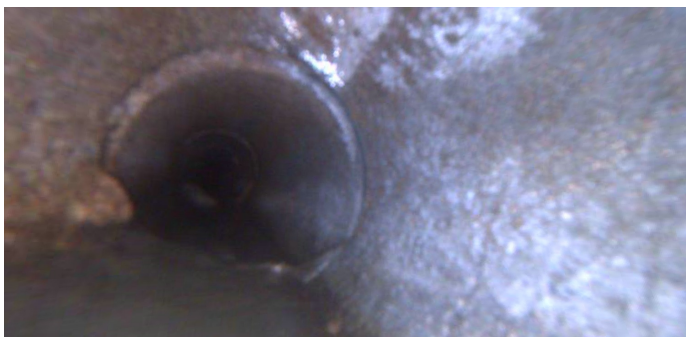
Code: **AMH**
Description: **Manhole**

Distance (ft): **.0**
Structural Grade: **0**
O&M Grade: **0**
Clock Start/From:
Clock To:
1st Value:
2nd Value:
Value Percent:
Continuous Index:
Within 8" of Joint: **NO**
Remarks: **M-605-066**

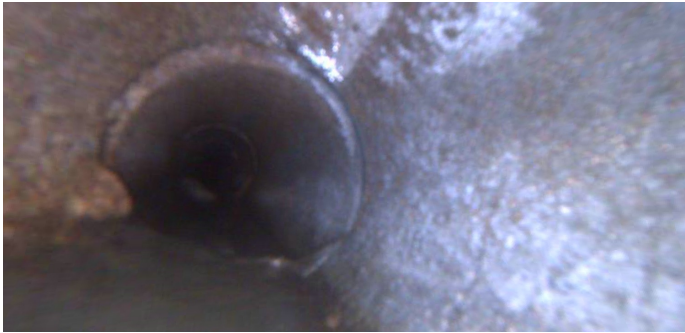
Code: **MWL**
Description: **Water Level**

Distance (ft): **.0**
Structural Grade: **0**
O&M Grade: **0**
Clock Start/From:
Clock To:
1st Value:
2nd Value:
Value Percent: **10.000**
Continuous Index:
Within 8" of Joint: **NO**
Remarks:

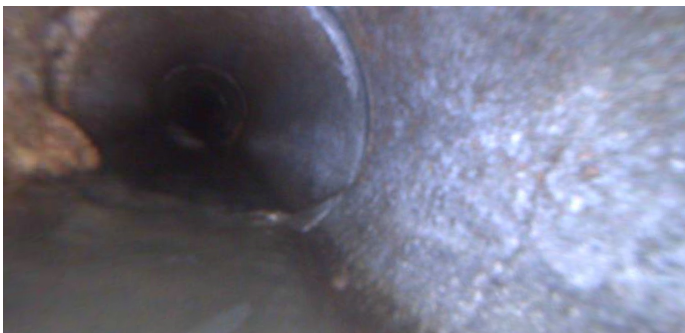
Code: **FC**
Description: **Fracture Circumferential**

Distance (ft): **.5**
Structural Grade: **2**
O&M Grade: **0**
Clock Start/From: **3**
Clock To: **4**
1st Value:
2nd Value:
Value Percent:
Continuous Index:
Within 8" of Joint:
Remarks:

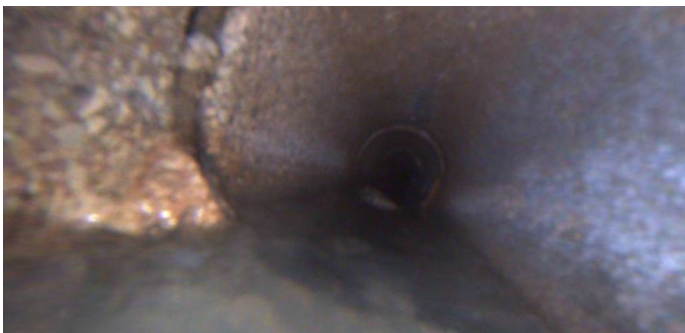
Code: **DAE**
Description: **Deposits Attached Encrustation**

Distance (ft): **2.2**
Structural Grade: **0**
O&M Grade: **2**
Clock Start/From: **8**
Clock To: **9**
1st Value:
2nd Value:
Value Percent: **5.000**
Continuous Index:
Within 8" of Joint: **YES**
Remarks:

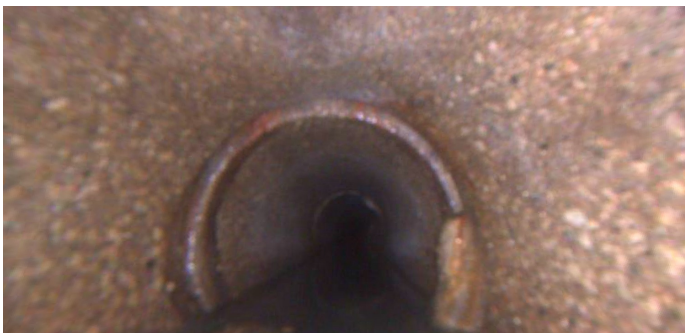
Code: **DAE**
Description: **Deposits Attached Encrustation**

Distance (ft): **4.6**
Structural Grade: **0**
O&M Grade: **2**
Clock Start/From: **8**
Clock To: **4**
1st Value:
2nd Value:
Value Percent: **5.000**
Continuous Index: **S02**
Within 8" of Joint: **YES**
Remarks:

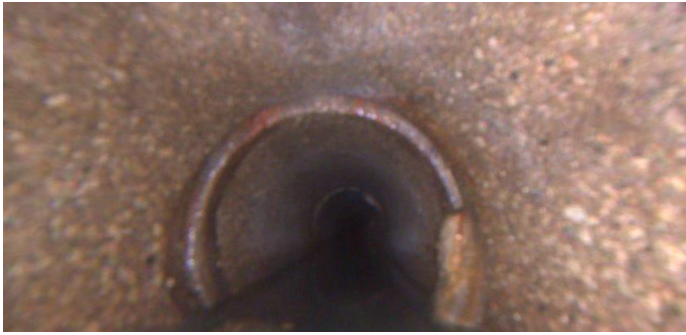
Code: **IW**
Description: **Infil Weeper**

Distance (ft): **4.6**
Structural Grade: **0**
O&M Grade: **2**
Clock Start/From: **8**
Clock To: **4**
1st Value:
2nd Value:
Value Percent:
Continuous Index: **S03**
Within 8" of Joint: **YES**
Remarks:

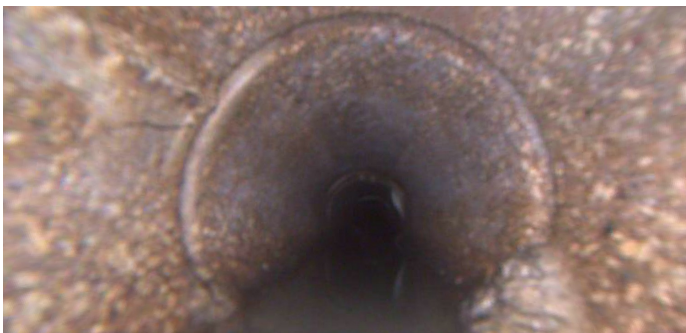
Code: **FM**
Description: **Fracture Multiple**

Distance (ft): **26.2**
Structural Grade: **4**
O&M Grade: **0**
Clock Start/From: **10**
Clock To: **11**
1st Value:
2nd Value:
Value Percent:
Continuous Index:
Within 8" of Joint: **YES**
Remarks:

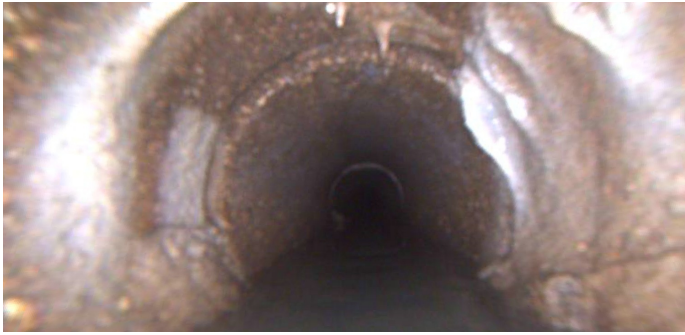
Code: **FM**
Description: **Fracture Multiple**

Distance (ft): **29.1**
Structural Grade: **4**
O&M Grade: **0**
Clock Start/From: **8**
Clock To: **4**
1st Value:
2nd Value:
Value Percent:
Continuous Index: **S04**
Within 8" of Joint: **YES**
Remarks:

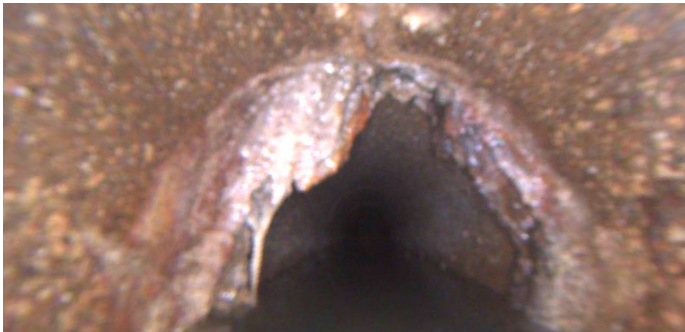
Code: **DAE**
Description: **Deposits Attached Encrustation**

Distance (ft): **64.7**
Structural Grade: **0**
O&M Grade: **3**
Clock Start/From: **8**
Clock To: **4**
1st Value:
2nd Value:
Value Percent: **20.000**
Continuous Index:
Within 8" of Joint: **YES**
Remarks:

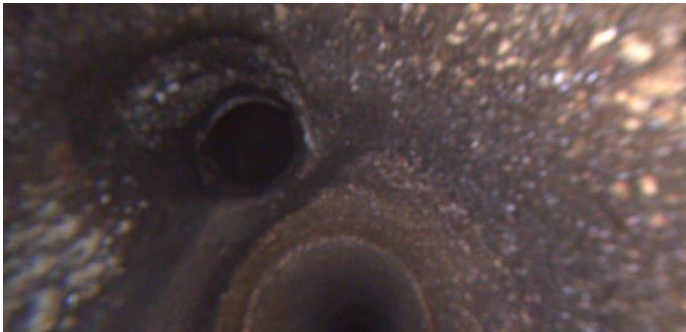
Code: **TF**
Description: **Tap Factory**

Distance (ft): **76.0**
Structural Grade: **0**
O&M Grade: **0**
Clock Start/From: **11**
Clock To:
1st Value: **4.000**
2nd Value:
Value Percent:
Continuous Index:
Within 8" of Joint:
Remarks:

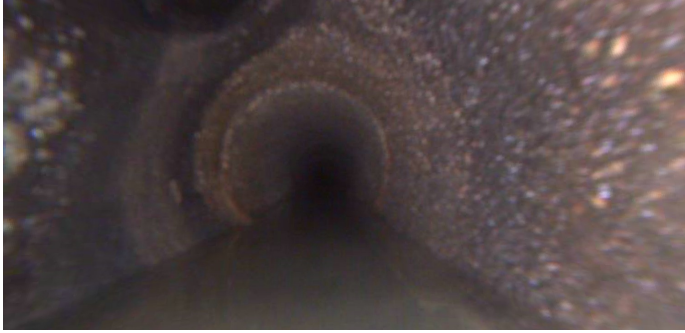
Code: **FM**
Description: **Fracture Multiple**

Distance (ft): **76.0**
Structural Grade: **4**
O&M Grade: **0**
Clock Start/From: **8**
Clock To: **4**
1st Value:
2nd Value:
Value Percent:
Continuous Index: **F04**
Within 8" of Joint: **YES**
Remarks:

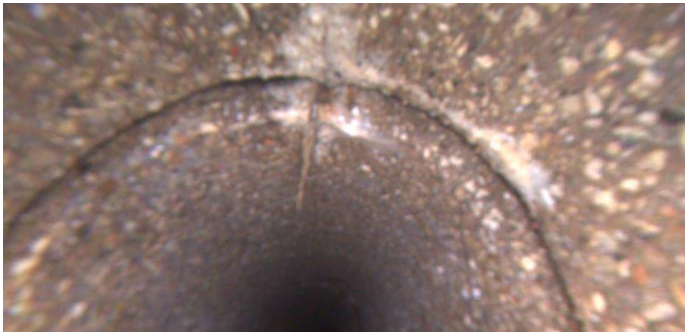
Code: **RFJ**
Description: **Roots Fine Joint**

Distance (ft): **95.6**
Structural Grade: **0**
O&M Grade: **1**
Clock Start/From: **12**
Clock To:
1st Value:
2nd Value:
Value Percent:
Continuous Index:
Within 8" of Joint: **YES**
Remarks:

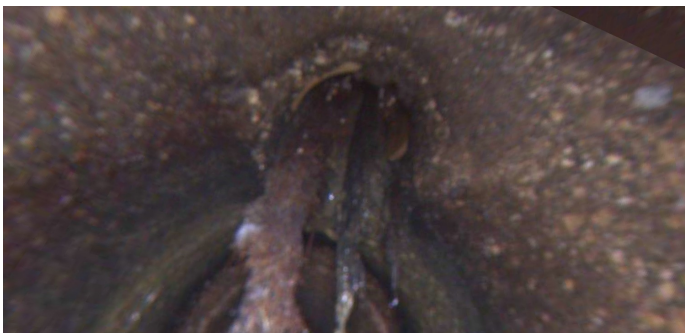
Code: **TFD**
Description: **Tap Factory Defective**

Distance (ft): **115.9**
Structural Grade: **0**
O&M Grade: **2**
Clock Start/From: **12**
Clock To:
1st Value: **4.000**
2nd Value:
Value Percent:
Continuous Index:
Within 8" of Joint:
Remarks: **rml**

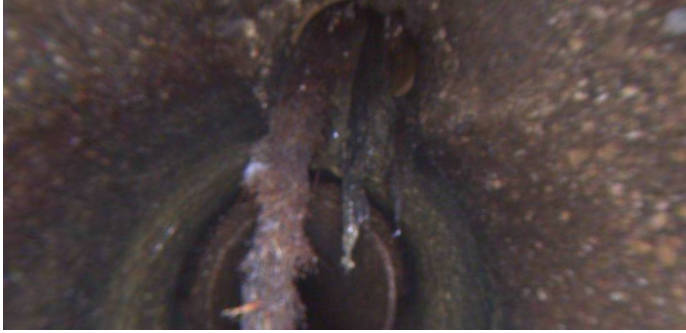
Code: **RML**
Description: **Roots Medium Lateral**

Distance (ft): **115.9**
Structural Grade: **0**
O&M Grade: **3**
Clock Start/From: **12**
Clock To:
1st Value:
2nd Value:
Value Percent: **10.000**
Continuous Index:
Within 8" of Joint: **NO**
Remarks:

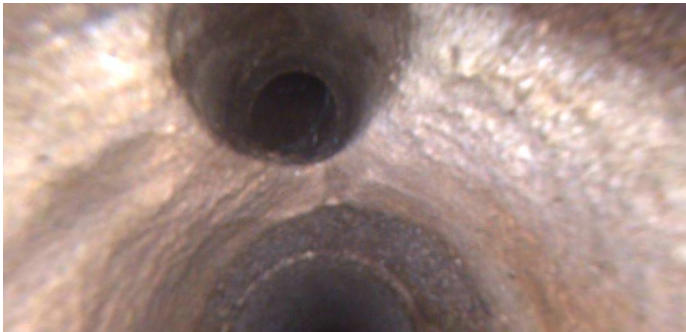
Code: **TF**
Description: **Tap Factory**

Distance (ft): **119.1**
Structural Grade: **0**
O&M Grade: **0**
Clock Start/From: **12**
Clock To:
1st Value: **4.000**
2nd Value:
Value Percent:
Continuous Index:
Within 8" of Joint:
Remarks:

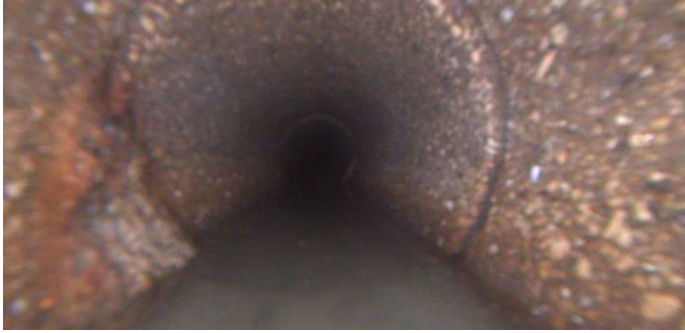
Code: **FL**
Description: **Fracture Longitudinal**

Distance (ft): **144.6**
Structural Grade: **3**
O&M Grade: **0**
Clock Start/From: **3**
Clock To:
1st Value:
2nd Value:
Value Percent:
Continuous Index:
Within 8" of Joint: **YES**
Remarks:

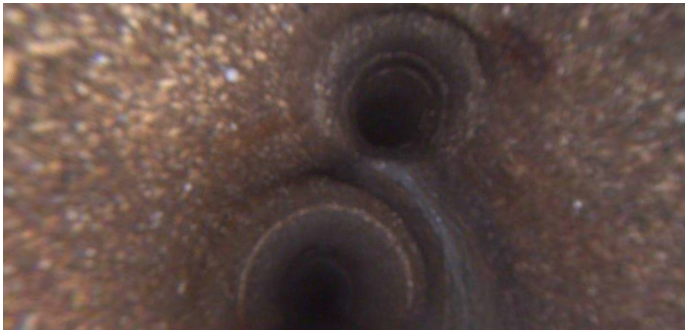
Code: **TF**
Description: **Tap Factory**

Distance (ft): **167.9**
Structural Grade: **0**
O&M Grade: **0**
Clock Start/From: **1**
Clock To:
1st Value: **4.000**
2nd Value:
Value Percent:
Continuous Index:
Within 8" of Joint:
Remarks:

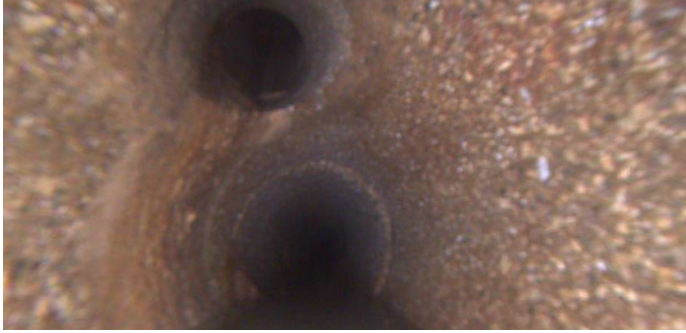
Code: **TF**
Description: **Tap Factory**

Distance (ft): **170.9**
Structural Grade: **0**
O&M Grade: **0**
Clock Start/From: **11**
Clock To:
1st Value: **4.000**
2nd Value:
Value Percent:
Continuous Index:
Within 8" of Joint:
Remarks:

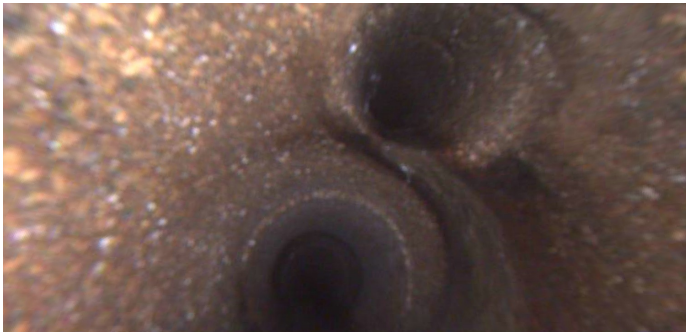
Code: **TFA**
Description: **Tap Factory Active**

Distance (ft): **220.0**
Structural Grade: **0**
O&M Grade: **0**
Clock Start/From: **1**
Clock To:
1st Value: **4.000**
2nd Value:
Value Percent:
Continuous Index:
Within 8" of Joint:
Remarks:

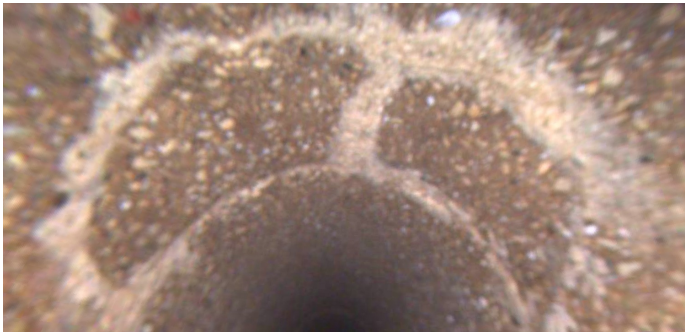
Code: **FM**
Description: **Fracture Multiple**

Distance (ft): **230.1**
Structural Grade: **4**
O&M Grade: **0**
Clock Start/From: **9**
Clock To: **3**
1st Value:
2nd Value:
Value Percent:
Continuous Index:
Within 8" of Joint: **YES**
Remarks:

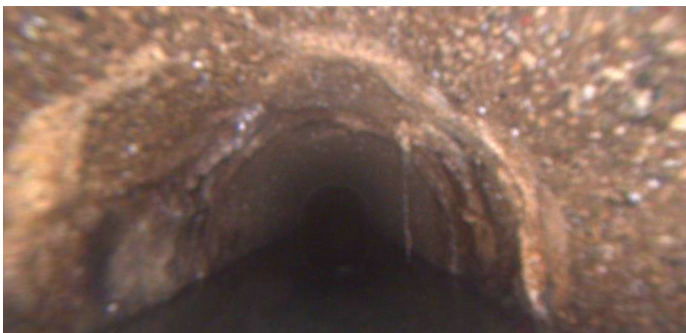
Code: **DAE**
Description: **Deposits Attached Encrustation**

Distance (ft): **315.4**
Structural Grade: **0**
O&M Grade: **2**
Clock Start/From: **8**
Clock To: **4**
1st Value:
2nd Value:
Value Percent: **5.000**
Continuous Index:
Within 8" of Joint: **YES**
Remarks:

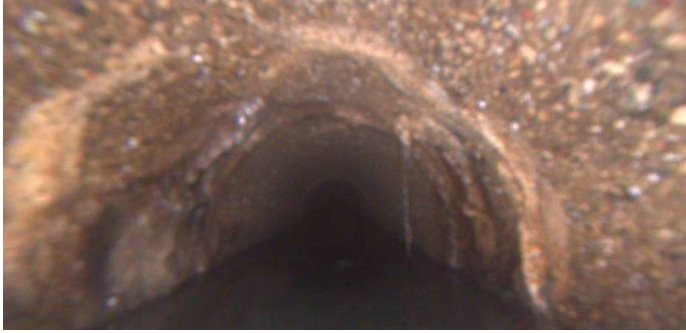
Code: **IW**
Description: **Infil Weeper**

Distance (ft): **315.4**
Structural Grade: **0**
O&M Grade: **2**
Clock Start/From: **8**
Clock To: **4**
1st Value:
2nd Value:
Value Percent:
Continuous Index:
Within 8" of Joint:
Remarks:

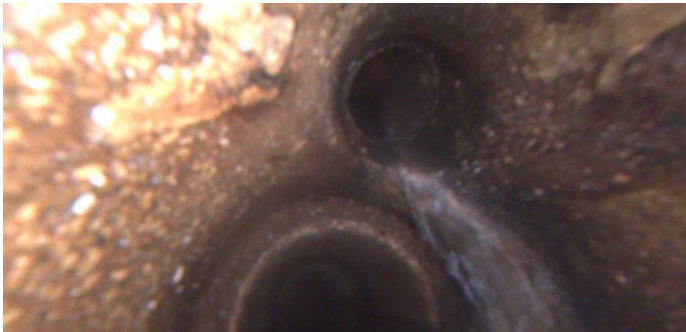
Code: **TFA**
Description: **Tap Factory Active**

Distance (ft): **321.1**
Structural Grade: **0**
O&M Grade: **0**
Clock Start/From: **1**
Clock To:
1st Value: **4.000**
2nd Value:
Value Percent:
Continuous Index:
Within 8" of Joint:
Remarks:

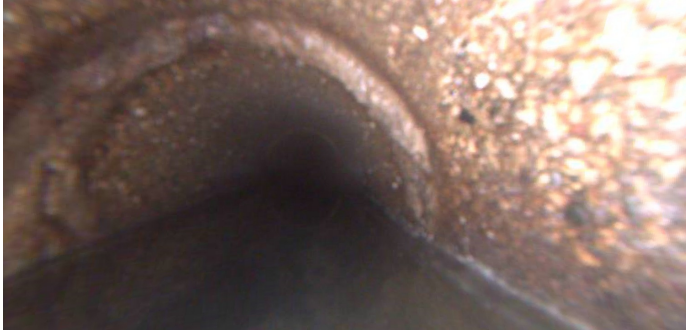
Code: **IW**
Description: **Infil Weeper**

Distance (ft): **328.0**
Structural Grade: **0**
O&M Grade: **2**
Clock Start/From: **8**
Clock To: **4**
1st Value:
2nd Value:
Value Percent:
Continuous Index:
Within 8" of Joint: **YES**
Remarks:

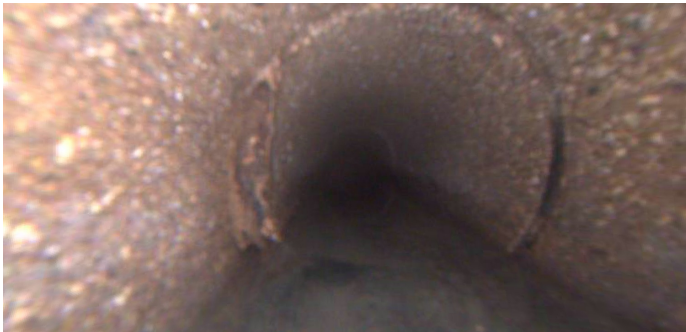
Code: **RFJ**
Description: **Roots Fine Joint**

Distance (ft): **340.1**
Structural Grade: **0**
O&M Grade: **1**
Clock Start/From: **8**
Clock To: **10**
1st Value:
2nd Value:
Value Percent:
Continuous Index:
Within 8" of Joint: **YES**
Remarks:

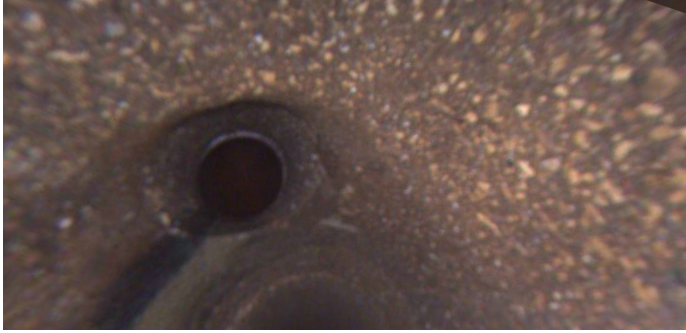
Code: **TF**
Description: **Tap Factory**

Distance (ft): **348.3**
Structural Grade: **0**
O&M Grade: **0**
Clock Start/From: **11**
Clock To:
1st Value: **4.000**
2nd Value:
Value Percent:
Continuous Index:
Within 8" of Joint:
Remarks:

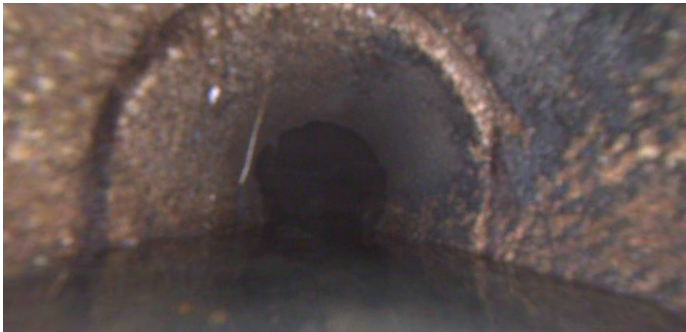
Code: **RFJ**
Description: **Roots Fine Joint**

Distance (ft): **355.7**
Structural Grade: **0**
O&M Grade: **1**
Clock Start/From: **8**
Clock To: **4**
1st Value:
2nd Value:
Value Percent:
Continuous Index:
Within 8" of Joint: **YES**
Remarks:

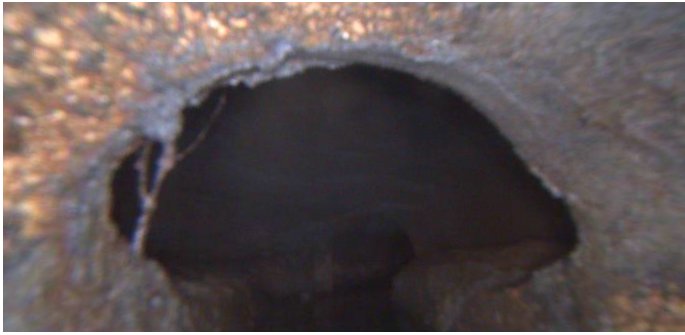
Code: **SAV**
Description: **Surface Aggregate Visible**

Distance (ft): **357.2**
Structural Grade: **3**
O&M Grade: **0**
Clock Start/From: **7**
Clock To: **5**
1st Value:
2nd Value:
Value Percent:
Continuous Index: **F01**
Within 8" of Joint:
Remarks:

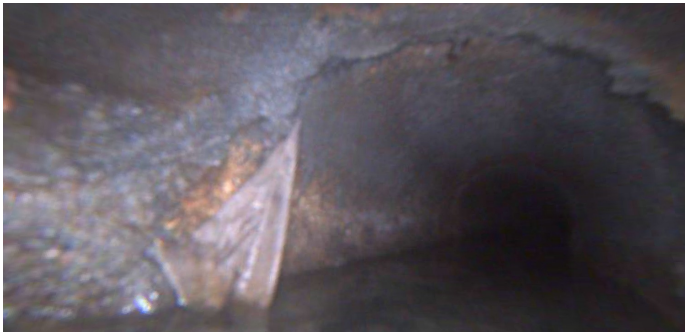
Code: **AMH**
Description: **Manhole**

Distance (ft): **359.5**
Structural Grade: **0**
O&M Grade: **0**
Clock Start/From:
Clock To:
1st Value:
2nd Value:
Value Percent:
Continuous Index:
Within 8" of Joint: **NO**
Remarks: **M-605-067**
