Profile/Photo Observation Report

Date:	04/23/2018	Weather:		Coding:	PACP 6.0
Pipe Length (ft):	364.4	Owner:	NA	Pre Clean:	Not Known
P.O.#:		Surveyor:	Jen Costello	PSR:	P-605-067-066
Customer:		Clean Date:	01/01/1900	Shape:	C

Street:	Beverly Blvd.	Flow Control:	Not Controlled
City:	Hobart, IN	Year Renewed:	
Location:	Other	Tape/Media #:	
Purpose:	Not Known	Dia/Height:	12"
Use:	Sanitary	Material:	CP
Drain Area:	NA	Lining:	
Category:	NA		
Comment:			
Location Details:		Direction of Survey:	Upstream
US MH:	M-605-067	DS MH:	M-605-066
		Total Length Surveyed (ft):	359.5

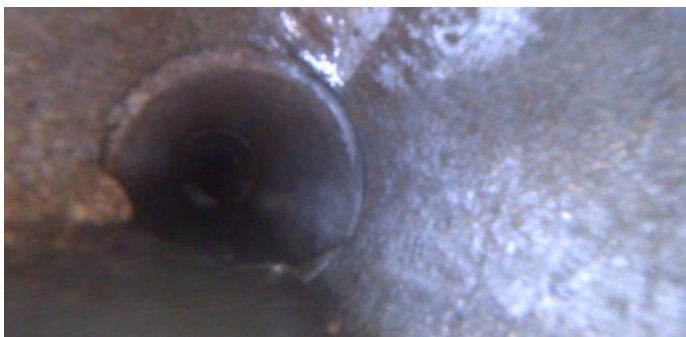
Code: **AMH**
Description: **Manhole**

Distance (ft): **.0**
Structural Grade: **0**
O&M Grade: **0**
Clock Start/From:
Clock To:
1st Value:
2nd Value:
Value Percent:
Continuous Index:
Within 8" of Joint: **NO**
Remarks: **M-605-066**

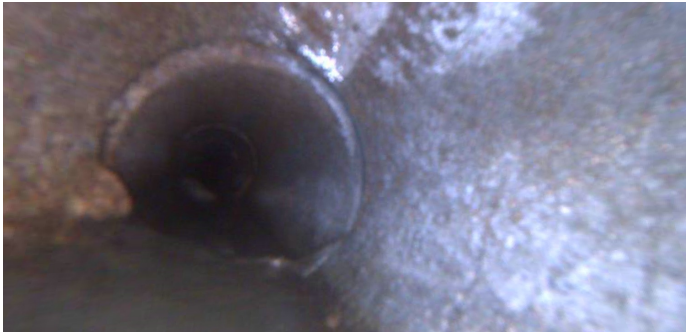
Code: **MWL**
Description: **Water Level**

Distance (ft): **.0**
Structural Grade: **0**
O&M Grade: **0**
Clock Start/From:
Clock To:
1st Value:
2nd Value:
Value Percent: **10.000**
Continuous Index:
Within 8" of Joint: **NO**
Remarks:

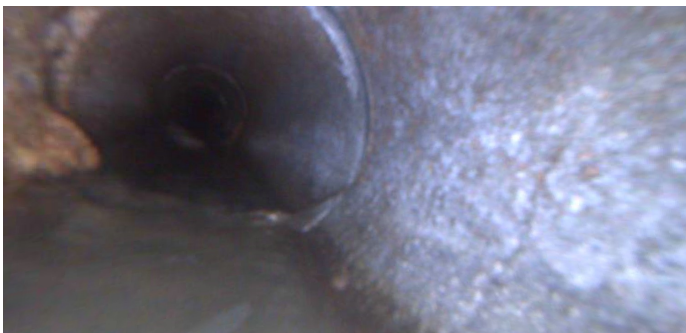
Code: **FC**
Description: **Fracture Circumferential**

Distance (ft): **.5**
Structural Grade: **2**
O&M Grade: **0**
Clock Start/From: **3**
Clock To: **4**
1st Value:
2nd Value:
Value Percent:
Continuous Index:
Within 8" of Joint:
Remarks:

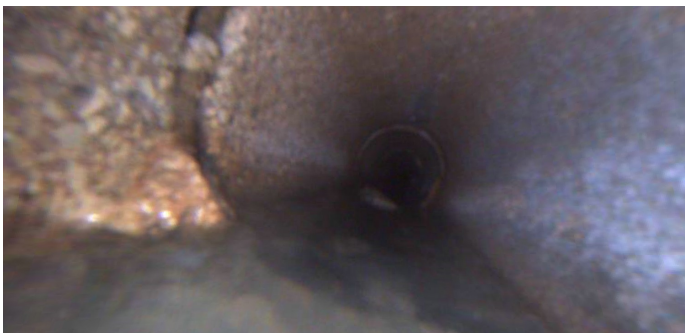
Code: **DAE**
Description: **Deposits Attached Encrustation**

Distance (ft): **2.2**
Structural Grade: **0**
O&M Grade: **2**
Clock Start/From: **8**
Clock To: **9**
1st Value:
2nd Value:
Value Percent: **5.000**
Continuous Index:
Within 8" of Joint: **YES**
Remarks:

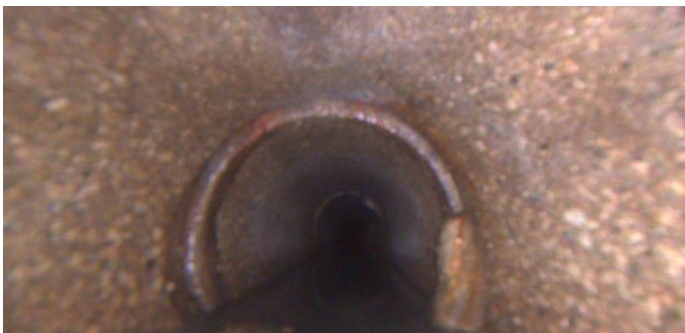
Code: **DAE**
Description: **Deposits Attached Encrustation**

Distance (ft): **4.6**
Structural Grade: **0**
O&M Grade: **2**
Clock Start/From: **8**
Clock To: **4**
1st Value:
2nd Value:
Value Percent: **5.000**
Continuous Index: **S02**
Within 8" of Joint: **YES**
Remarks:

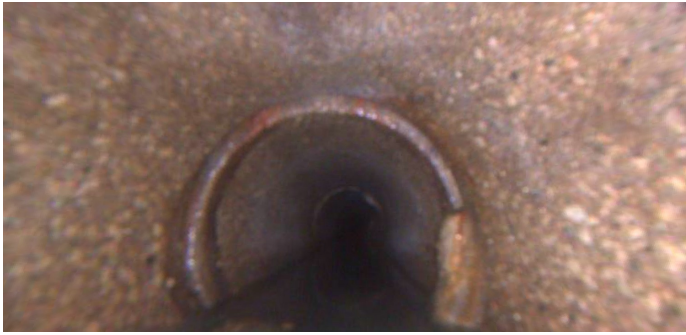
Code: **IW**
Description: **Infil Weeper**

Distance (ft): **4.6**
Structural Grade: **0**
O&M Grade: **2**
Clock Start/From: **8**
Clock To: **4**
1st Value:
2nd Value:
Value Percent:
Continuous Index: **S03**
Within 8" of Joint: **YES**
Remarks:

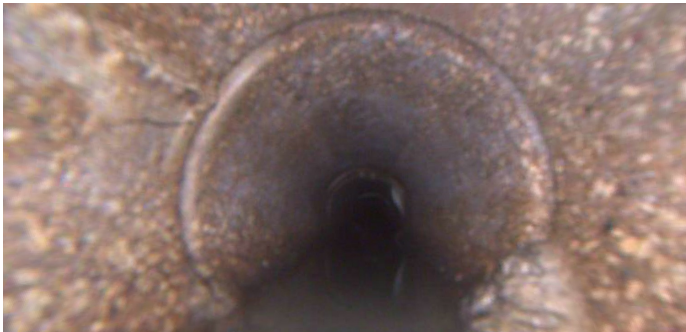
Code: **FM**
Description: **Fracture Multiple**

Distance (ft): **26.2**
Structural Grade: **4**
O&M Grade: **0**
Clock Start/From: **10**
Clock To: **11**
1st Value:
2nd Value:
Value Percent:
Continuous Index:
Within 8" of Joint: **YES**
Remarks:

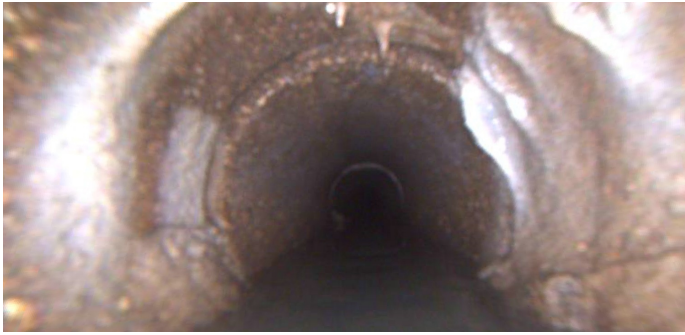
Code: **FM**
Description: **Fracture Multiple**

Distance (ft): **29.1**
Structural Grade: **4**
O&M Grade: **0**
Clock Start/From: **8**
Clock To: **4**
1st Value:
2nd Value:
Value Percent:
Continuous Index: **S04**
Within 8" of Joint: **YES**
Remarks:

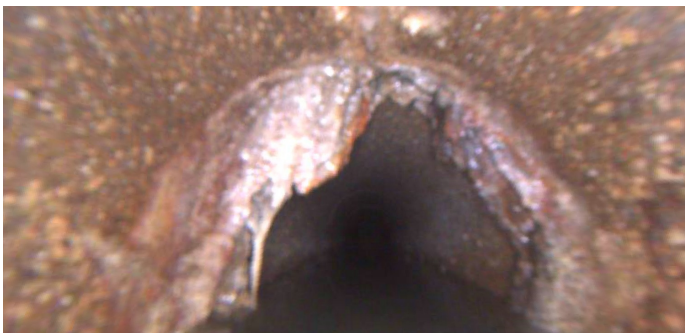
Code: **DAE**
Description: **Deposits Attached Encrustation**

Distance (ft): **64.7**
Structural Grade: **0**
O&M Grade: **3**
Clock Start/From: **8**
Clock To: **4**
1st Value:
2nd Value:
Value Percent: **20.000**
Continuous Index:
Within 8" of Joint: **YES**
Remarks:

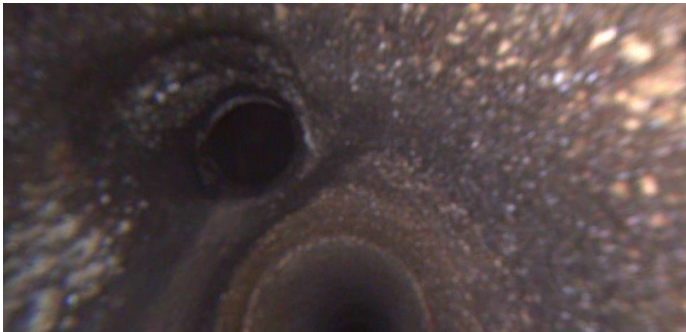
Code: **TF**
Description: **Tap Factory**

Distance (ft): **76.0**
Structural Grade: **0**
O&M Grade: **0**
Clock Start/From: **11**
Clock To:
1st Value: **4.000**
2nd Value:
Value Percent:
Continuous Index:
Within 8" of Joint:
Remarks:

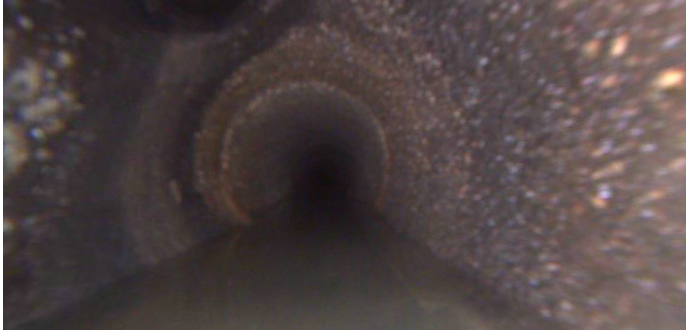
Code: **FM**
Description: **Fracture Multiple**

Distance (ft): **76.0**
Structural Grade: **4**
O&M Grade: **0**
Clock Start/From: **8**
Clock To: **4**
1st Value:
2nd Value:
Value Percent:
Continuous Index: **F04**
Within 8" of Joint: **YES**
Remarks:

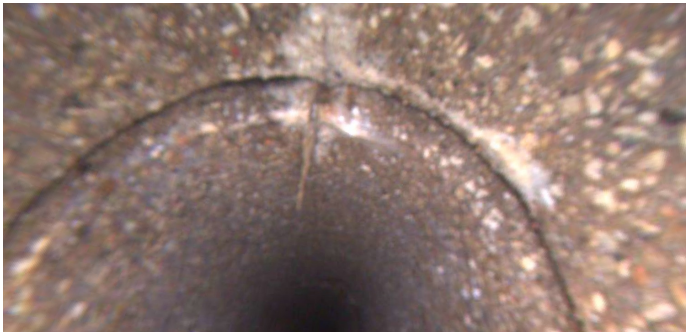
Code: **RFJ**
Description: **Roots Fine Joint**

Distance (ft): **95.6**
Structural Grade: **0**
O&M Grade: **1**
Clock Start/From: **12**
Clock To:
1st Value:
2nd Value:
Value Percent:
Continuous Index:
Within 8" of Joint: **YES**
Remarks:

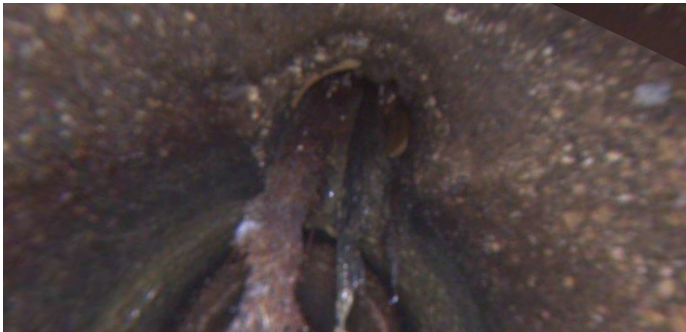
Code: **TFD**
Description: **Tap Factory Defective**

Distance (ft): **115.9**
Structural Grade: **0**
O&M Grade: **2**
Clock Start/From: **12**
Clock To:
1st Value: **4.000**
2nd Value:
Value Percent:
Continuous Index:
Within 8" of Joint:
Remarks: **rml**

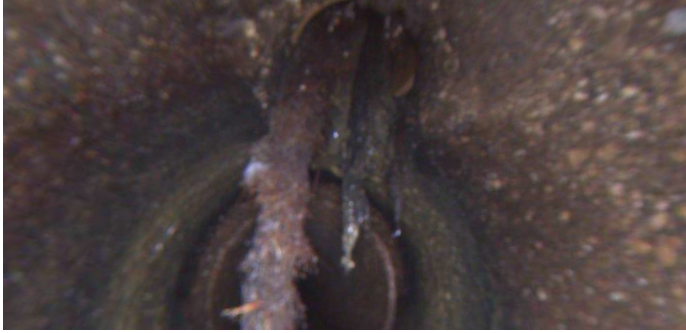
Code: **RML**
Description: **Roots Medium Lateral**

Distance (ft): **115.9**
Structural Grade: **0**
O&M Grade: **3**
Clock Start/From: **12**
Clock To:
1st Value:
2nd Value:
Value Percent: **10.000**
Continuous Index:
Within 8" of Joint: **NO**
Remarks:

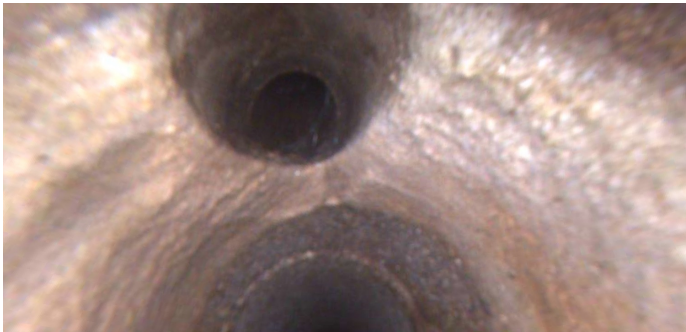
Code: **TF**
Description: **Tap Factory**

Distance (ft): **119.1**
Structural Grade: **0**
O&M Grade: **0**
Clock Start/From: **12**
Clock To:
1st Value: **4.000**
2nd Value:
Value Percent:
Continuous Index:
Within 8" of Joint:
Remarks:

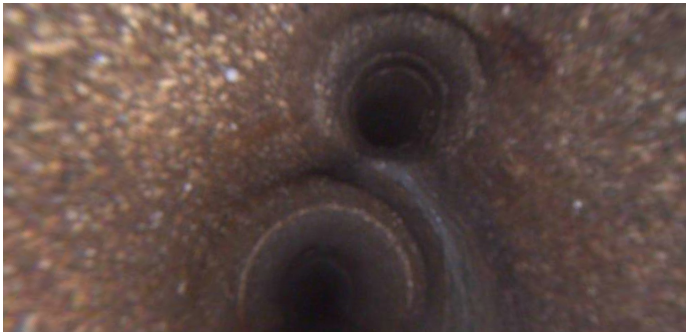
Code: **TF**
Description: **Tap Factory**

Distance (ft): **167.9**
Structural Grade: **0**
O&M Grade: **0**
Clock Start/From: **1**
Clock To:
1st Value: **4.000**
2nd Value:
Value Percent:
Continuous Index:
Within 8" of Joint:
Remarks:

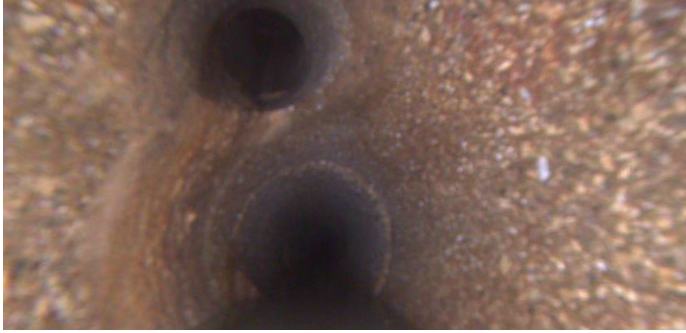
Code: **TF**
Description: **Tap Factory**

Distance (ft): **170.9**
Structural Grade: **0**
O&M Grade: **0**
Clock Start/From: **11**
Clock To:
1st Value: **4.000**
2nd Value:
Value Percent:
Continuous Index:
Within 8" of Joint:
Remarks:

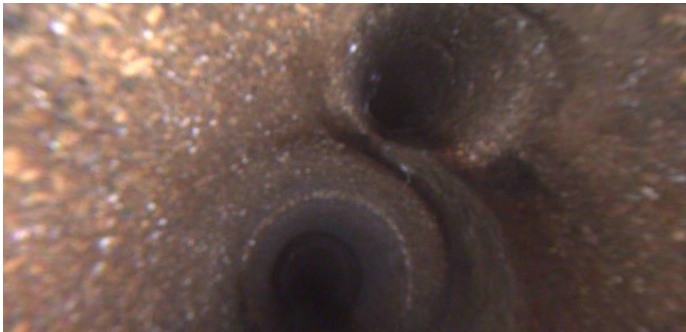
Code: **TFA**
Description: **Tap Factory Active**

Distance (ft): **220.0**
Structural Grade: **0**
O&M Grade: **0**
Clock Start/From: **1**
Clock To:
1st Value: **4.000**
2nd Value:
Value Percent:
Continuous Index:
Within 8" of Joint:
Remarks:

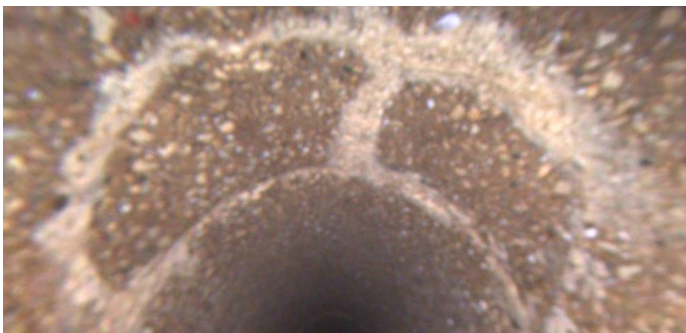
Code: **FM**
Description: **Fracture Multiple**

Distance (ft): **230.1**
Structural Grade: **4**
O&M Grade: **0**
Clock Start/From: **9**
Clock To: **3**
1st Value:
2nd Value:
Value Percent:
Continuous Index:
Within 8" of Joint: **YES**
Remarks:

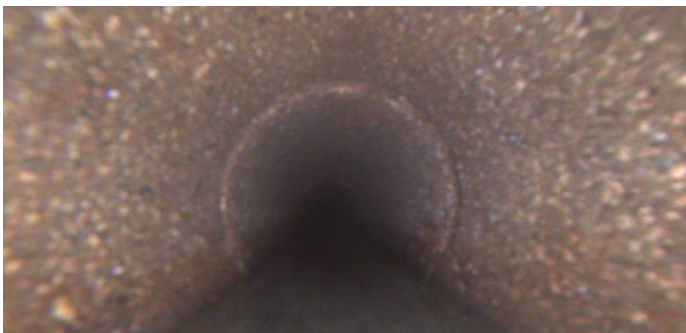
Code: **DAE**
Description: **Deposits Attached Encrustation**

Distance (ft): **306.1**
Structural Grade: **0**
O&M Grade: **2**
Clock Start/From: **8**
Clock To: **4**
1st Value:
2nd Value:
Value Percent: **5.000**
Continuous Index: **F02**
Within 8" of Joint: **YES**
Remarks:

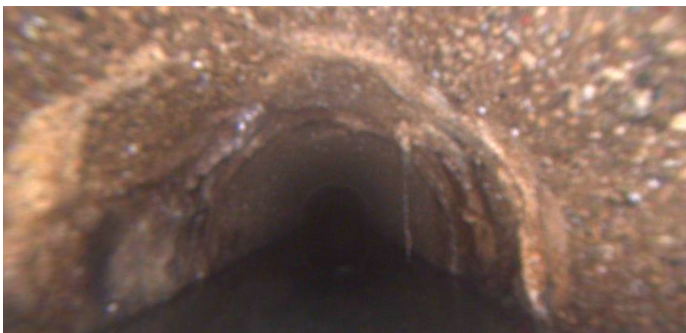
Code: **DAE**
Description: **Deposits Attached Encrustation**

Distance (ft): **315.4**
Structural Grade: **0**
O&M Grade: **2**
Clock Start/From: **8**
Clock To: **4**
1st Value:
2nd Value:
Value Percent: **5.000**
Continuous Index:
Within 8" of Joint: **YES**
Remarks:

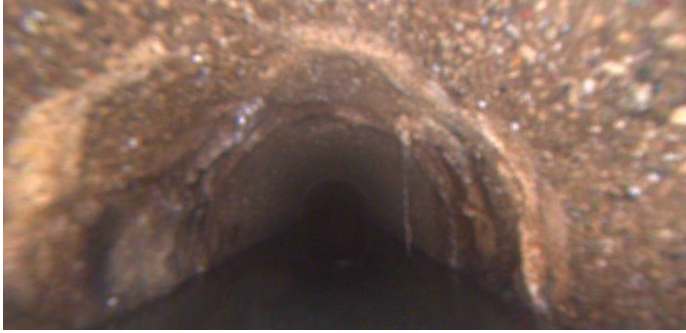
Code: **IW**
Description: **Infil Weeper**

Distance (ft): **315.4**
Structural Grade: **0**
O&M Grade: **2**
Clock Start/From: **8**
Clock To: **4**
1st Value:
2nd Value:
Value Percent:
Continuous Index:
Within 8" of Joint:
Remarks:

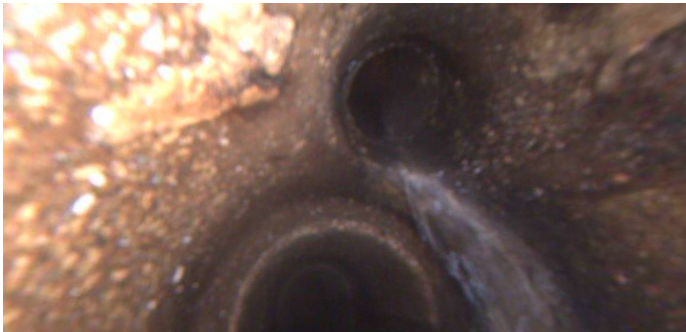
Code: **TFA**
Description: **Tap Factory Active**

Distance (ft): **321.1**
Structural Grade: **0**
O&M Grade: **0**
Clock Start/From: **1**
Clock To:
1st Value: **4.000**
2nd Value:
Value Percent:
Continuous Index:
Within 8" of Joint:
Remarks:

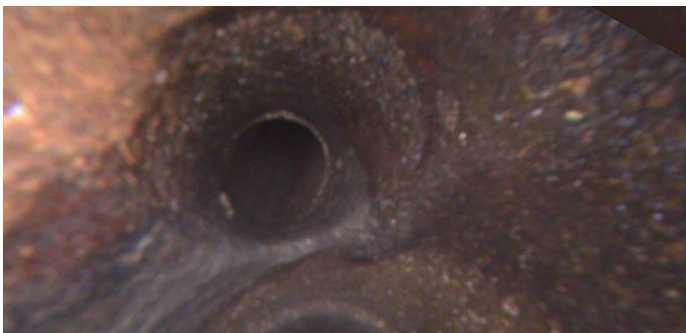
Code: **TF**
Description: **Tap Factory**

Distance (ft): **324.1**
Structural Grade: **0**
O&M Grade: **0**
Clock Start/From: **11**
Clock To:
1st Value: **4.000**
2nd Value:
Value Percent:
Continuous Index:
Within 8" of Joint:
Remarks:

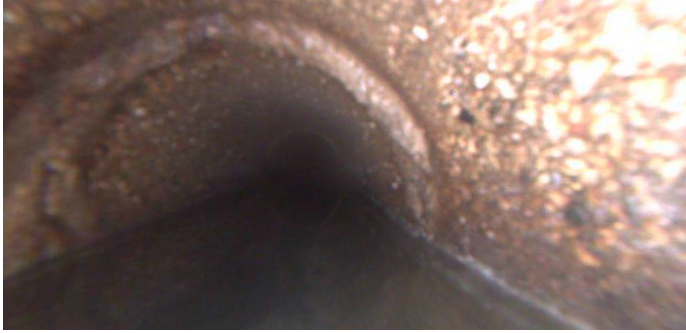
Code: **IW**
Description: **Infil Weeper**

Distance (ft): **328.0**
Structural Grade: **0**
O&M Grade: **2**
Clock Start/From: **8**
Clock To: **4**
1st Value:
2nd Value:
Value Percent:
Continuous Index:
Within 8" of Joint: **YES**
Remarks:

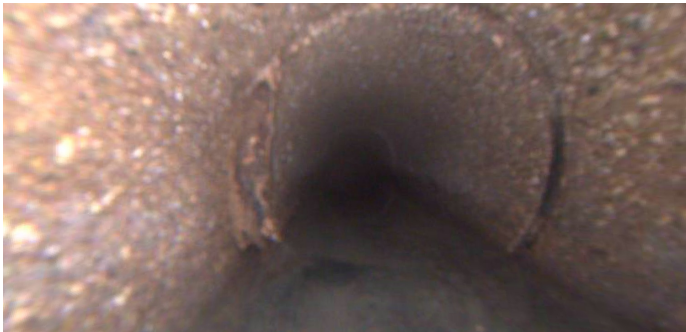
Code: **RFJ**
Description: **Roots Fine Joint**

Distance (ft): **340.1**
Structural Grade: **0**
O&M Grade: **1**
Clock Start/From: **8**
Clock To: **10**
1st Value:
2nd Value:
Value Percent:
Continuous Index:
Within 8" of Joint: **YES**
Remarks:

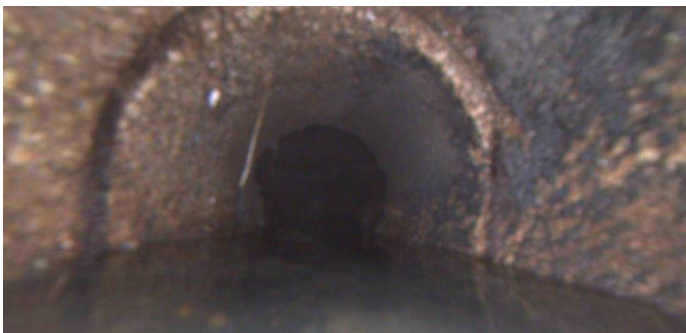
Code: **RFJ**
Description: **Roots Fine Joint**

Distance (ft): **355.7**
Structural Grade: **0**
O&M Grade: **1**
Clock Start/From: **8**
Clock To: **4**
1st Value:
2nd Value:
Value Percent:
Continuous Index:
Within 8" of Joint: **YES**
Remarks:

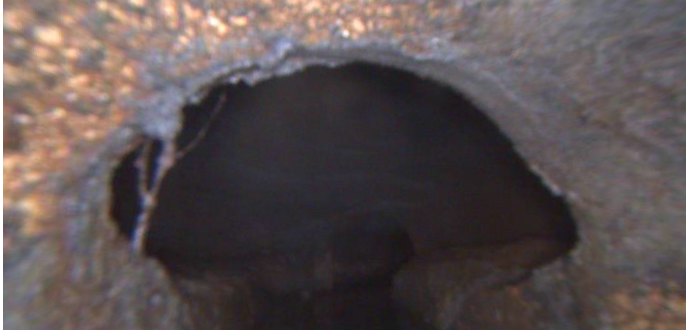
Code: **SAV**
Description: **Surface Aggregate Visible**

Distance (ft): **357.2**
Structural Grade: **3**
O&M Grade: **0**
Clock Start/From: **7**
Clock To: **5**
1st Value:
2nd Value:
Value Percent:
Continuous Index: **F01**
Within 8" of Joint:
Remarks:

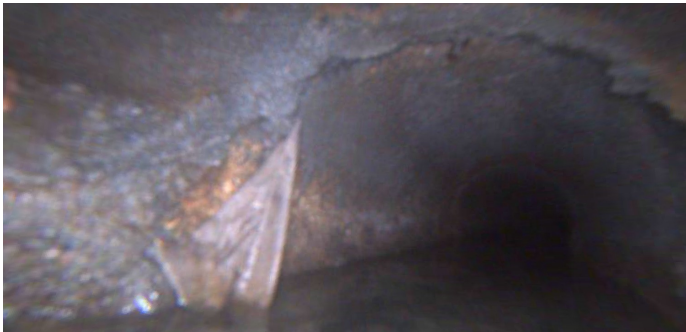
Code: **AMH**
Description: **Manhole**

Distance (ft): **359.5**
Structural Grade: **0**
O&M Grade: **0**
Clock Start/From:
Clock To:
1st Value:
2nd Value:
Value Percent:
Continuous Index:
Within 8" of Joint: **NO**
Remarks: **M-605-067**
