Profile/Photo Observation Report

Street:	South Lake Park	Flow Control:	Not Controlled
City:	Hobart, IN	Year Renewed:	
Location:	Light Highway	Tape/Media #:	DEP299
Purpose:	Routine Assessment	Dia/Height:	18"
Use:	Sanitary	Material:	VCP
Drain Area:		Lining:	
Category:	NA		
Comment:	5-21-2018

Location Details:		Direction of Survey:	Upstream
US MH:	M-606-003	DS MH:	M-606-004
		Total Length Surveyed (ft):	23.0

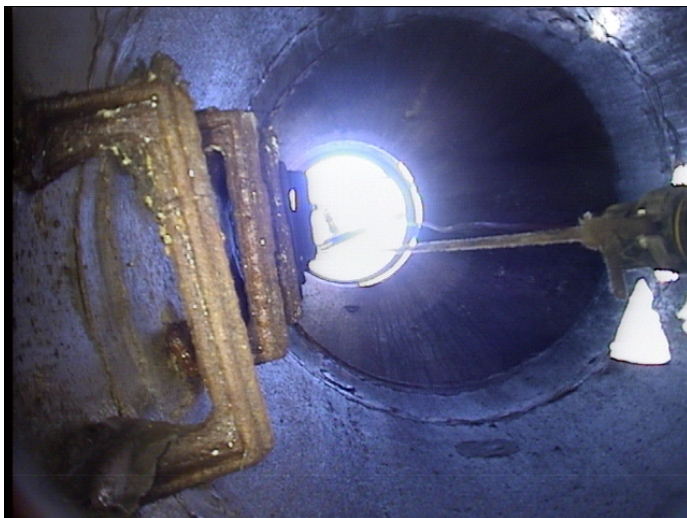
Code: **AMH**
Description: **Manhole**

Distance (ft): **.0**
Structural Grade: **0**
O&M Grade: **0**
Clock Start/From:
Clock To:
1st Value:
2nd Value:
Value Percent:
Continuous Index:
Within 8" of Joint: **NO**
Remarks: **M-606-004**

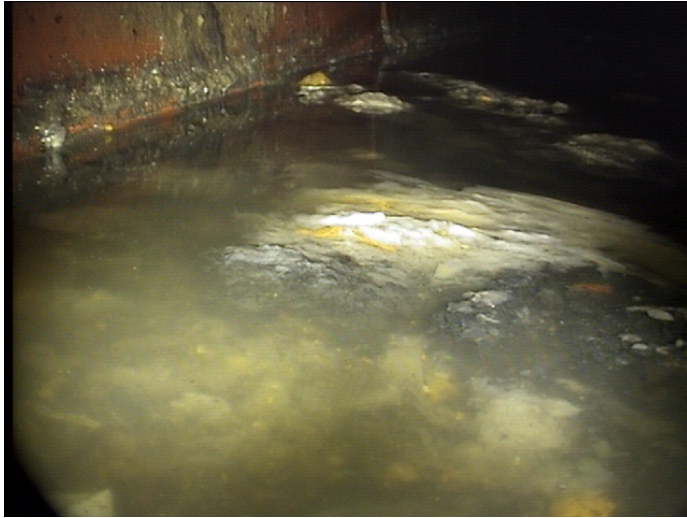
Code: **MWL**
Description: **Water Level**

Distance (ft): **.0**
Structural Grade: **0**
O&M Grade: **0**
Clock Start/From:
Clock To:
1st Value:
2nd Value:
Value Percent: **25.000**
Continuous Index:
Within 8" of Joint: **NO**
Remarks:

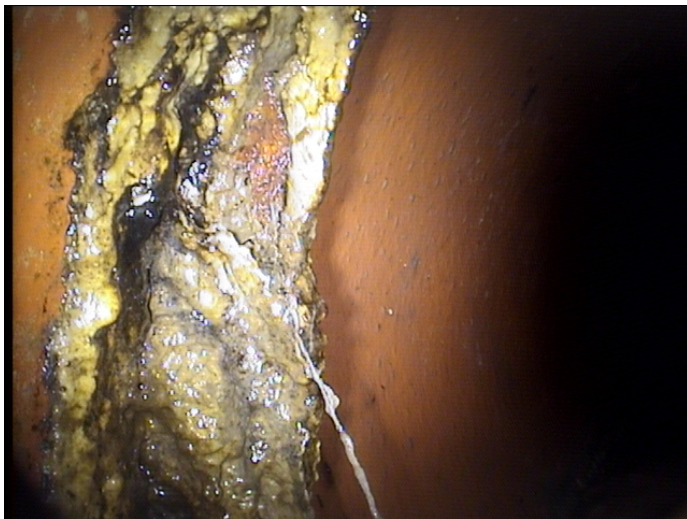
Code: **DAE**
Description: **Deposits Attached Encrustation**

Distance (ft): **17.3**
Structural Grade: **0**
O&M Grade: **2**
Clock Start/From: **8**
Clock To: **2**
1st Value:
2nd Value:
Value Percent: **5.000**
Continuous Index:
Within 8" of Joint: **YES**
Remarks:

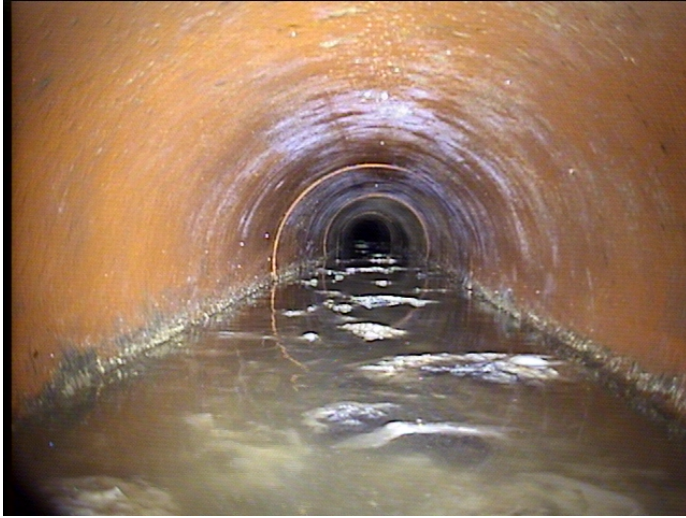
Code: **DSF**
Description: **Deposits Settled Fine**

Distance (ft): **17.3**
Structural Grade: **0**
O&M Grade: **4**
Clock Start/From: **4**
Clock To: **8**
1st Value:
2nd Value:
Value Percent: **25.000**
Continuous Index: **S01**
Within 8" of Joint: **NO**
Remarks:

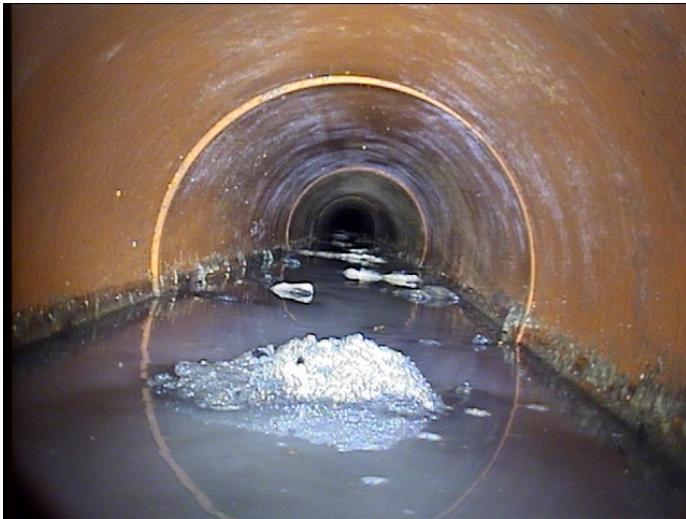
Code: **DSF**
Description: **Deposits Settled Fine**

Distance (ft): **23.0**
Structural Grade: **0**
O&M Grade: **4**
Clock Start/From: **4**
Clock To: **8**
1st Value:
2nd Value:
Value Percent: **25.000**
Continuous Index: **F01**
Within 8" of Joint: **NO**
Remarks:

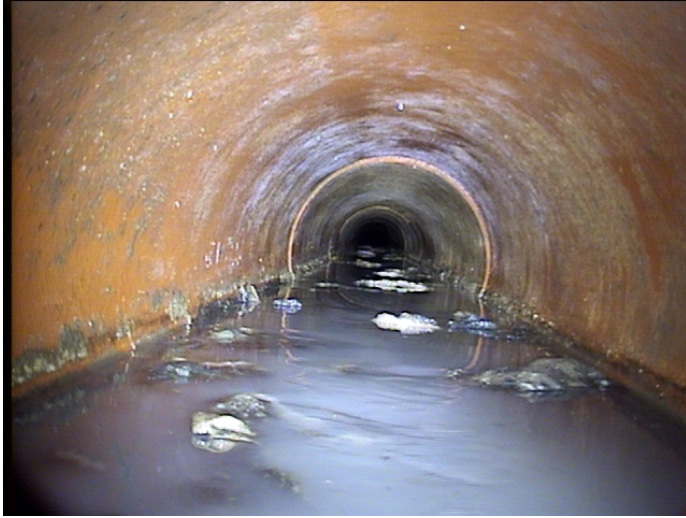
Code:	MSA
Description:	Abandoned Survey
Distance (ft):	23.0
Structural Grade:	0
O&M Grade:	0
Clock Start/From:	
Clock To:	
1st Value:	
2nd Value:	
Value Percent:	
Continuous Index:	
Within 8" of Joint:	NO
Remarks:	Heavy Sediment
