Profile/Photo Observation Report

Date:	05/04/2018	Weather:		Coding:	PACP 6.0
Pipe Length (ft):		Owner:	City of Hobart	Pre Clean:	Not Known
P.O.#:	296	Surveyor:	B. Helbling	PSR:	P-606-004-005
Customer:	City of Hobart	Clean Date:		Shape:	C

Street:	South Lake Park	Flow Control:	Not Controlled
City:	Hobart, IN	Year Renewed:	
Location:	Light Highway	Tape/Media #:	DEP296
Purpose:	Routine Assessment	Dia/Height:	18"
Use:	Sanitary	Material:	VCP
Drain Area:		Lining:	
Category:	NA		
Comment:	5-21-2018		
Location Details:		Direction of Survey:	Upstream
US MH:	M-606-004	DS MH:	M-606-005
		Total Length Surveyed (ft):	41.0

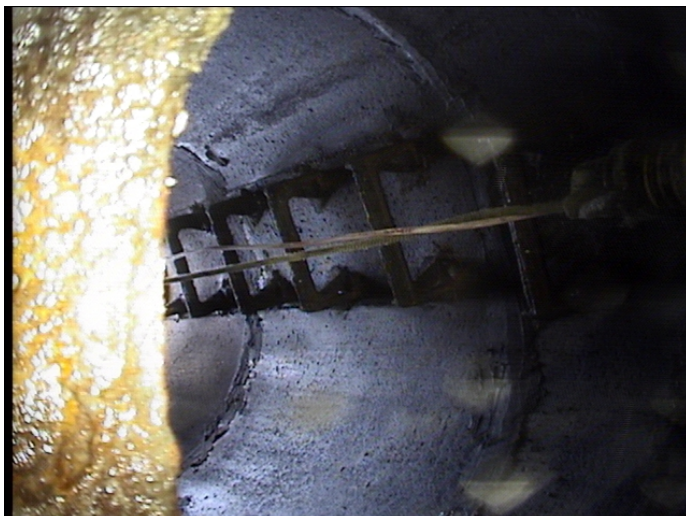
Code: **AMH**
 Description: **Manhole**

Distance (ft): **.0**
 Structural Grade: **0**
 O&M Grade: **0**
 Clock Start/From:
 Clock To:
 1st Value:
 2nd Value:
 Value Percent:
 Continuous Index:
 Within 8" of Joint: **NO**
 Remarks: **M-606-005**

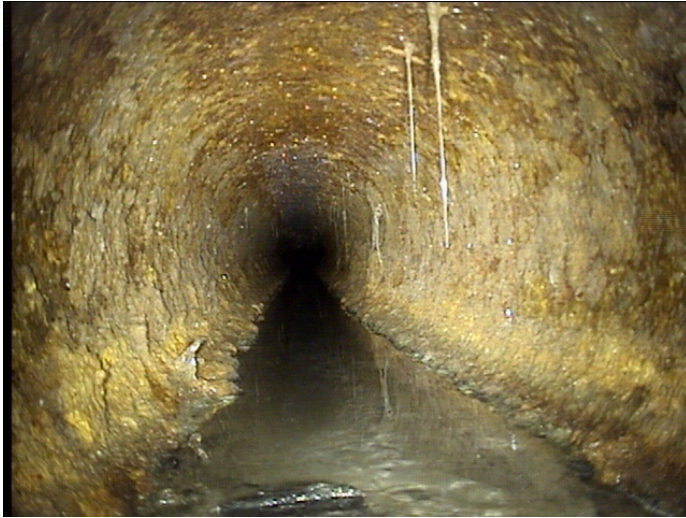
Code: **MWL**
Description: **Water Level**

Distance (ft): **.0**
Structural Grade: **0**
O&M Grade: **0**
Clock Start/From:
Clock To:
1st Value:
2nd Value:
Value Percent: **5.000**
Continuous Index:
Within 8" of Joint: **NO**
Remarks:

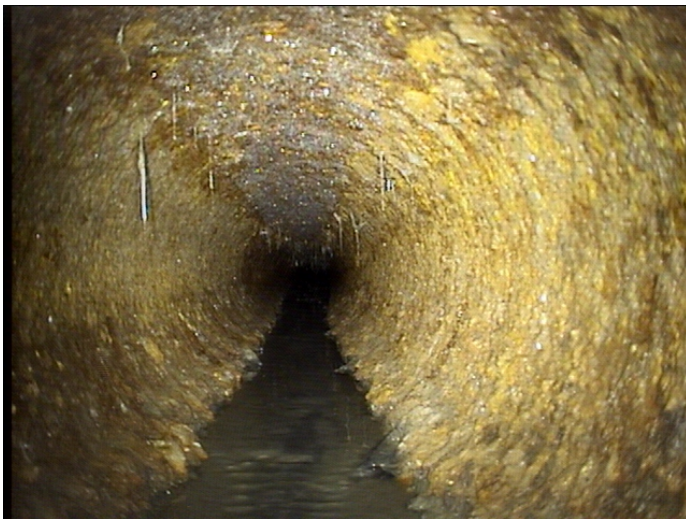
Code: **DAE**
Description: **Deposits Attached Encrustation**

Distance (ft): **12.6**
Structural Grade: **0**
O&M Grade: **2**
Clock Start/From: **7**
Clock To: **5**
1st Value:
2nd Value:
Value Percent: **5.000**
Continuous Index: **S01**
Within 8" of Joint: **NO**
Remarks:

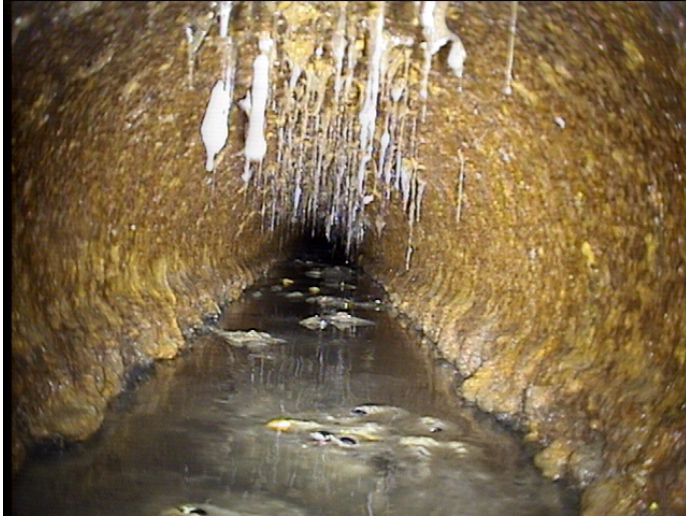
Code: **DSF**
Description: **Deposits Settled Fine**

Distance (ft): **29.9**
Structural Grade: **0**
O&M Grade: **2**
Clock Start/From: **5**
Clock To: **7**
1st Value:
2nd Value:
Value Percent: **5.000**
Continuous Index: **S02**
Within 8" of Joint: **NO**
Remarks:

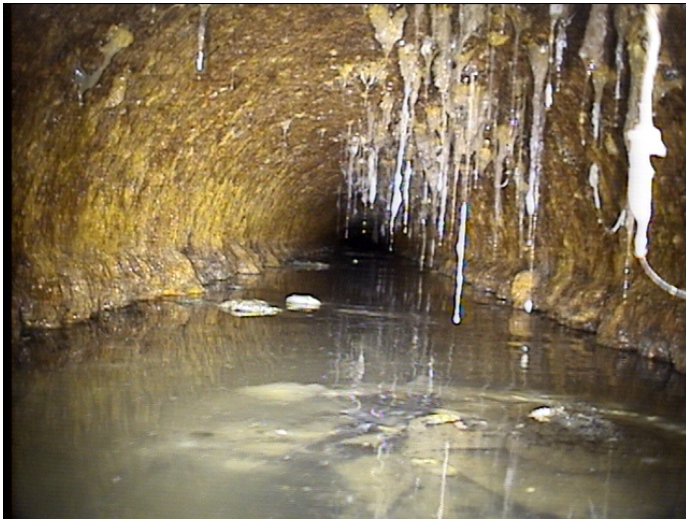
Code: **DAE**
Description: **Deposits Attached Encrustation**

Distance (ft): **41.0**
Structural Grade: **0**
O&M Grade: **2**
Clock Start/From: **7**
Clock To: **5**
1st Value:
2nd Value:
Value Percent: **5.000**
Continuous Index: **F01**
Within 8" of Joint: **NO**
Remarks:

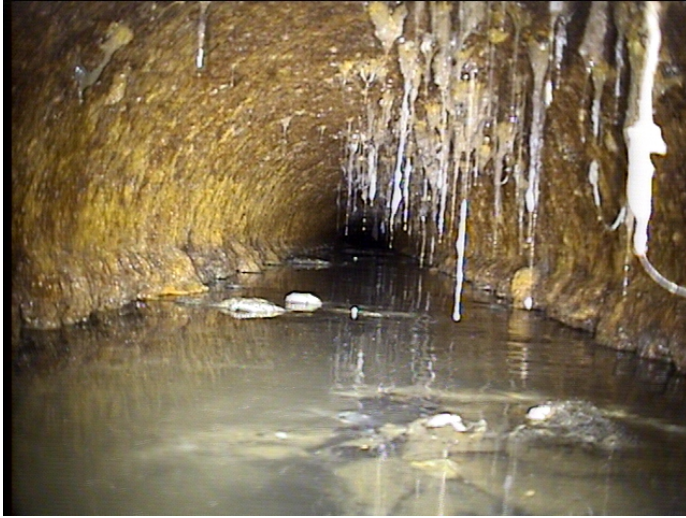
Code:	DSF
Description:	Deposits Settled Fine
Distance (ft):	41.0
Structural Grade:	0
O&M Grade:	2
Clock Start/From:	5
Clock To:	7
1st Value:	
2nd Value:	
Value Percent:	5.000
Continuous Index:	F02
Within 8" of Joint:	NO
Remarks:

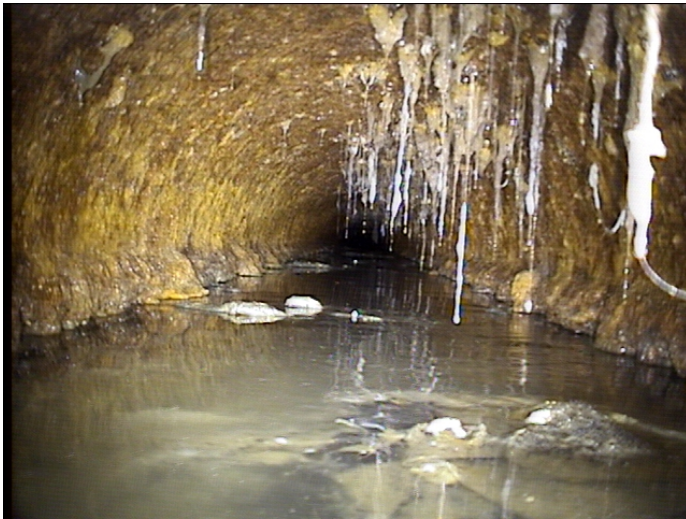
Code:	MSA
Description:	Abandoned Survey
Distance (ft):	41.0
Structural Grade:	0
O&M Grade:	0
Clock Start/From:	
Clock To:	
1st Value:	
2nd Value:	
Value Percent:	
Continuous Index:	
Within 8" of Joint:	NO
Remarks:	Heavy sediment
